## CONDITION SURVEY REPORT

**PALMA DEL MAR 5**

**CONDOMINIUM**

**6372 PALMA DEL MAR BLVD. S.**

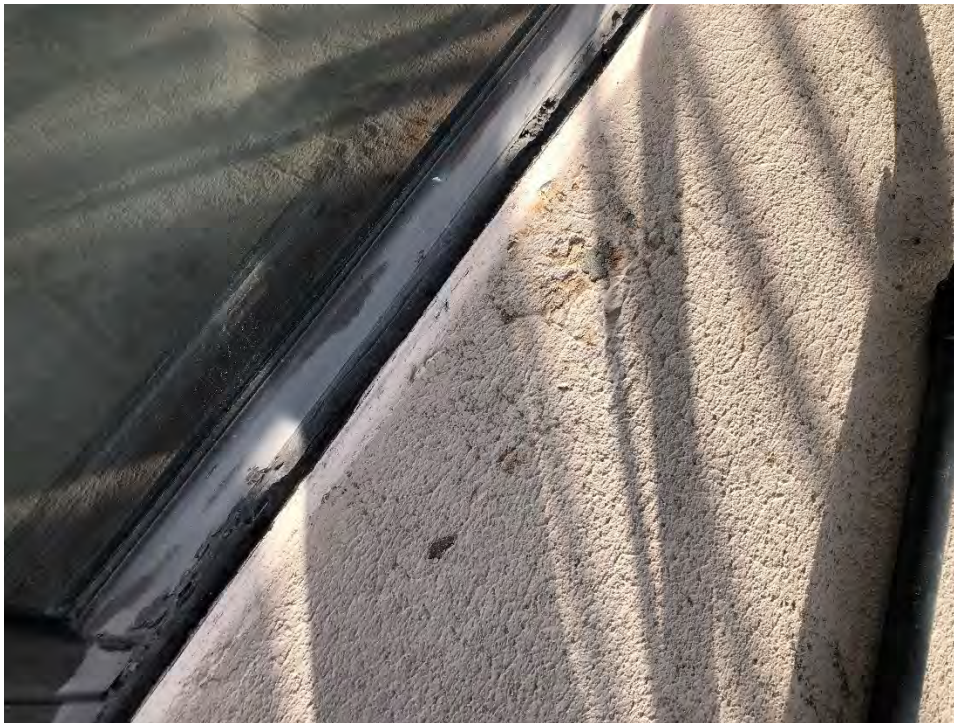
- Localized areas of unsound concrete/concrete spalls were observed at Unit 1202 and 906 (Refer to Figure A-8).
- Areas of delaminated exterior stucco ceiling finishes were observed at Unit 1106, 906, and 801 (Refer to Figure A-9).

*Figure A- 8 – Unit 906 Area of Unsound Concrete/Concrete Spall*

2. Concrete repair for spalls and cracks on concrete surfaces.
3. Repair of delaminated and/or cracked exterior wall stucco finishes.
4. Installation of a pedestrian grade waterproofing deck membrane as preventative maintenance to all elevated balcony concrete slab surfaces to slow further corrosion and concrete deterioration. Waterproofing membrane installation should include the following:

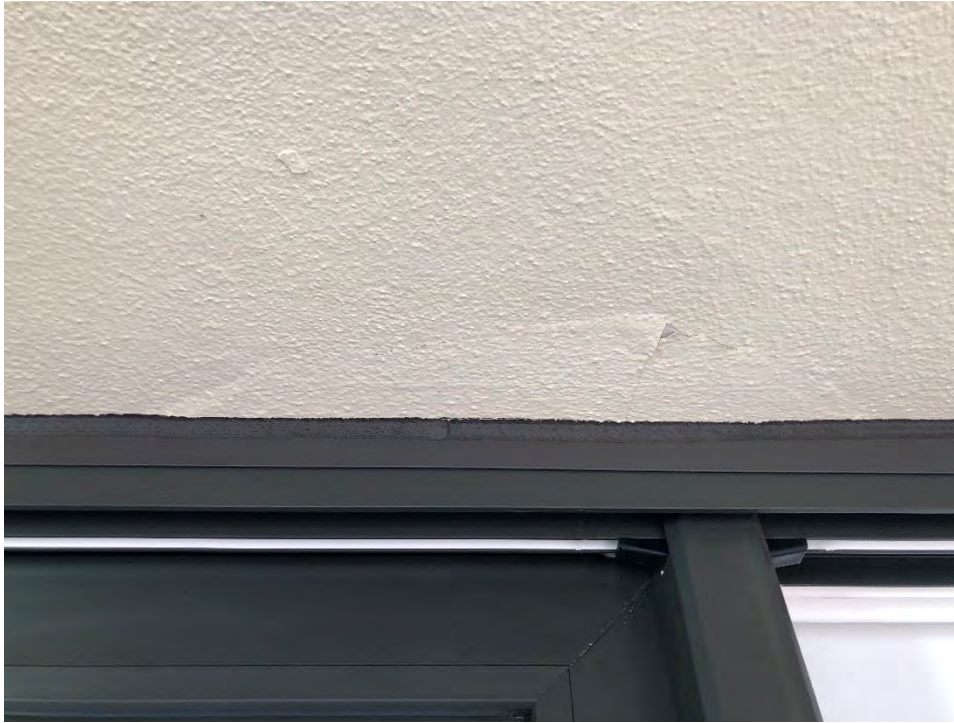
*Figure A- 9 – Unit 1106 Delaminated Exterior Stucco Ceiling Finishes*

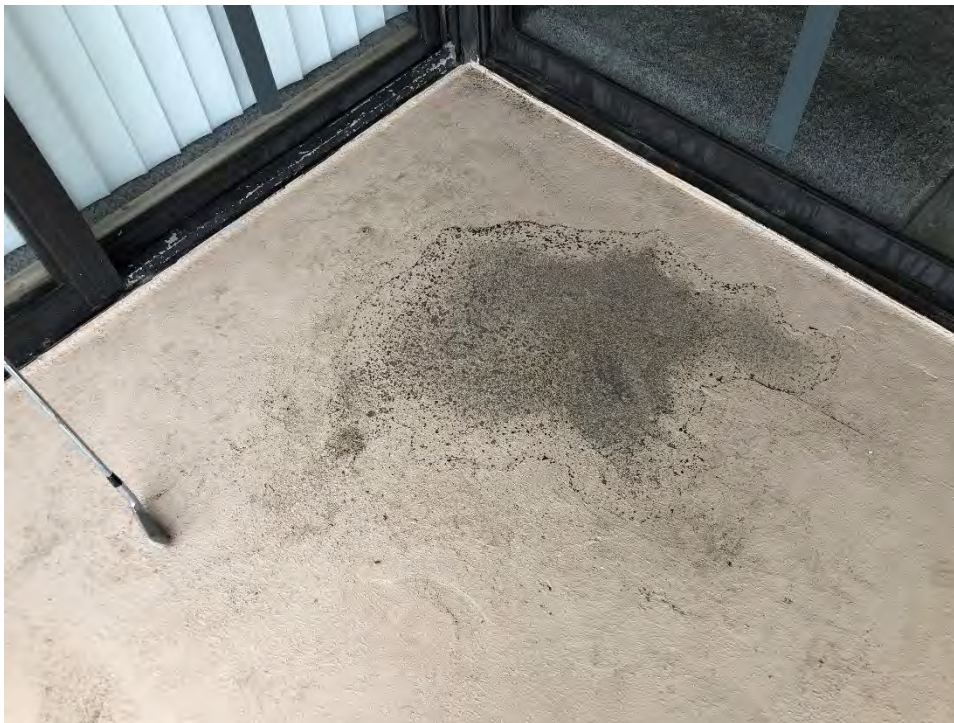
- Ponding water stains were observed along the floor surface of Unit 704 (Refer to Figure A-10).

*Figure A- 10 – Unit 704 Ponding Water Stains*

- a. Removal of all existing elevated balcony floor coatings/finishes.
  - b. Water testing of balcony surfaces to identify potential areas of ponding water and application of a concrete overlay to reduce ponding water where possible.

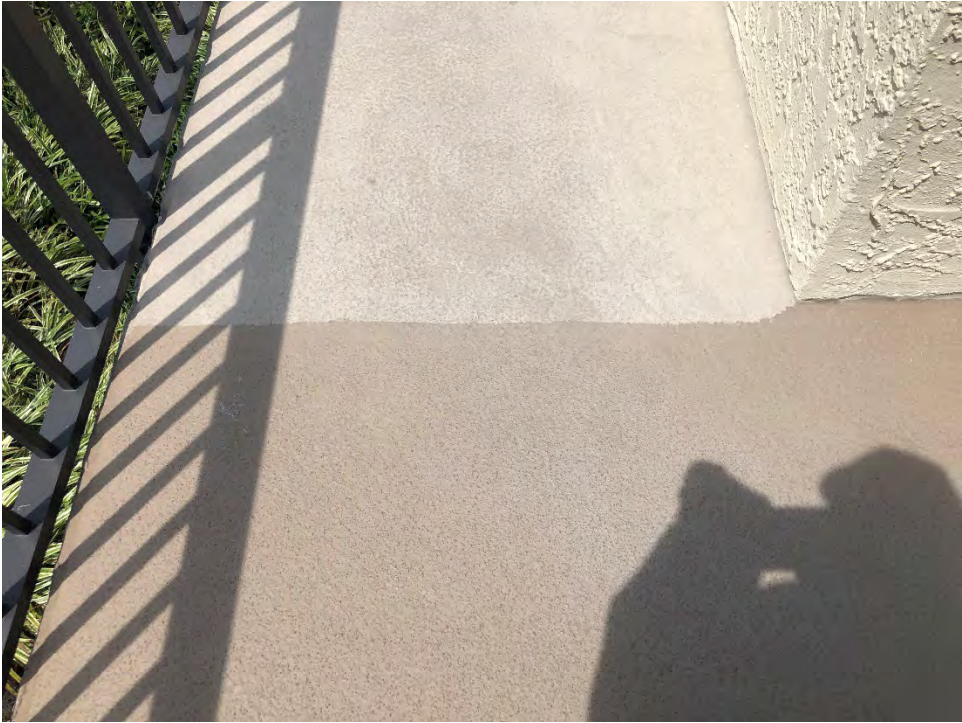
- Localized areas of peeling paint and/or oxidization were observed on guardrails components (Refer to Figure B-9 and Figure B-10).
- Deteriorated waterproofing membrane top coating were observed on the west end of the walkways and stairways with the east end appearing to have been recently recoated (Refer to Figure B-11).

Figure B- 11 – Deteriorated Waterproofing Membrane Top Coating

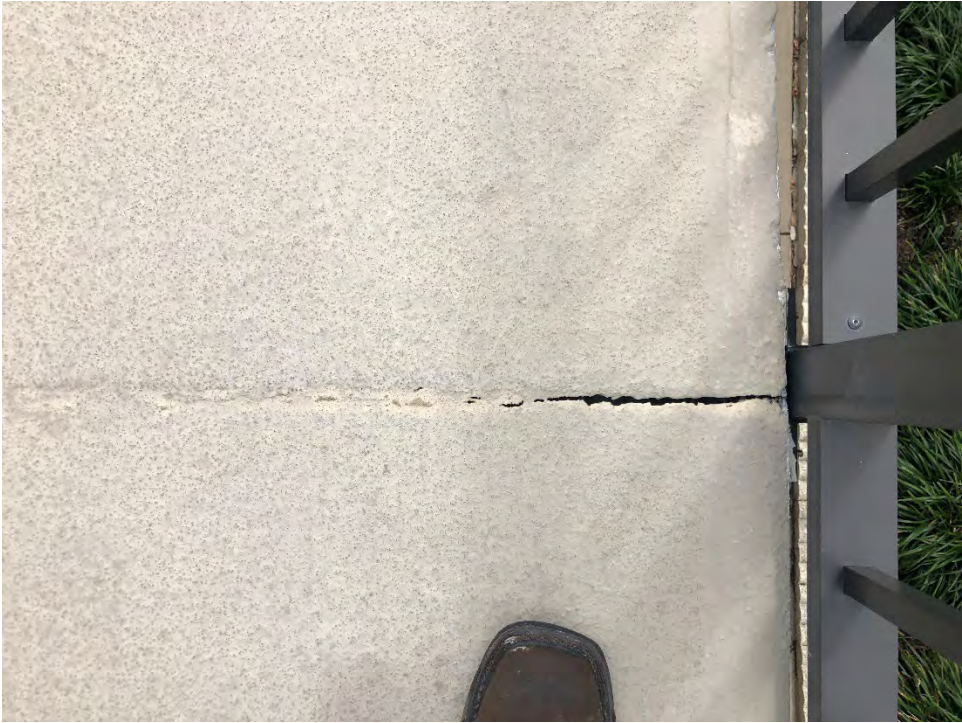
- Multiple areas of ponding water and/or ponding water stains were observed on the walkways and stairways (Refer to Figure B-12 through Figure B-14).
- Areas of deteriorated and/or failed expansion joints were observed along the walkways with portions having vertical displacement (Refer to Figure B-15 and Figure B-16).

Figure B- 15 – Deteriorated/Failed Expansion Joint

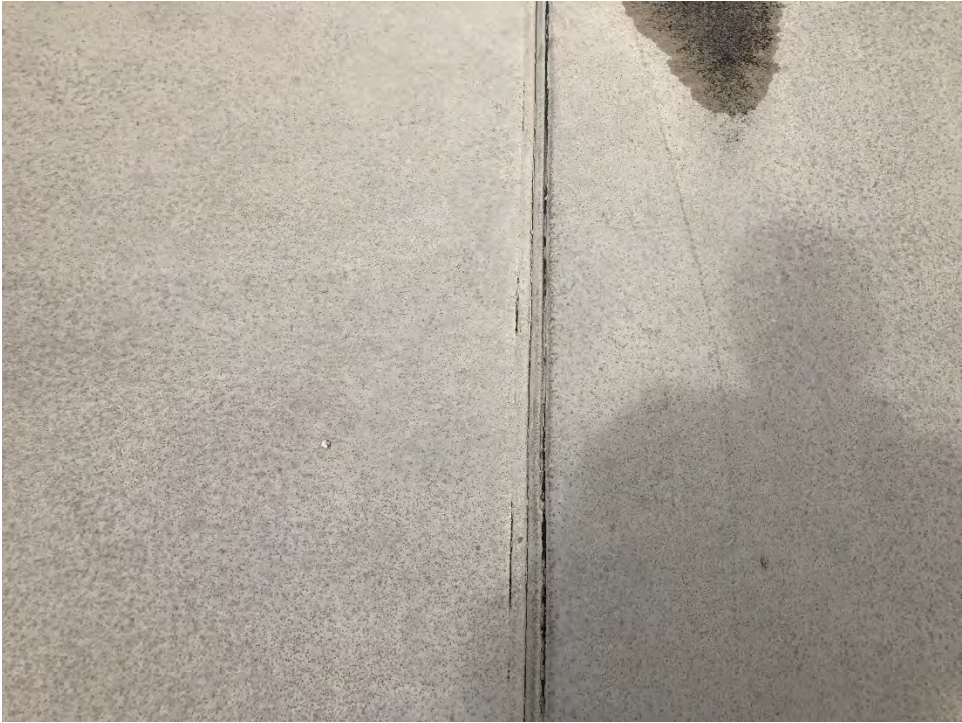
Figure B- 16 – Deteriorated/Failed Expansion Joint

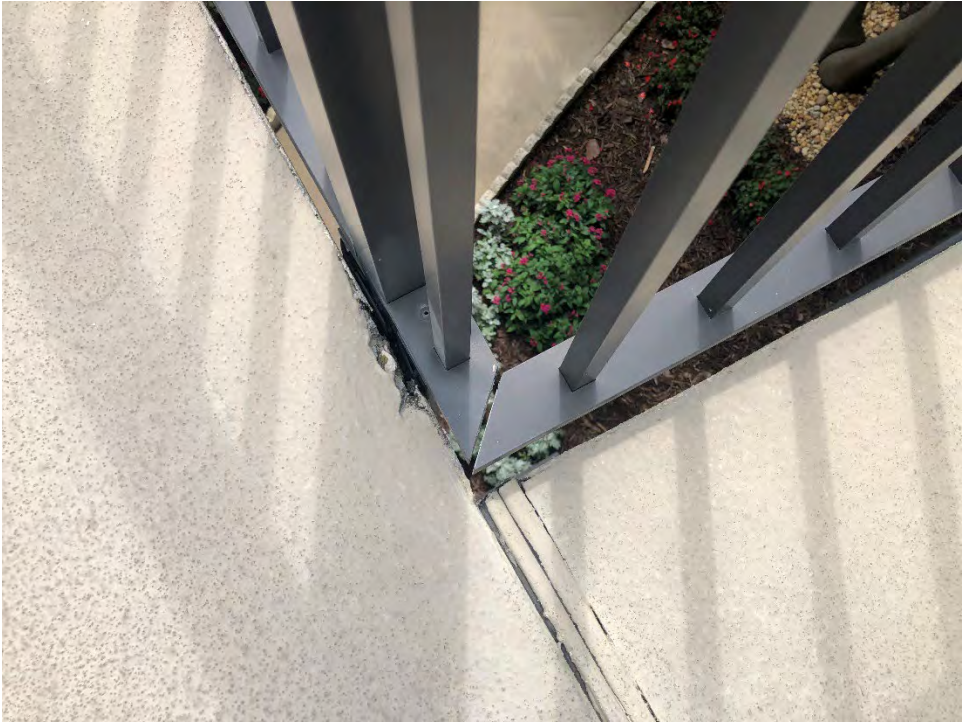
- Loose guardrail bottom rail connections were observed at walkway expansion joints (Refer to Figure B-17 and Figure B-18).
- Localized areas of floor staining were observed along stairways (Refer to Figure B-19).

Figure B- 17 – Loose Bottom Rail Connection

1. Surface preparation and painting of areas of peeling painting and/or oxidization on aluminum guardrail components.
2. Surface preparation and painting of areas of blistering exterior paint coatings.
3. Repair of loose guardrail bottom rail connections and bent guardrail picket.
4. Concrete repair for spalls and cracks on concrete surfaces.
5. Repair of delaminated and/or cracked exterior wall stucco finishes.
6. Removal/replacement and/or repair of deteriorated and/or failed expansion joints.
7. Recoating of deteriorated waterproofing membrane top coating on the west end of the walkways and stairways. Please note the condition of existing waterproofing membrane top coating may not be suitable for recoating and should be reviewed by waterproofing membrane product representative prior to application.

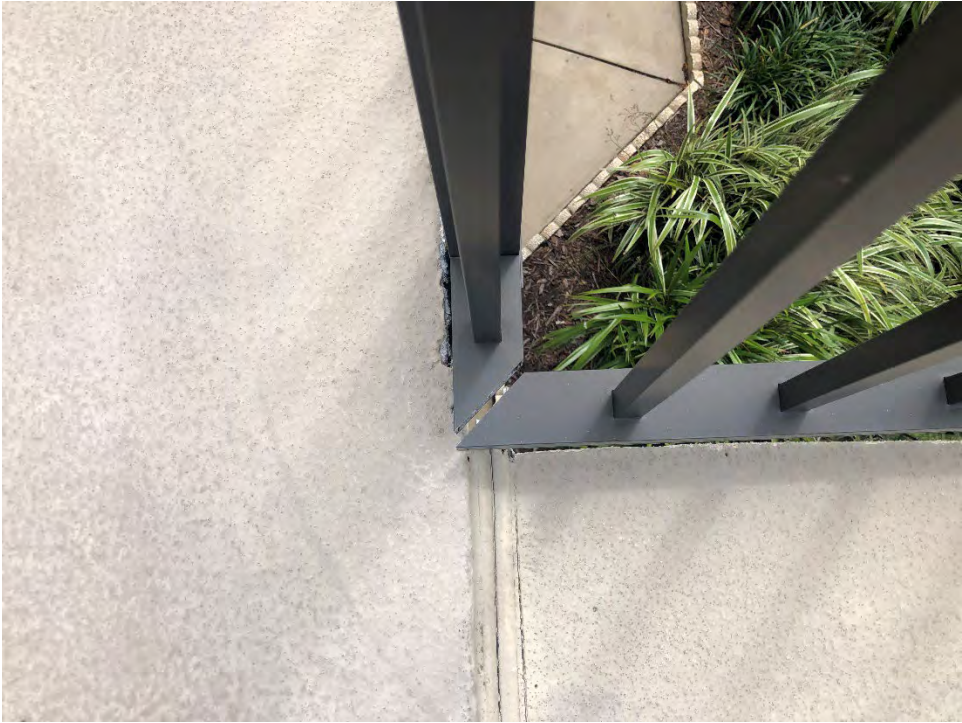
Figure B- 18 – Loose Bottom Rail Connection

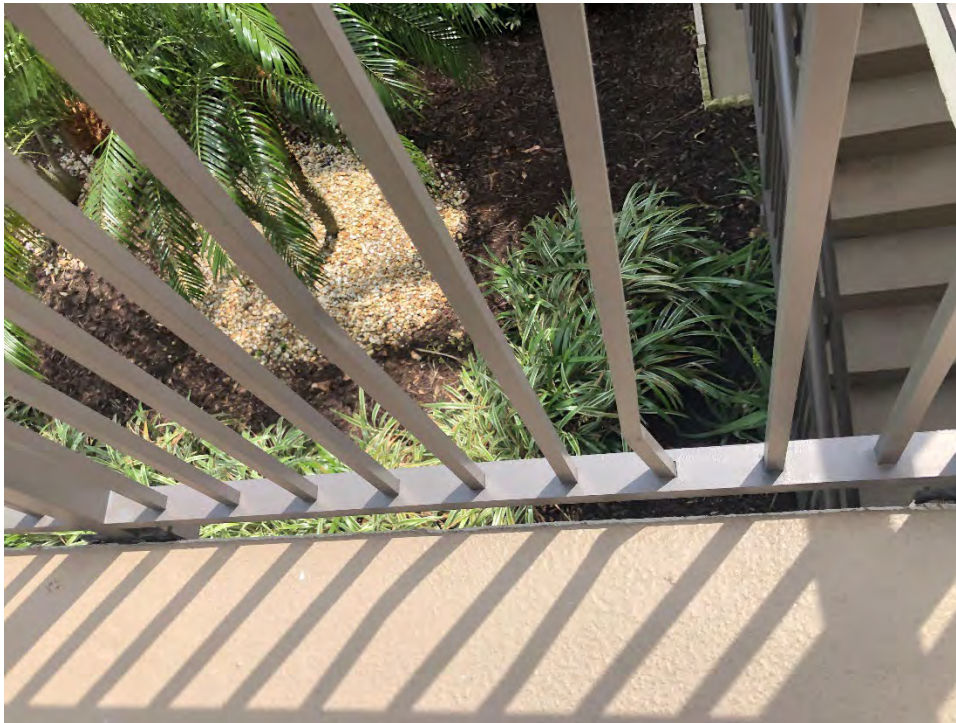
- Bent guardrail picket was observed on the 2<sup>nd</sup> floor walkway adjacent to the tower entrance (Refer to Figure B-20).

Figure B- 20 – Bent Guardrail Picket

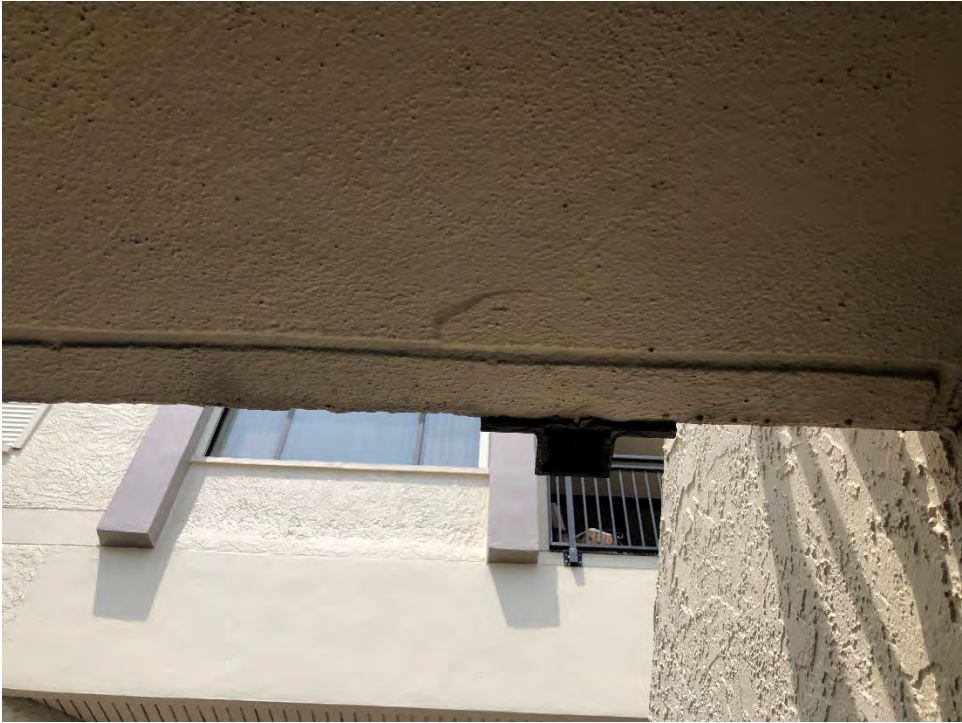
- Localized concrete spalls were observed along the underside of the walkway slabs at guardrail surface mounted connections (Refer to Figure B-21 and Figure B-22).
- Multiple concrete spalls were observed along the underside of the stairway slabs on the 1<sup>st</sup> floor level (Refer to Figure B-23 through Figure B-25).
- Localized areas of blistering exterior paint coatings were observed along the underside of the walkway slabs (Refer to Figure B-26 and Figure B-27).
- Localized areas of delaminated exterior wall stucco finishes were observed.

Figure B- 21 – Concrete Spall

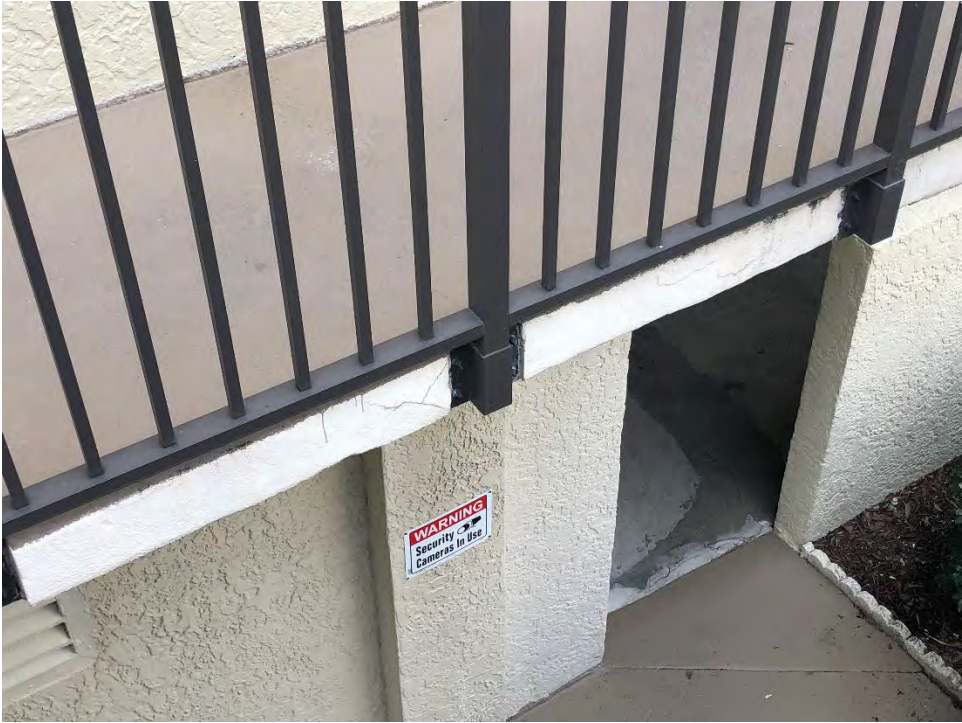
Figure B- 22 – Concrete Spall

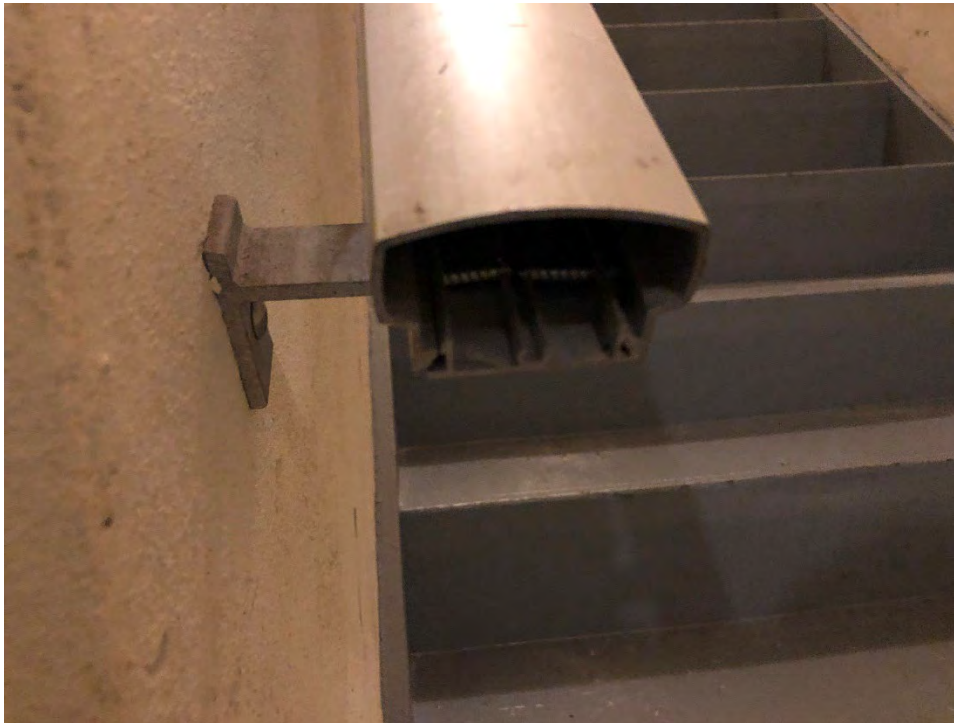
- Multiple handrails were observed with missing end caps (Refer to Figure C-4 and Figure C-5).
- Localized hairline wall and ceiling cracks were observed in the interior wall finishes, but the areas observed would be expected for a structure of this age and construction type (Refer to Figure C-6 and Figure C-7).

*Figure C- 4 – Missing Handrail End Cap*

1. Installation of new handrail end caps at missing end cap locations.
2. Ideally the interior handrails on the south stairway would be modification and/or replaced to allow for continuous interior handrails between floor levels. It should be noted typically if a building element was constructed as per the building code at the time it was constructed, it is "grandfathered" in as far as the Building Department is concerned. Elevated Engineering has not conducted intensive research to determine if the stair handrails were installed as per the prevailing code at the time of construction and therefore Elevated Engineering cannot comment on that aspect. It is possible that the Fire Marshal may require the stairwell handrails to be brought up to current life safety code at any time as it is at their discretion. However, given the existing railing geometry, the Fire Marshal may prefer the grabrails remain as they are without a return as addition of the handrail extensions may create a clearance issue on the landing. This issue would require direct input from the Fire Marshal as it ultimately comes down to their judgement call.

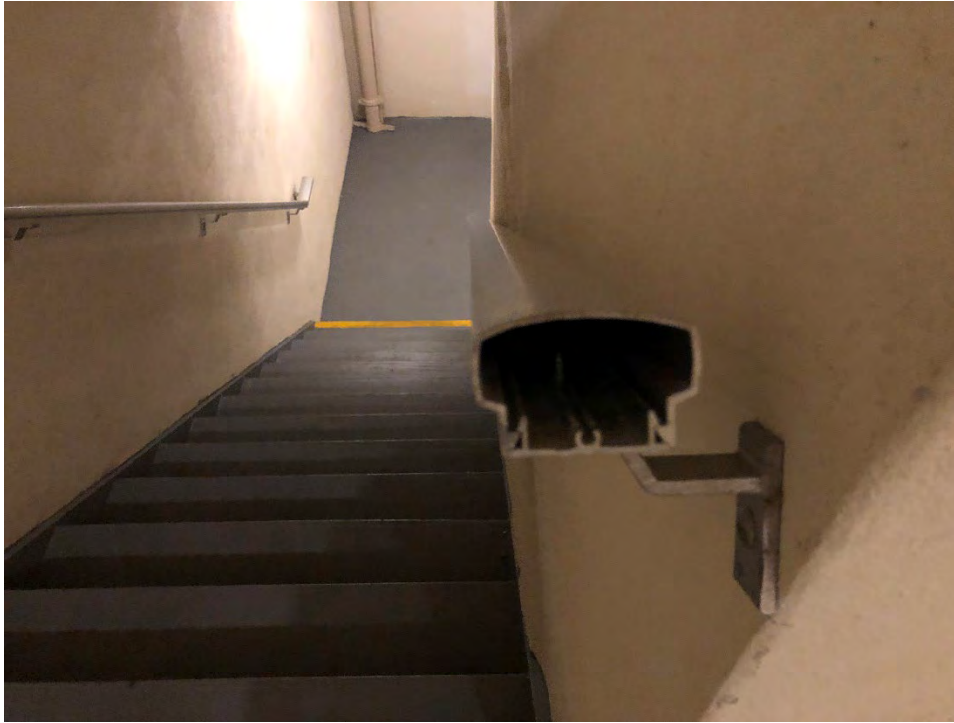
*Figure C- 5 – Missing Handrail End Cap*

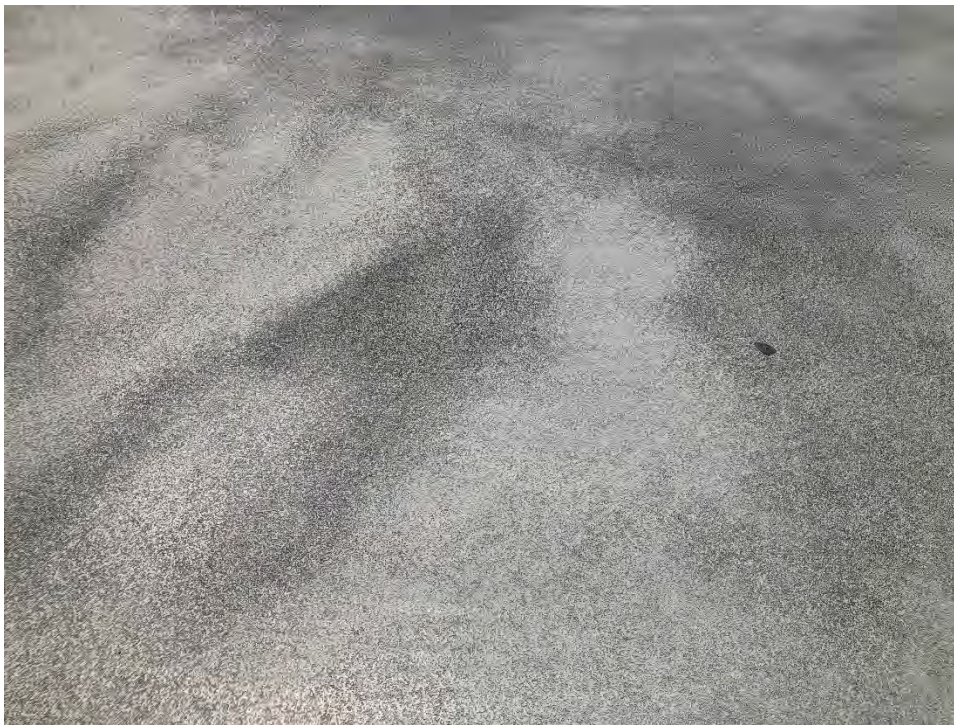
- The overall parking garage is shown in Figure D-1 through Figure D-3.
- The 2<sup>nd</sup> floor level and the elevated portion of the entrance/exit ramp appears to be finished with a waterproofing membrane, which was observed especially in heavy traffic areas to be worn/deteriorated (Refer to Figure D-4).

*Figure D- 4 – Worn/Deteriorated Waterproofing Membrane*

4. Installation of a new vehicular grade waterproofing deck membrane to all 2<sup>nd</sup> floor parking deck and elevated entrance/exit ramp concrete slab surfaces to prevent further corrosion and concrete deterioration. Waterproofing membrane installation should include the following:

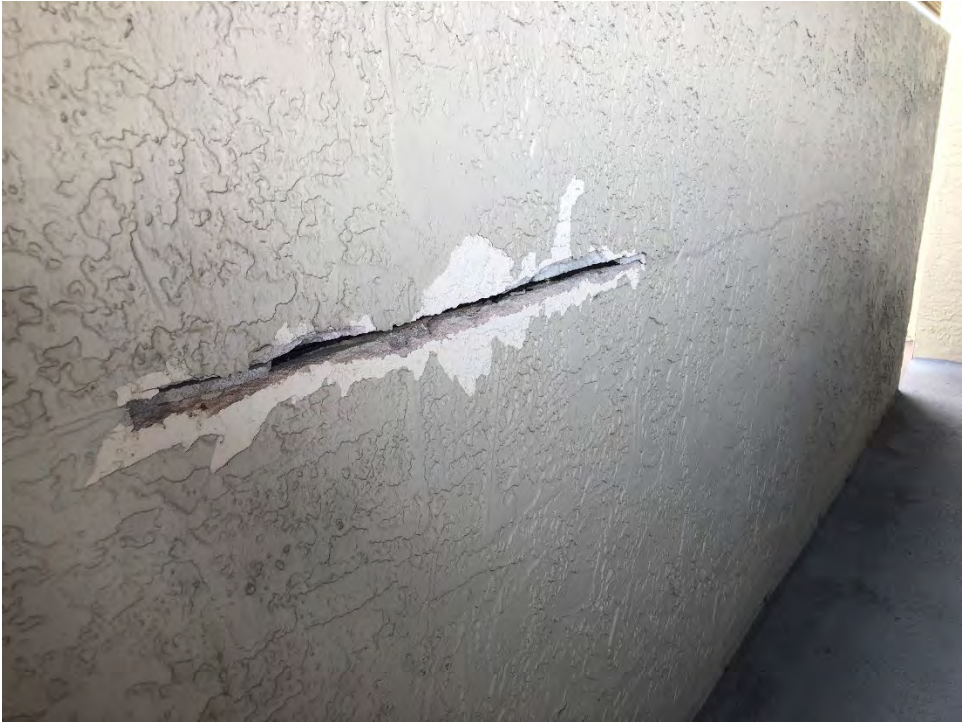
- Multiple areas of delaminated exterior stucco finishes were observed along the concrete columns on the 2<sup>nd</sup> floor level.
- Area of exposed rusting metal and delaminated exterior wall stucco finishes were observed along concrete wall on the east end of the 2<sup>nd</sup> floor level (Refer to Figure D-14).

Figure D- 14 – Exposed Rusting Metal and Delaminated Stucco

1. Concrete repair for spalls and cracks.
2. Repair of delaminated and/or spalled exterior wall stucco finishes.
3. Adhere all unadhered parking stops on the 2<sup>nd</sup> floor level.

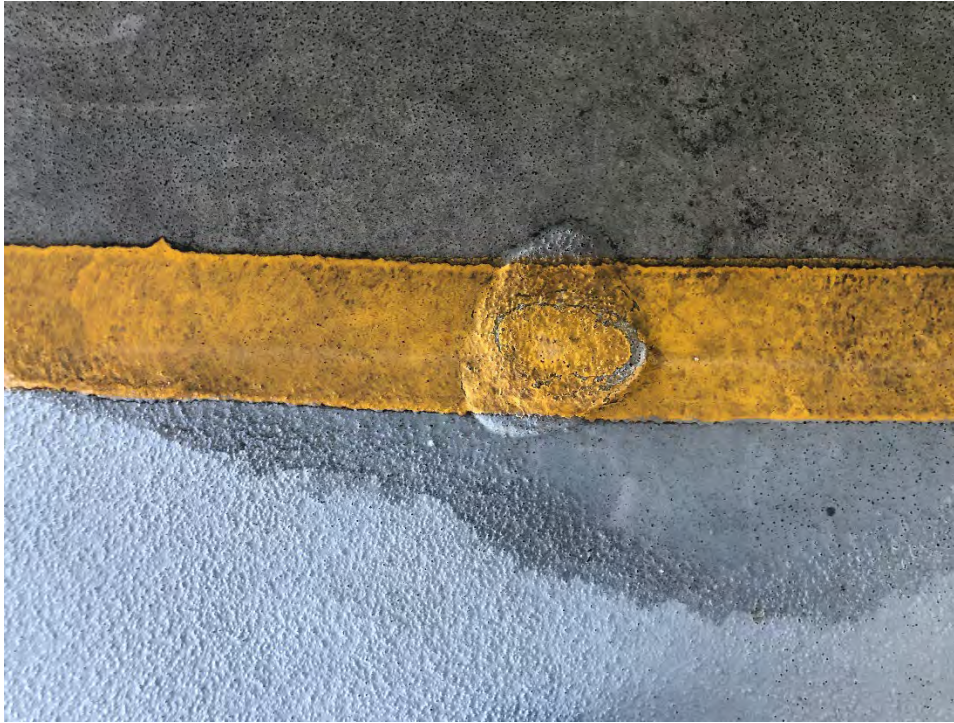
- Concrete spall was observed on the top surface of the 2<sup>nd</sup> floor level concrete slab (Refer to Figure D-15).
- Deteriorated and/or peeling waterproofing membrane was observed along expansion joints on the 2<sup>nd</sup> floor level (Refer to Figure D-16). It is likely that this joint is not a compatible material for the urethane membrane and likely should not have had coating applied to it in the first place.

*Figure D- 15 – Concrete Spall*

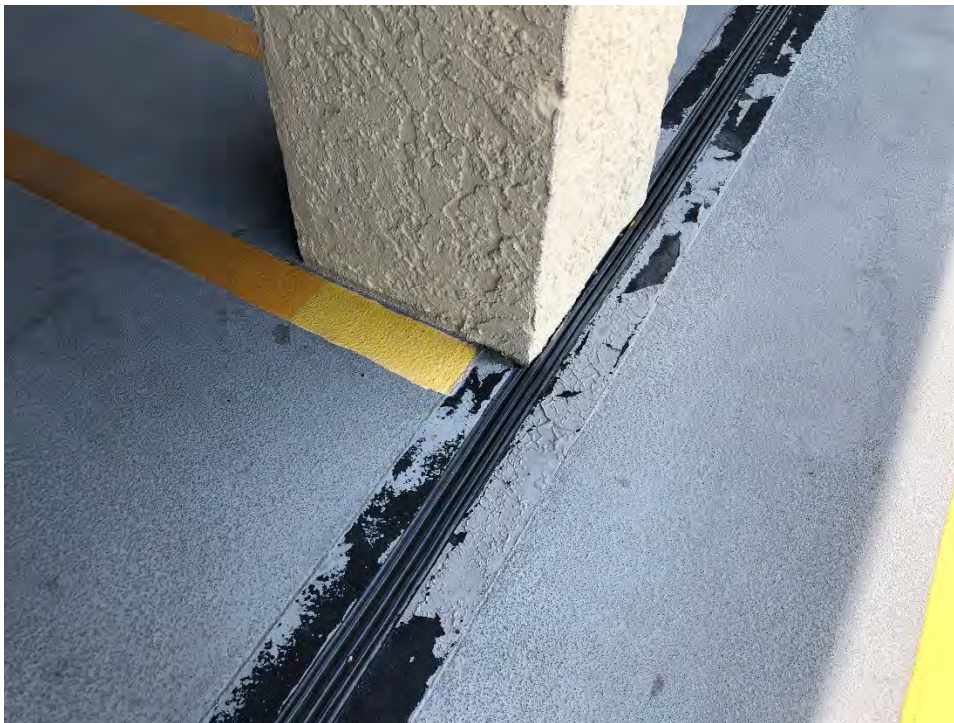
*Figure D- 16 – Deteriorated/Peeling Waterproofing Membrane*

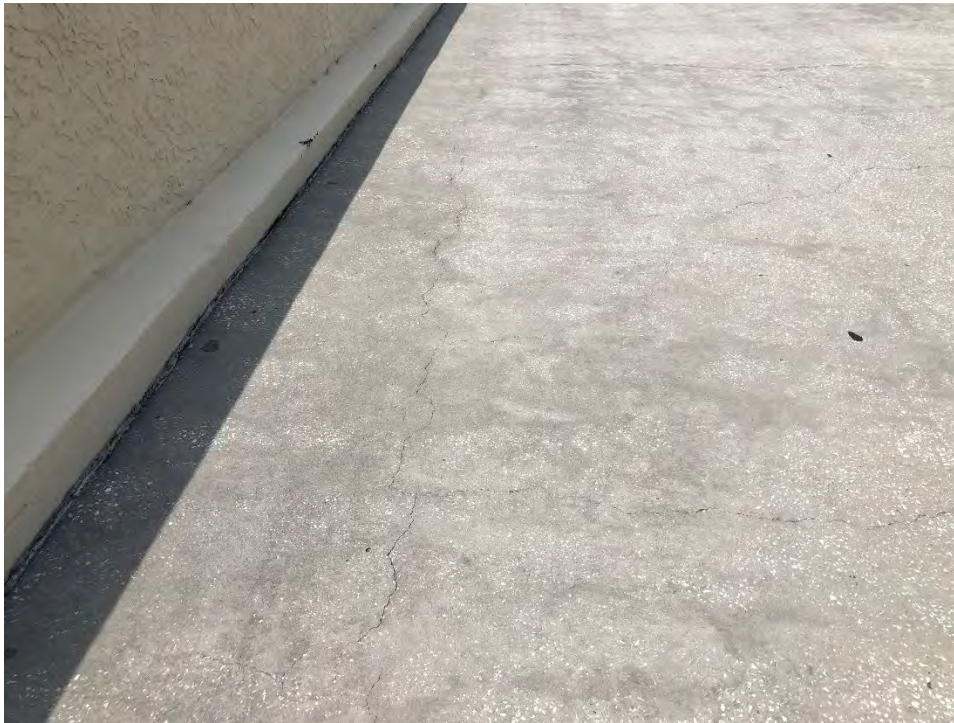
- Concrete spall with exposed rusting metal was observed on the top surface of the 2<sup>nd</sup> floor level concrete slab (Refer to Figure D-17).
- Multiple slab cracks were observed along the slab on grade portion of the entrance/exit ramp (Refer to Figure D-18).

*Figure D- 18 – Concrete Slab Cracks*

- c. Repair concrete slab cracking via routing and sealing with a urethane sealant.
  - d. Removal and replacement and/or installation of urethane sealant at horizontal/vertical interfaces (wall to slab, slab to guardrail post, etc.), and interfaces between adjoining wall surfaces.

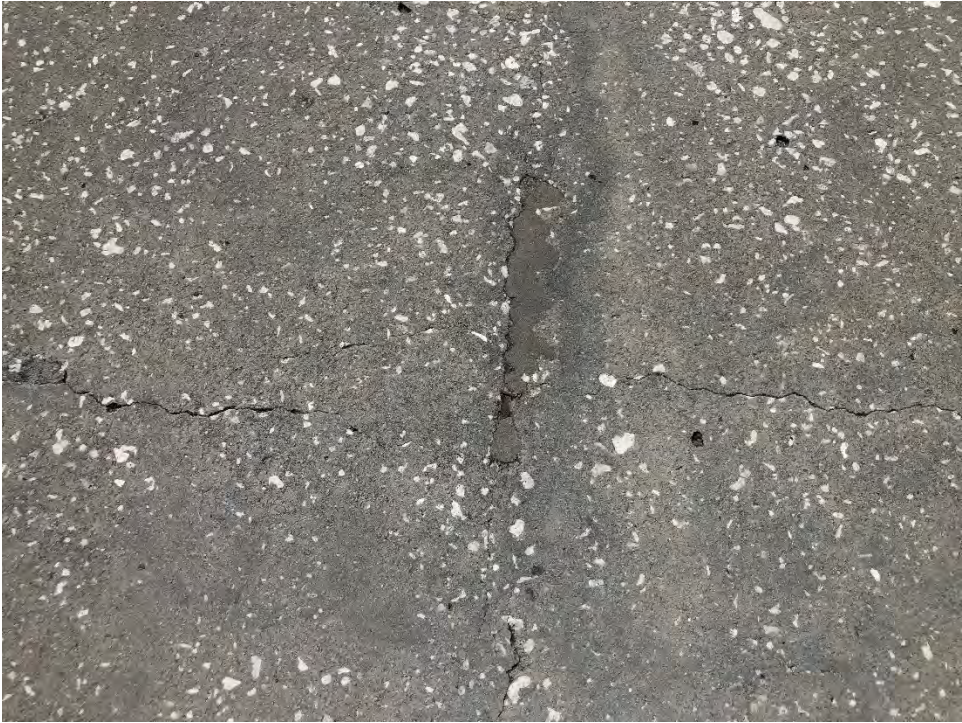
- Localized areas of exposed rusting reinforcement were observed along the slab on grade portion of the entrance/exit ramp (Refer to Figure D-19).
- Multiple concrete spalls and cracks were observed in the architectural concrete panels along the north end of the 1<sup>st</sup> floor level (Refer to Figure D-20 through Figure D-22).

Figure D- 19 – Exposed Rusting Reinforcement

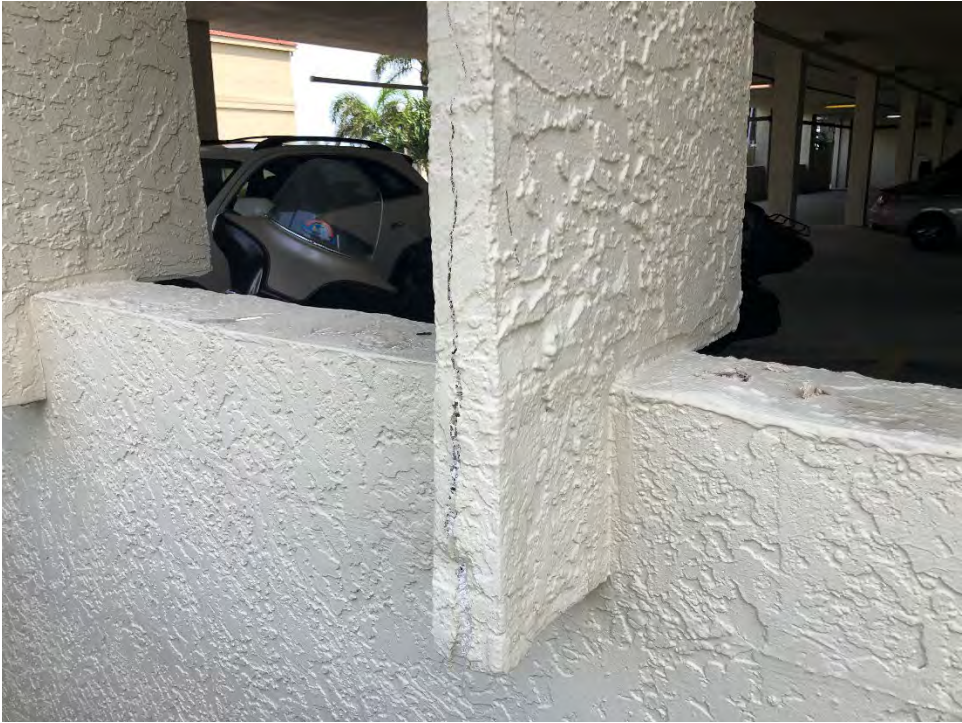
Figure D- 20 – Concrete Spall

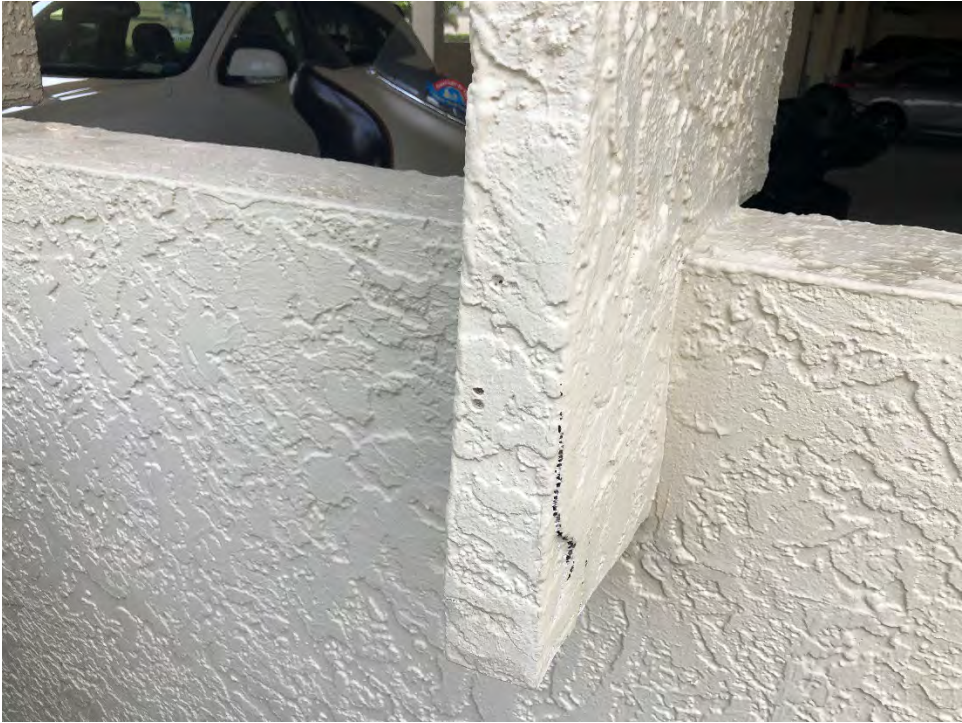
Figure D- 21 – Concrete Spall

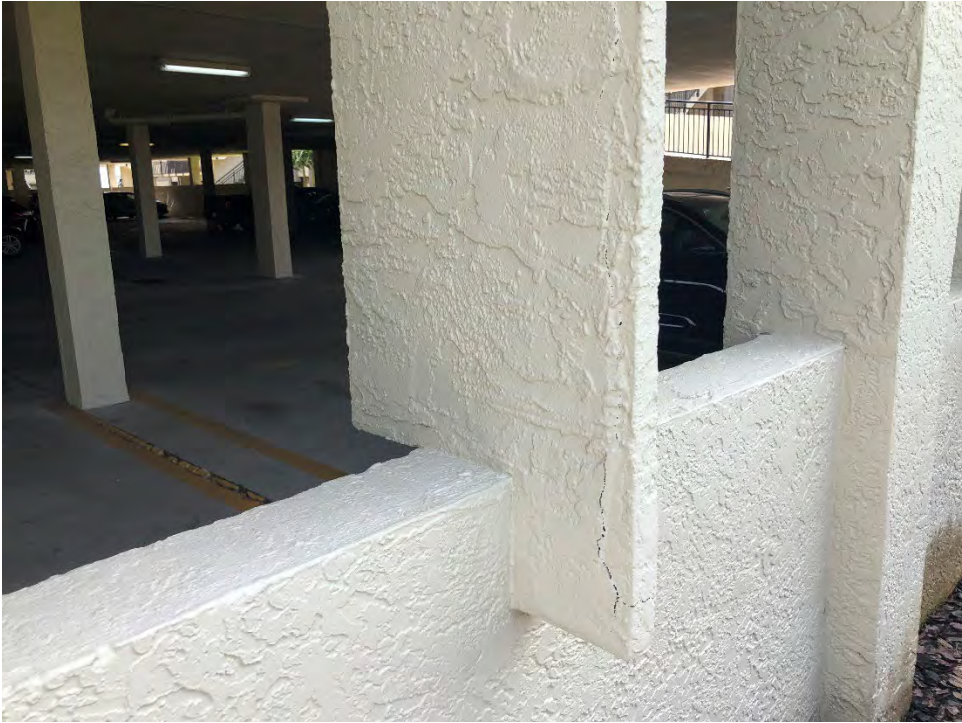
Figure D- 22 – Concrete Spall

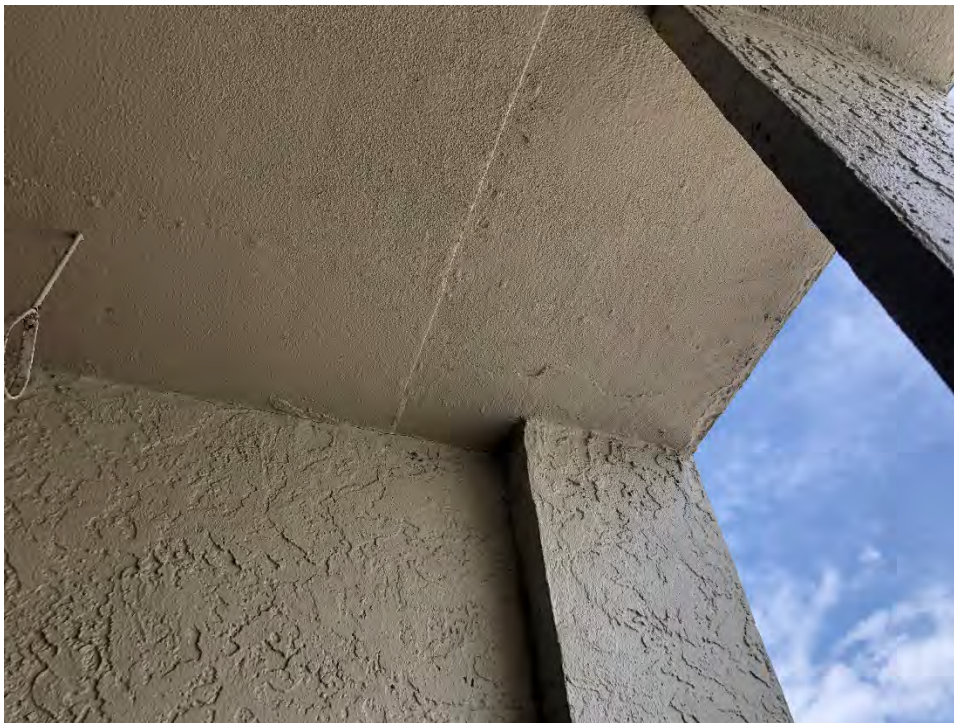
- Previously repaired stair-step exterior wall crack was observed at the north end of the 1<sup>st</sup> floor level (Refer to Figure D-23).
- Localized concrete spalls were observed along the underside of the 2<sup>nd</sup> floor concrete slab at the north end of the 1<sup>st</sup> floor level (Refer to Figure D-24 and Figure D-25).

*Figure D- 24 – Concrete Spall*

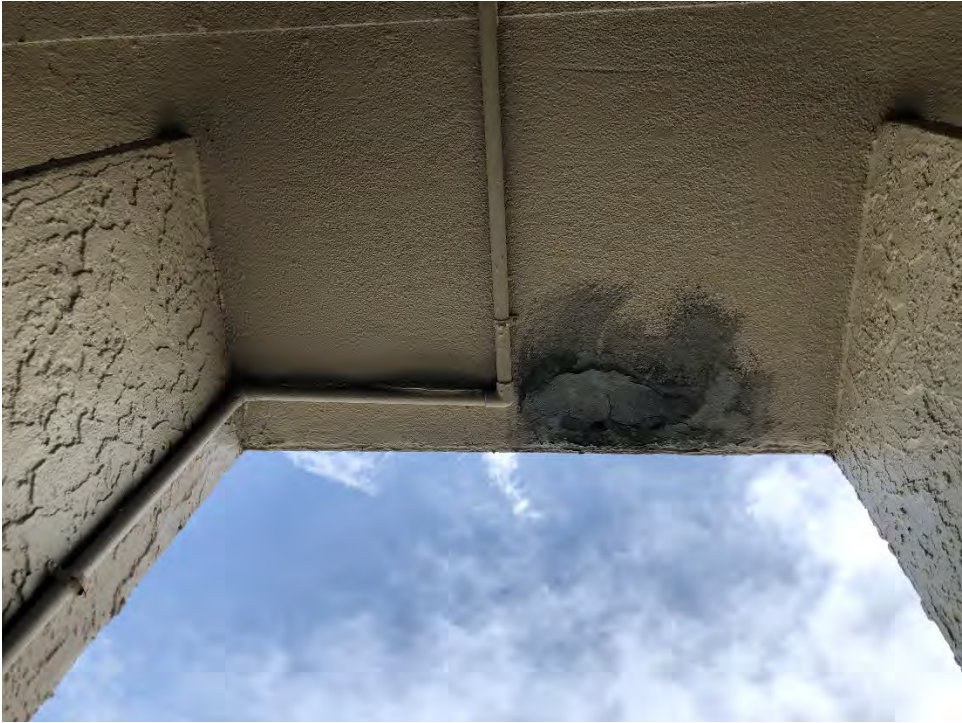
Figure D- 25 – Concrete Spall

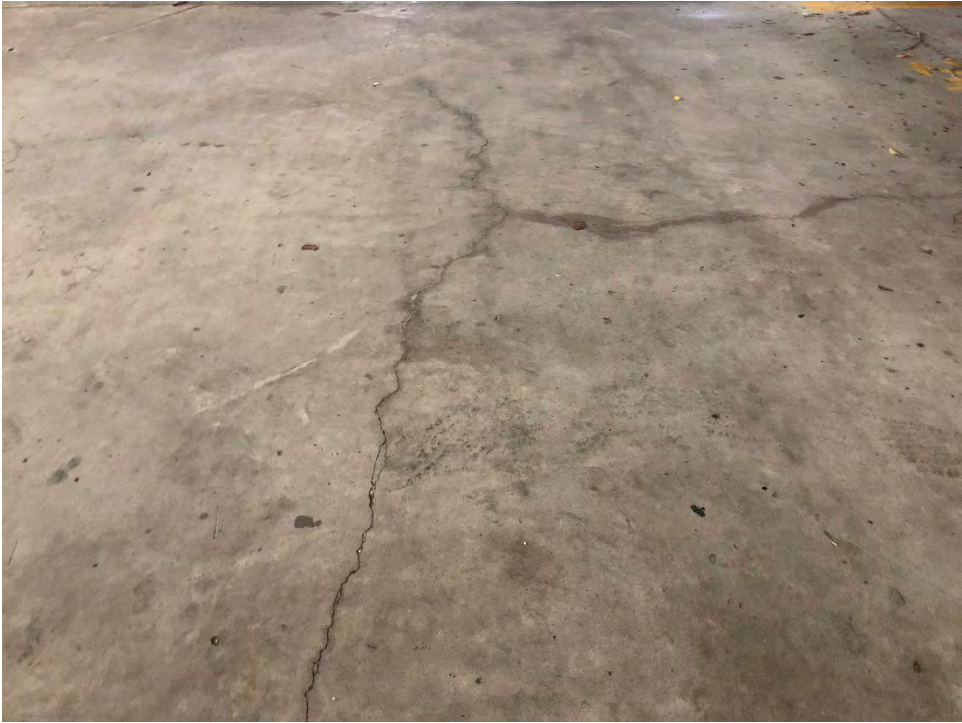
- Multiple cracks were observed on the slab on grade slab on the 1<sup>st</sup> floor level, which should be expected for a structure of this age and construction type (Refer to Figure D-26).

Figure D- 26 – Concrete Slab Cracks

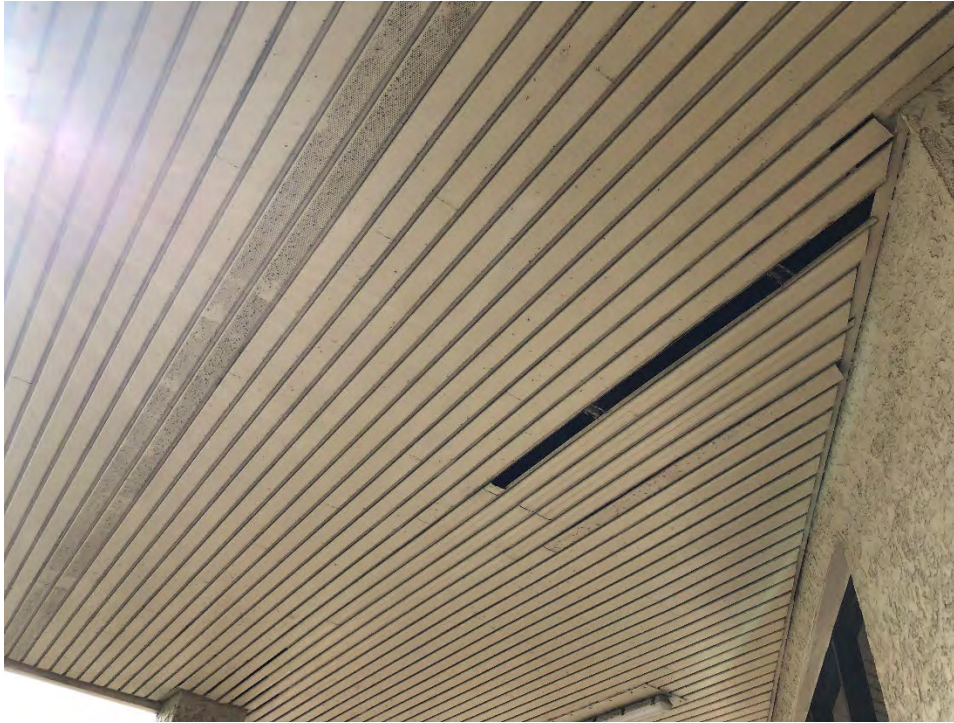
*Figure E- 7 – Missing Soffit*

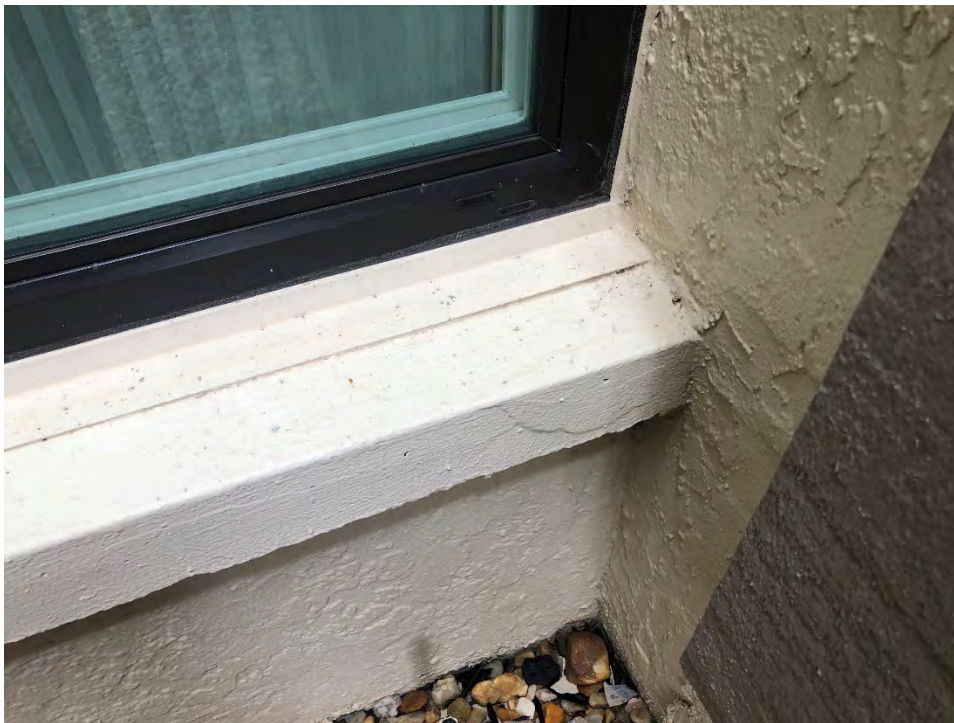
*Figure E- 34 – Windowsill Spall (Unit 103)*

1. Concrete repair for spalls and cracks on balcony slabs, windowsills, and lintels.
2. Repair of delaminated and/or spalled exterior wall stucco finishes.
3. Removal and replacement of rotten wood trim components
4. Removal and replacement of deteriorated sealants and storefront window components on the tower structure.
5. Installation of missing soffit components above the 2<sup>nd</sup> floor lobby entrance of the tower structure.
6. Surface preparation and painting of all previously painted exterior surfaces (walls, ceilings, columns, beams, etc.). Typically building exterior surface painting is recommended every 7 years. Please note that the current paint job is approximately one year old currently.

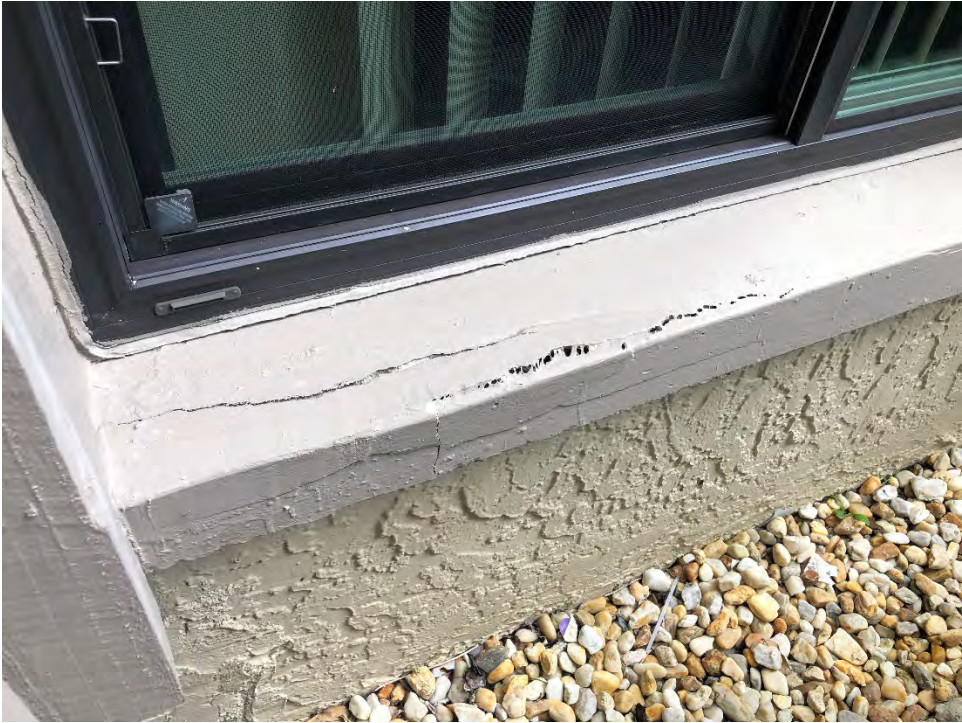
Figure E- 35 – Windowsill Spall (Unit 104)

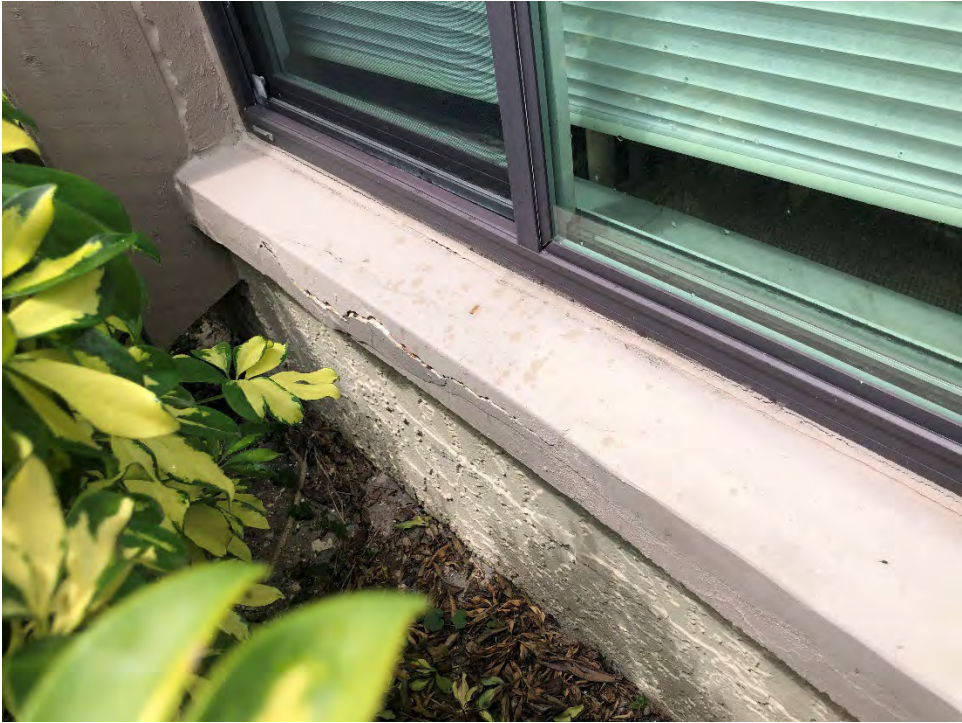
Figure E- 36 – Windowsill Spall (Unit 104)
