## CONDITION SURVEY REPORT

**PALMA DEL MAR 5**

**CONDOMINIUM**

**6372 PALMA DEL MAR BLVD. S.**

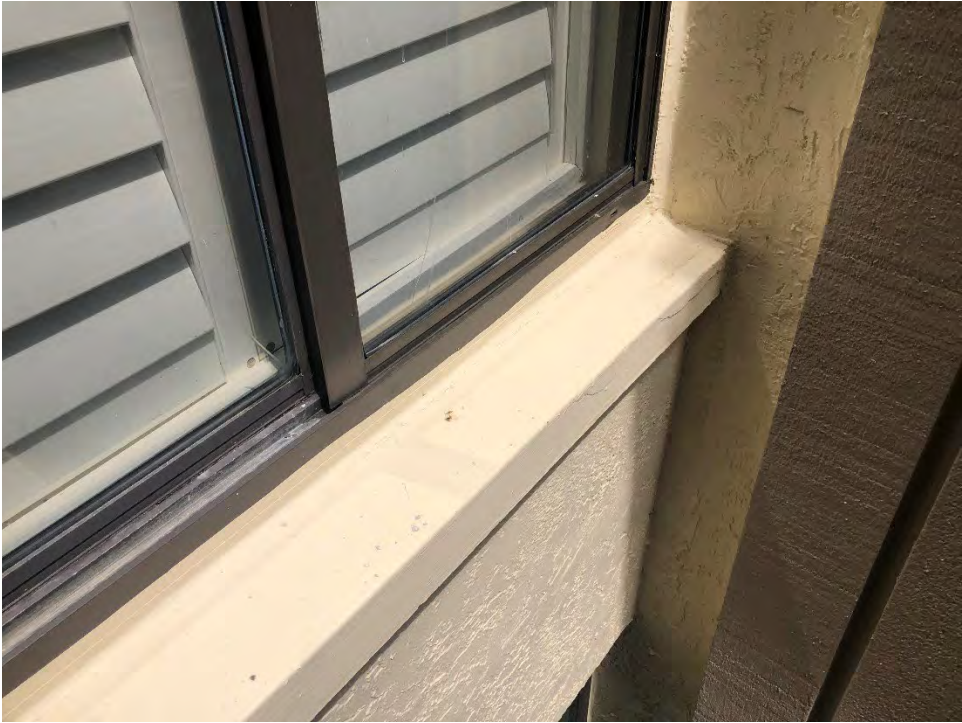
Figure E- 37 – Windowsill Spall (Unit 203)

1. Concrete repair for spalls and cracks on balcony slabs, windowsills, and lintels.
2. Repair of delaminated and/or spalled exterior wall stucco finishes.
3. Removal and replacement of rotten wood trim components
4. Removal and replacement of deteriorated sealants and storefront window components on the tower structure.
5. Installation of missing soffit components above the 2<sup>nd</sup> floor lobby entrance of the tower structure.
6. Surface preparation and painting of all previously painted exterior surfaces (walls, ceilings, columns, beams, etc.). Typically building exterior surface painting is recommended every 7 years. Please note that the current paint job is approximately one year old currently.

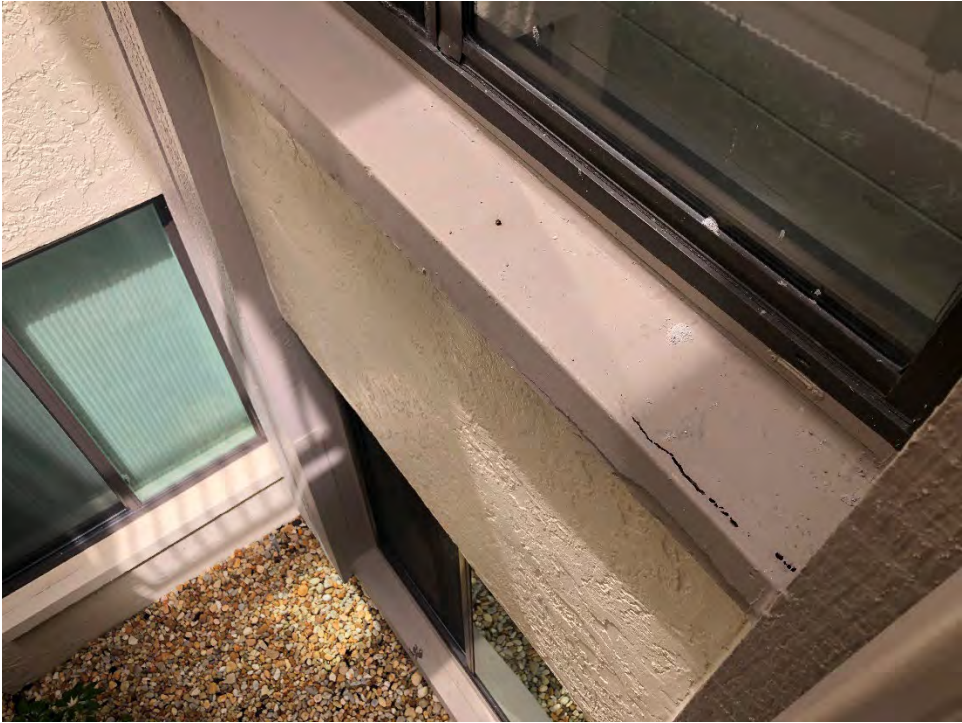
Figure E- 38 – Windowsill Spall (Unit 203)

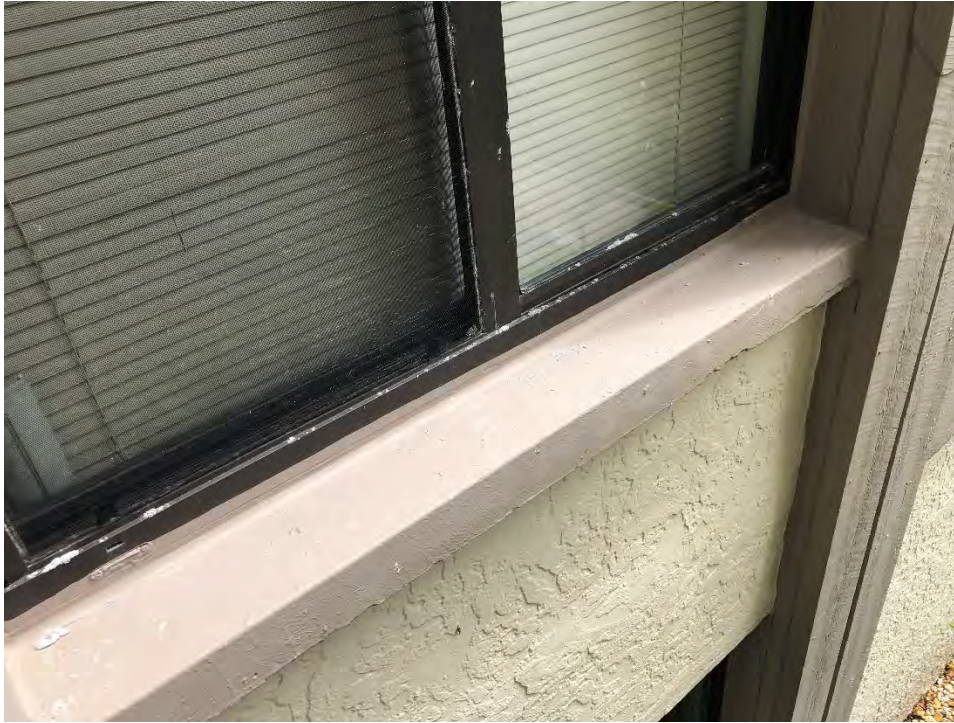
*Figure E- 39 – Windowsill Spall (Unit 204)*

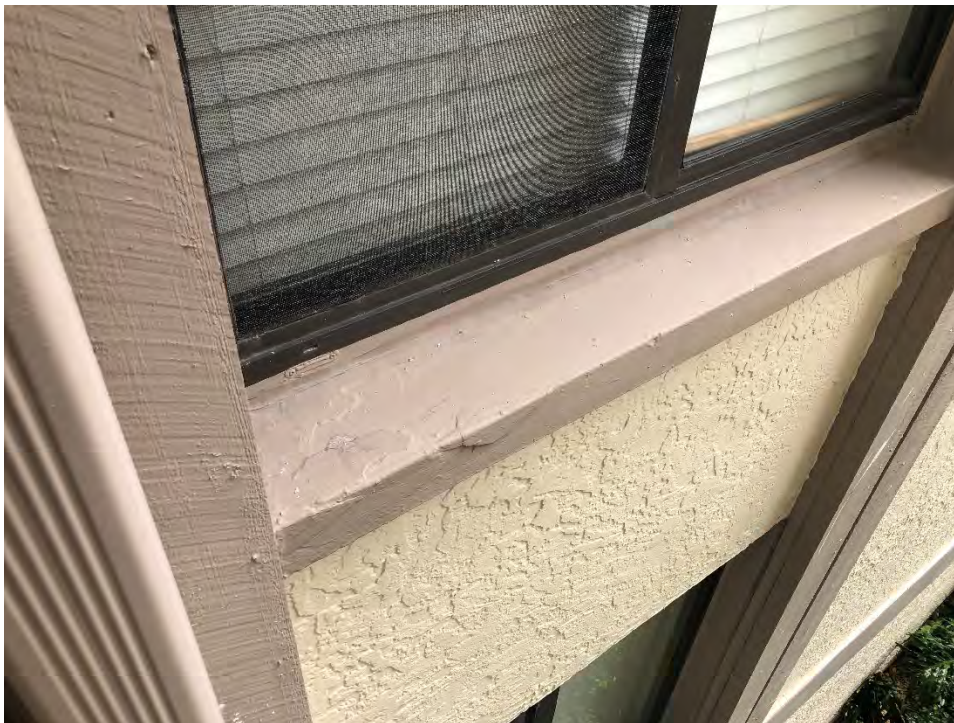
*Figure E- 40 – Windowsill Spall (Unit 304)*

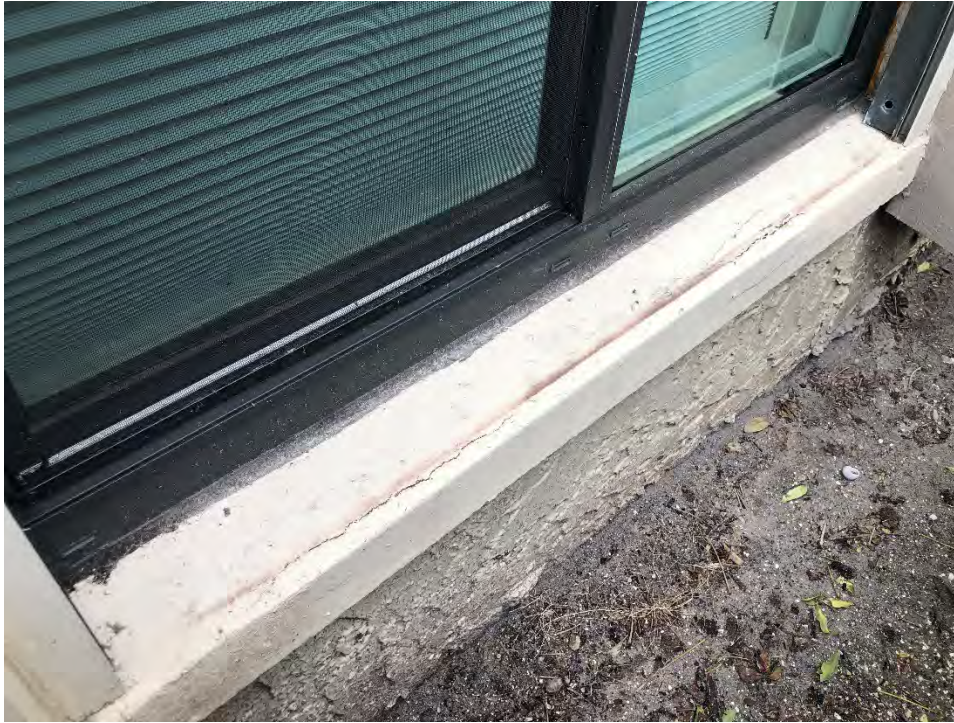
Figure E- 41 – Windowsill Spall (Unit 105)

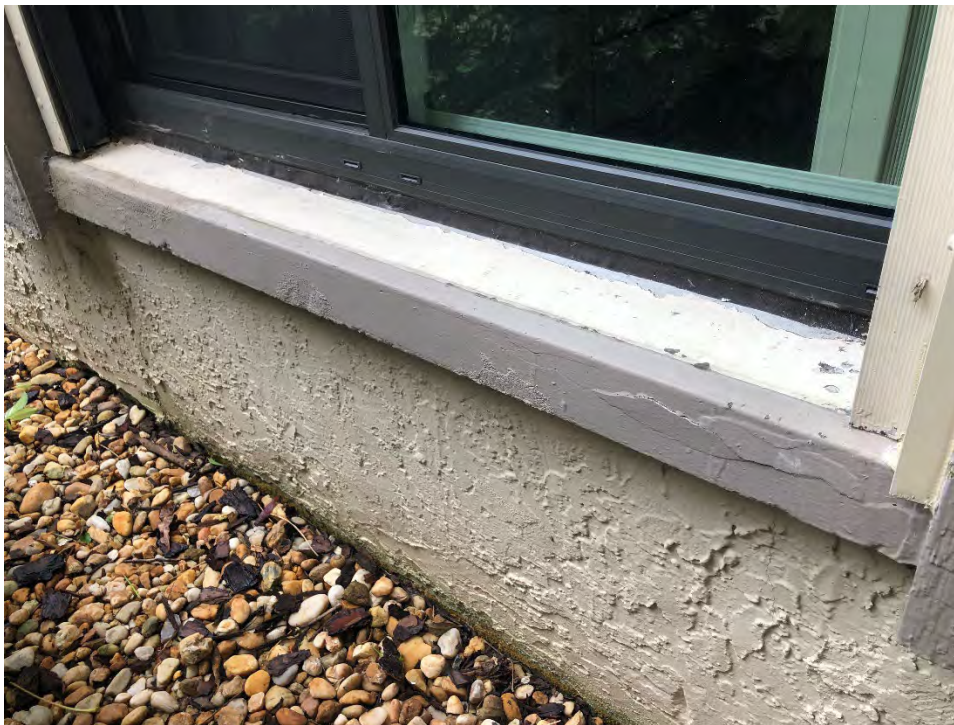
Figure E- 42 – Windowsill Spall (Unit 105)

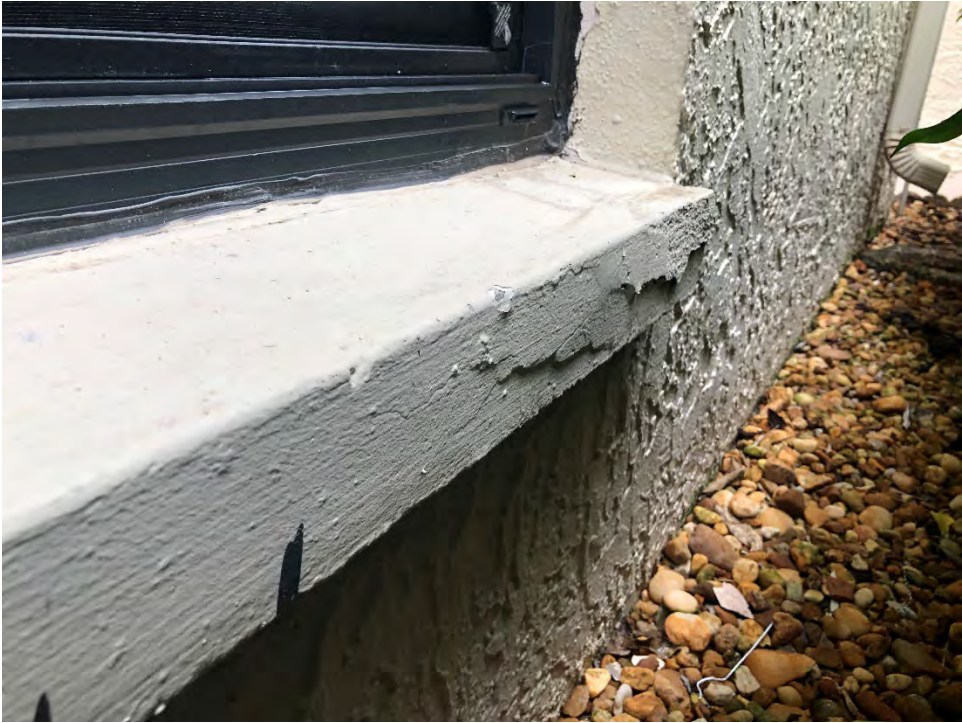
Figure E- 43 – Windowsill Spall (Unit 108)

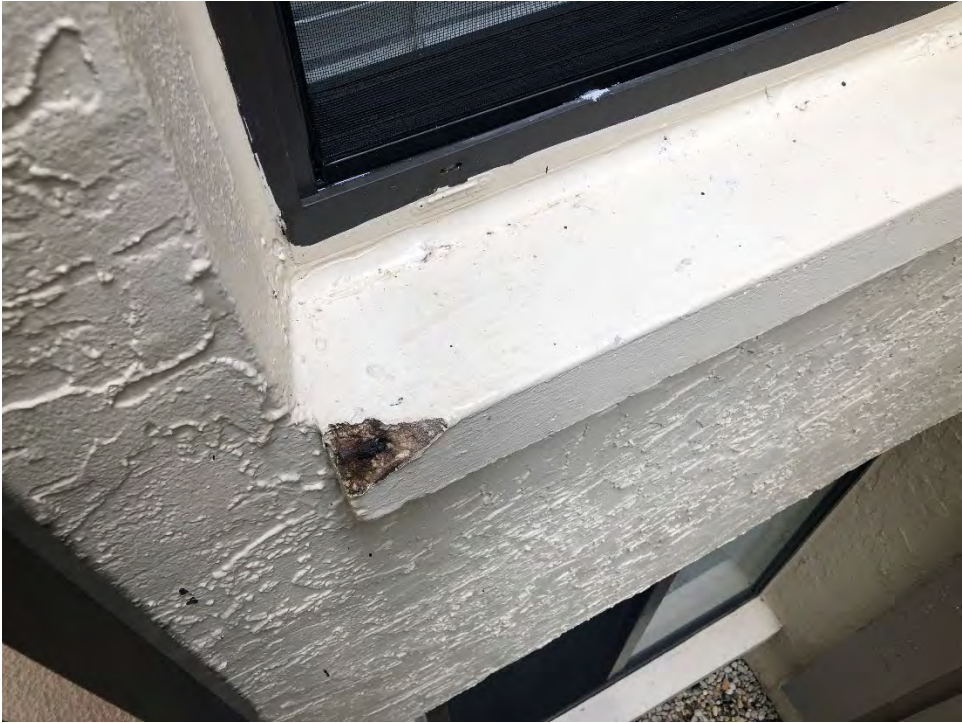
Figure E- 44 – Windowsill Spall (Unit 207)

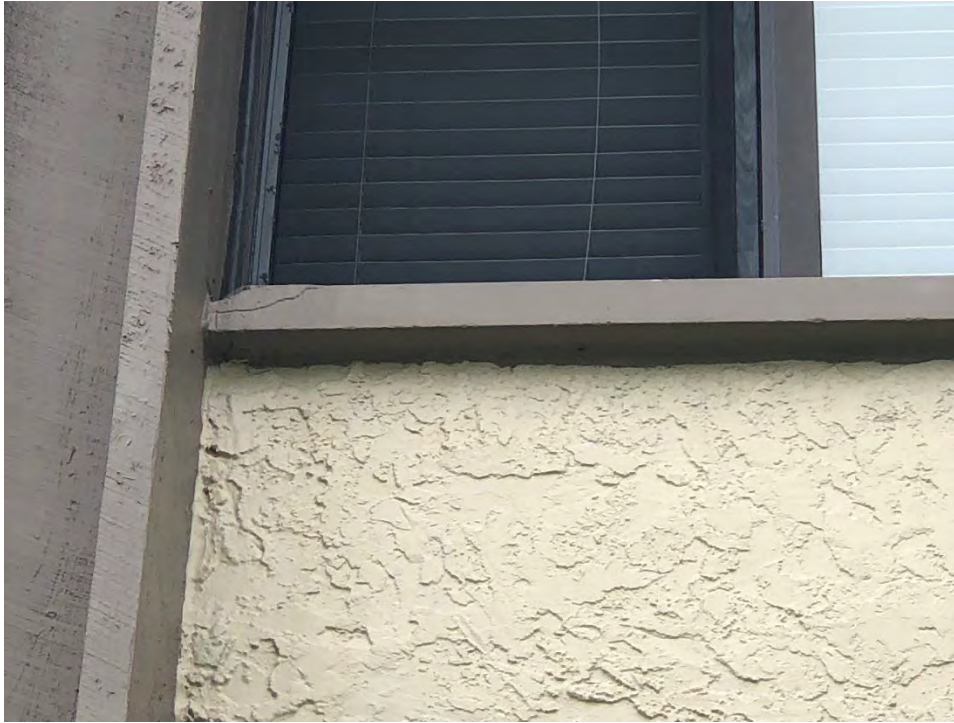
Figure E- 45 – Windowsill Spall (Unit 305)

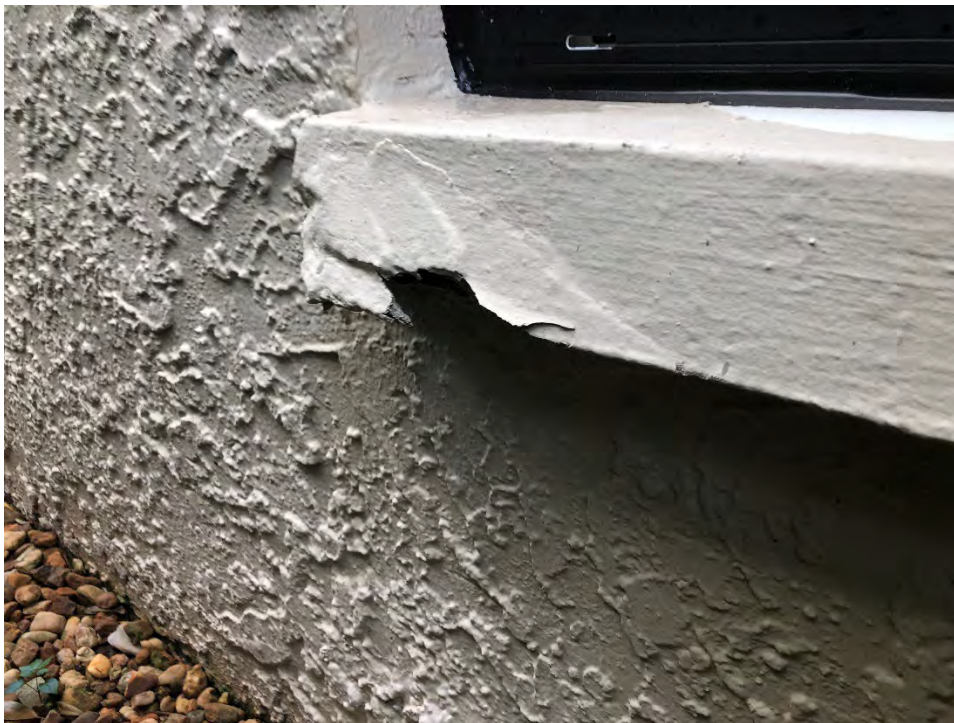
Figure E- 46 – Windowsill Spall (Unit 109)

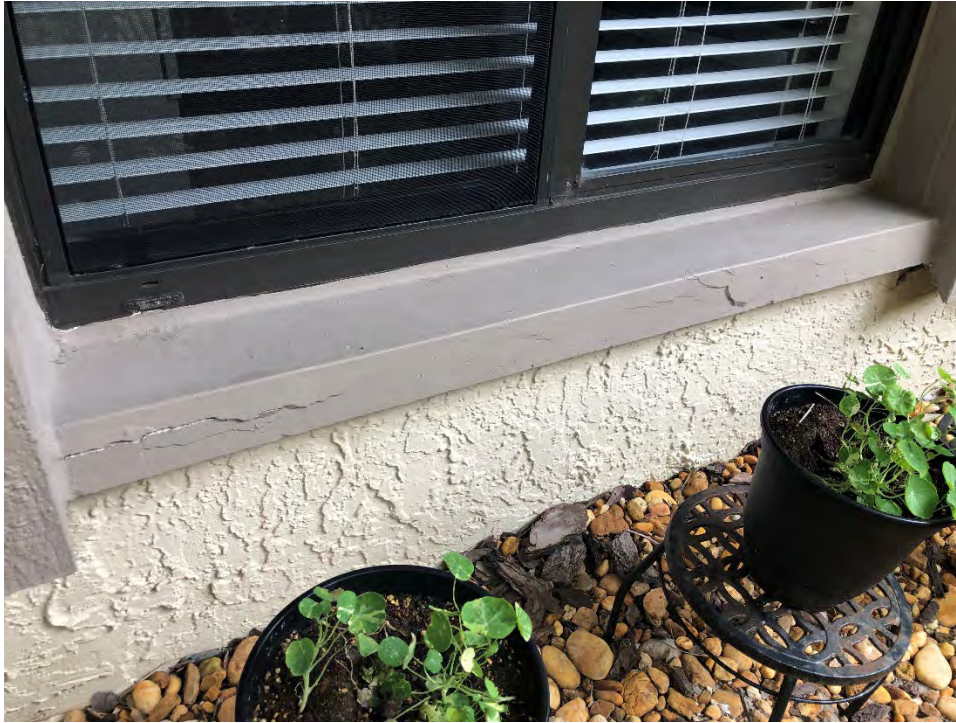
Figure E- 47 – Windowsill Spall (Unit 110)

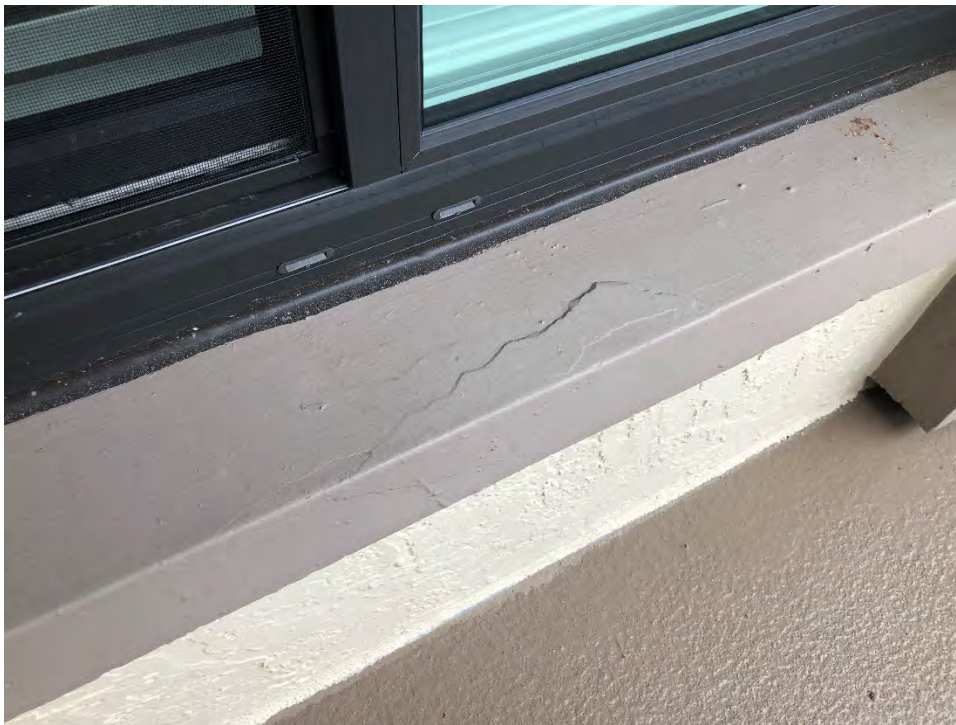
Figure E- 48 – Windowsill Spall (Unit 210)

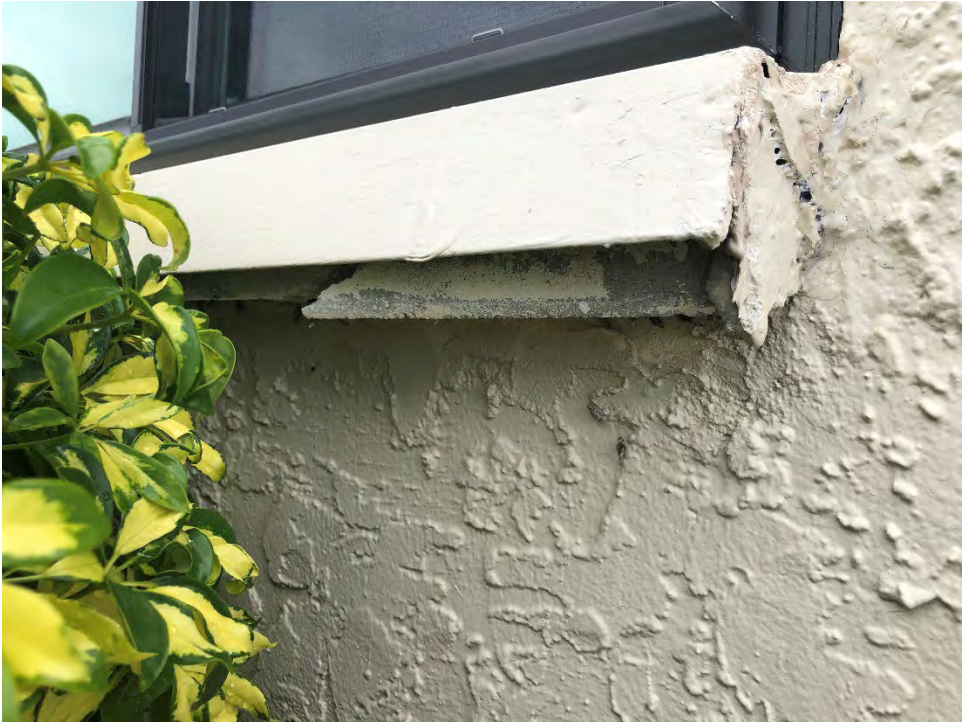
Figure E- 49 – Windowsill Spall (Unit 113)

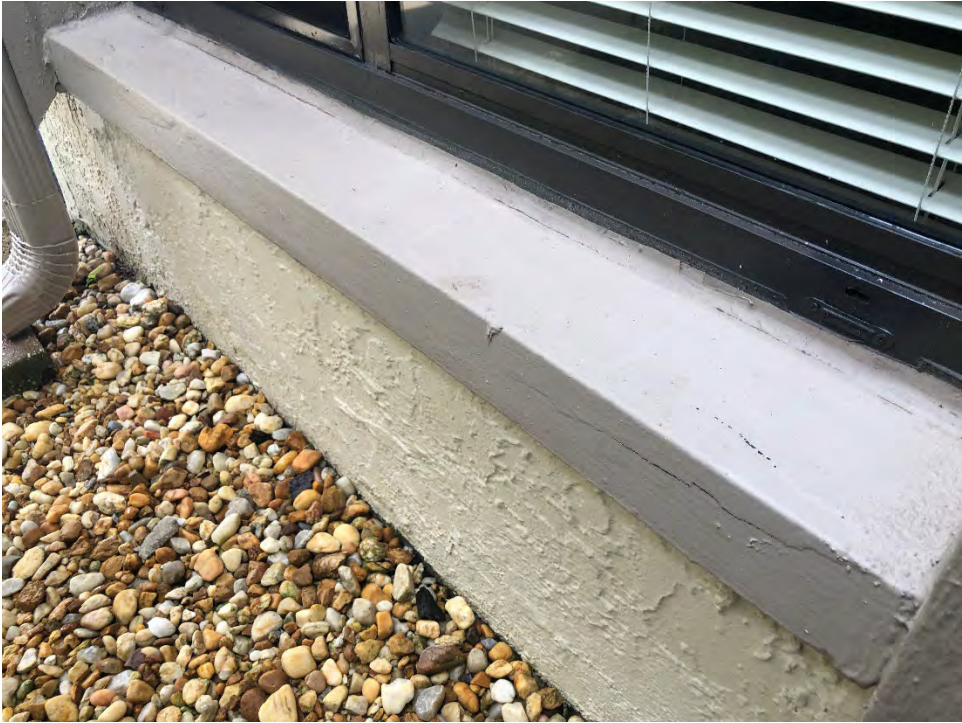
Figure E- 50 – Windowsill Spall (Unit 114)

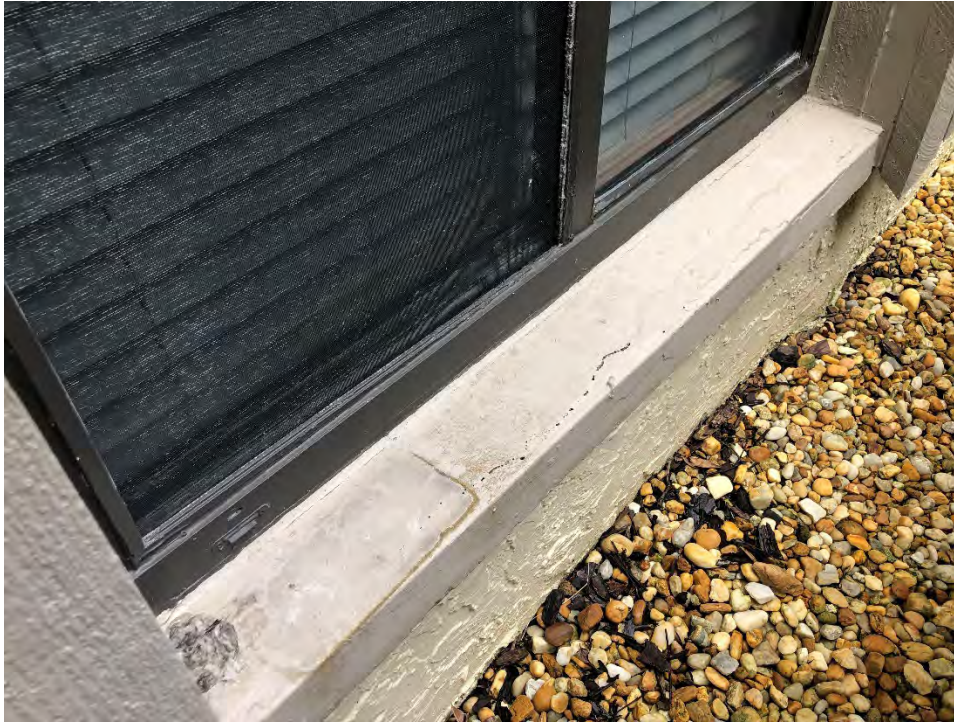
*Figure E- 51 – Windowsill Spall (Unit 116)*

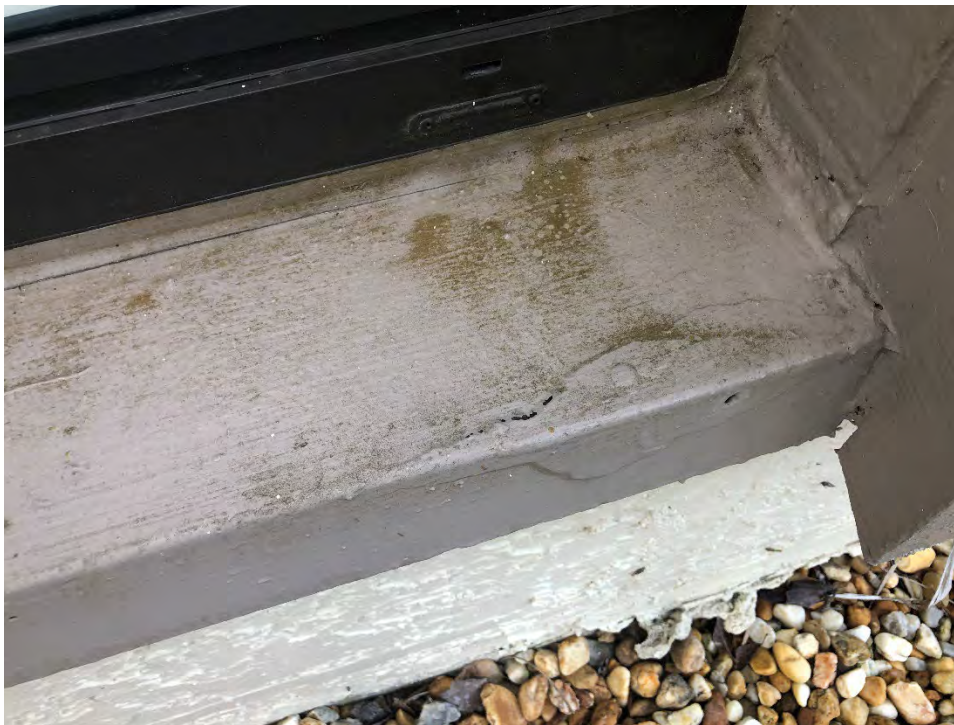
*Figure E- 52 – Windowsill Spall (Unit 120)*

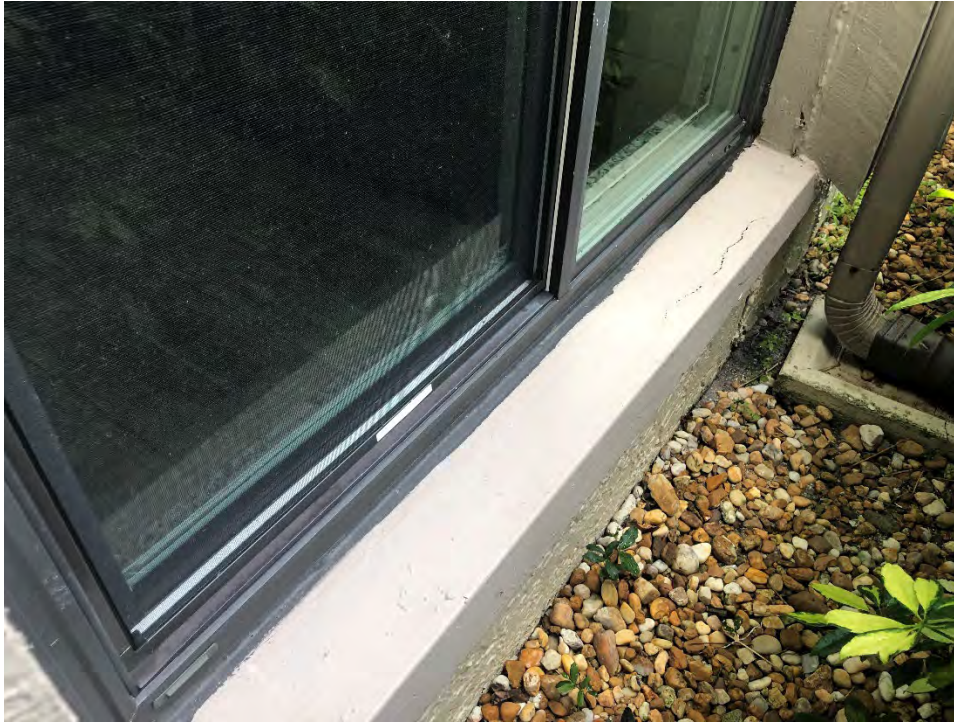
- North elevation of Unit 223 (Refer to Figure E-53).
- Metal flashing was observed over windowsills at window openings throughout the building exteriors with portions having peeling paint and oxidation. It is possible that the metal flashing may be concealing concrete windowsill deterioration/spalls but there is no way to observe the area without removing the flashing (Refer to Figure E-54 through Figure E-59).

*Figure E- 53 – Windowsill Spall (Unit 223)*

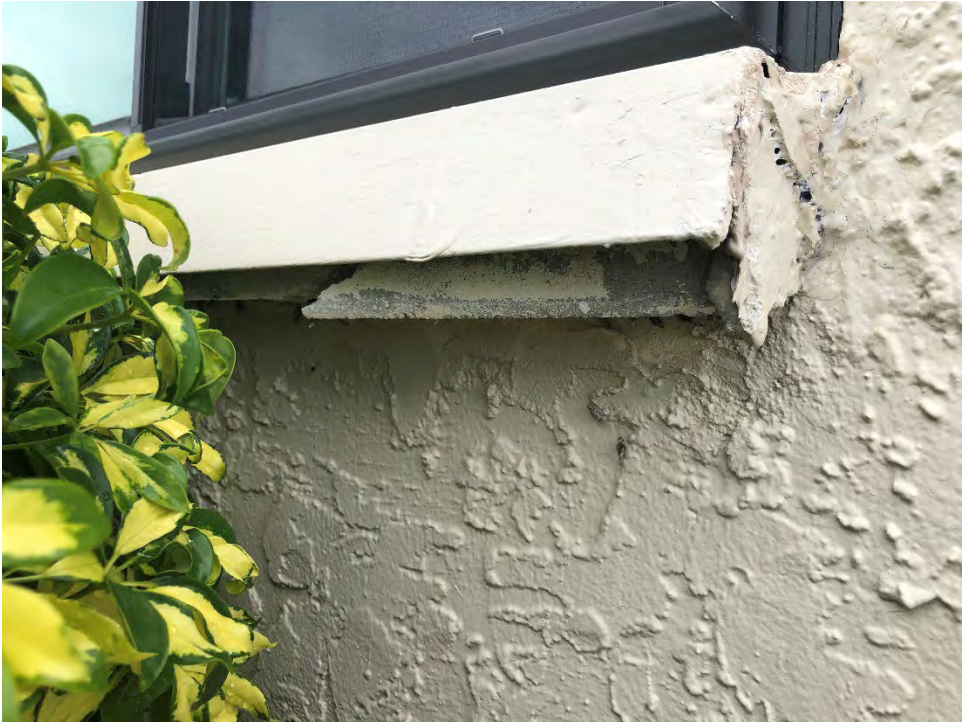
Figure E- 58 – Typical Metal Flashing at Windowsill

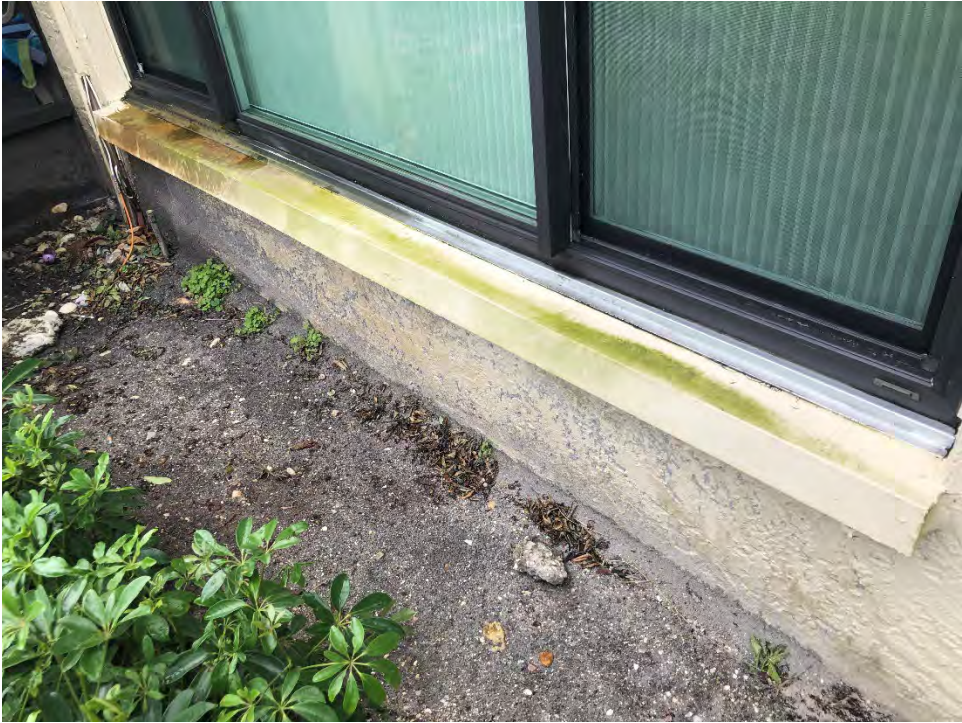
*Figure E- 59 – Typical Metal Flashing at Windowsill*

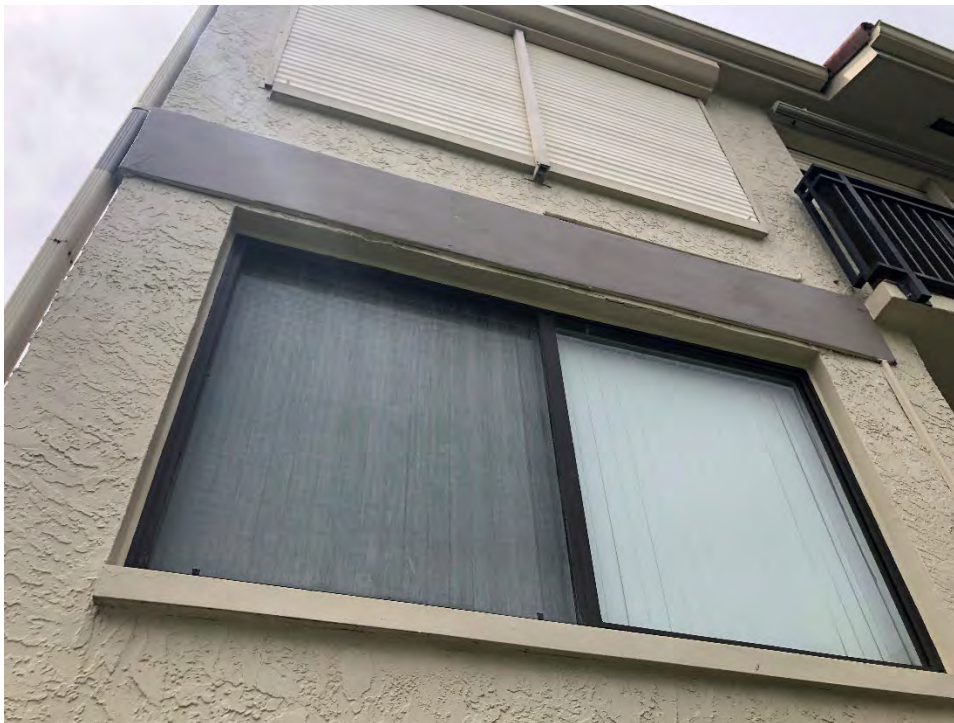
Figure E- 61 – Concrete Lintel Spall (Unit 303)

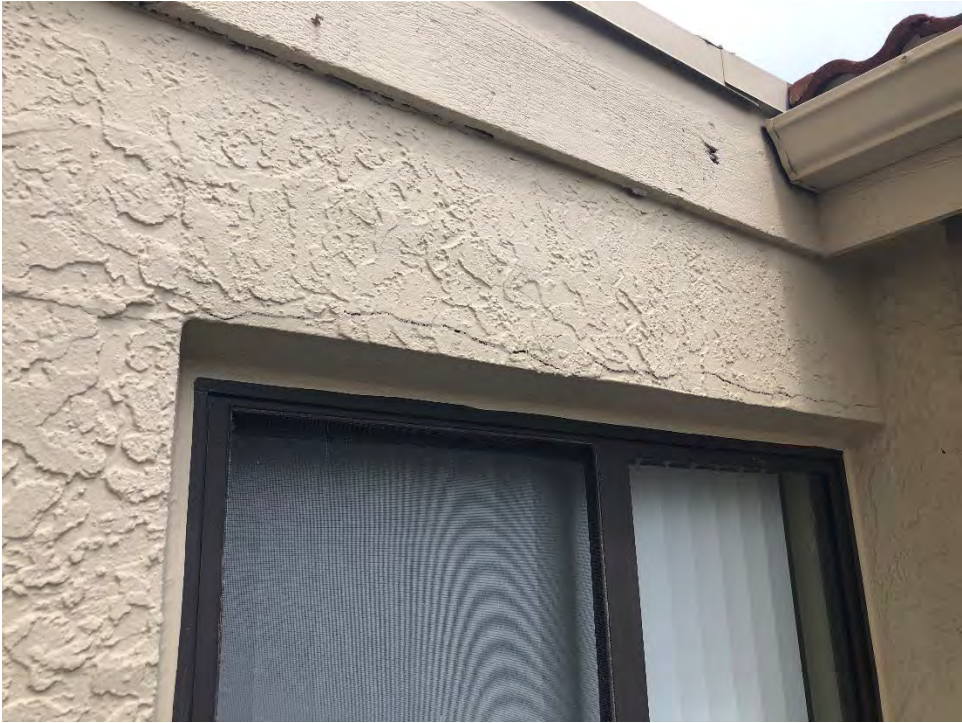
Figure E- 62 – Concrete Lintel Spall (Unit 113)

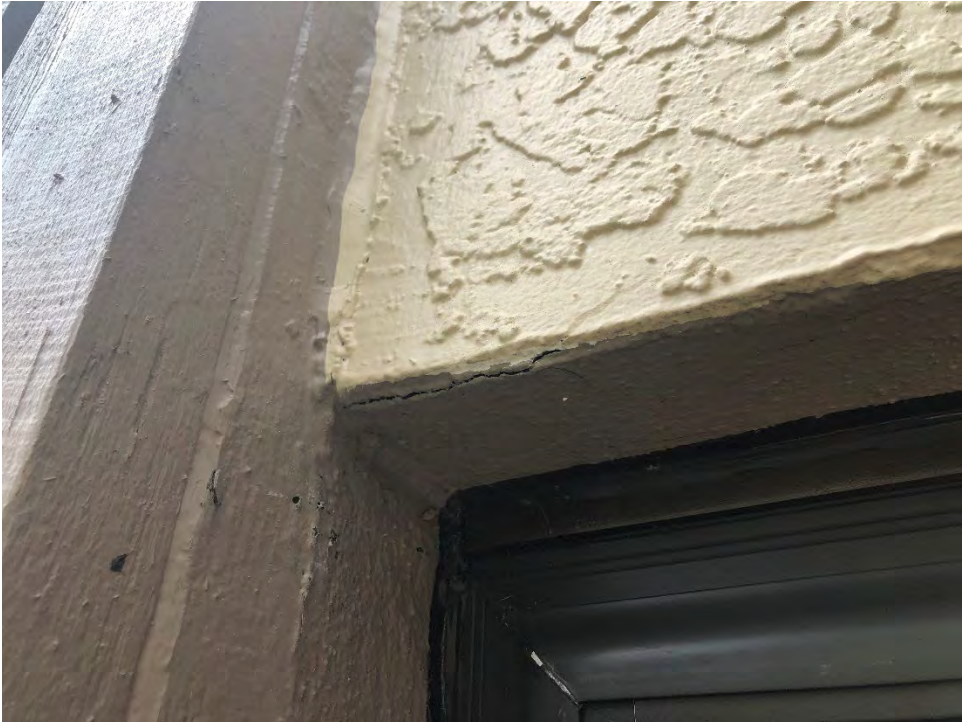
Figure E- 63 – Concrete Lintel Spall (Unit 120)

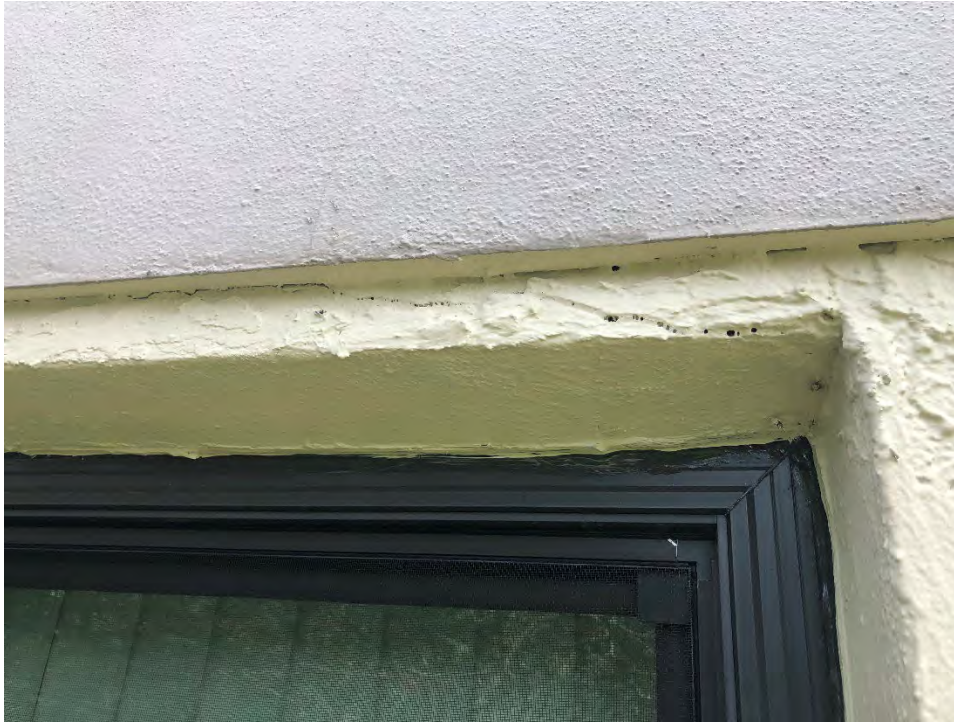
- Areas of blistering and/or peeling exterior paint coatings were observed along the exterior surfaces along the building exteriors (Refer E-64 and Figure E-65).

Figure E- 64 – Blistering Exterior Paint Coatings

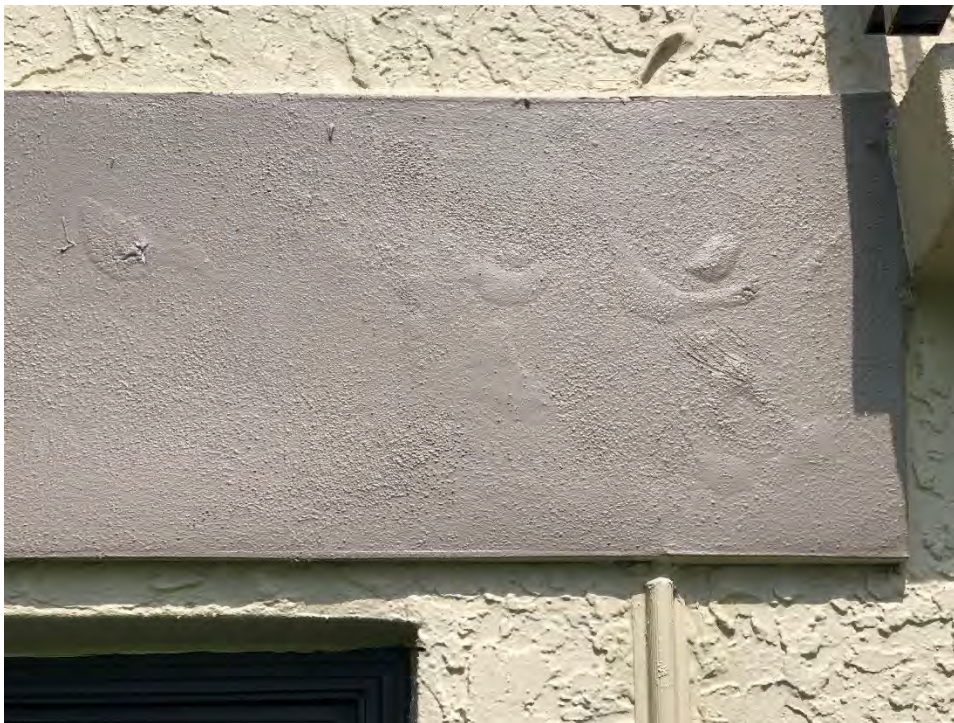
Figure E- 65 – Peeling Exterior Paint Coatings

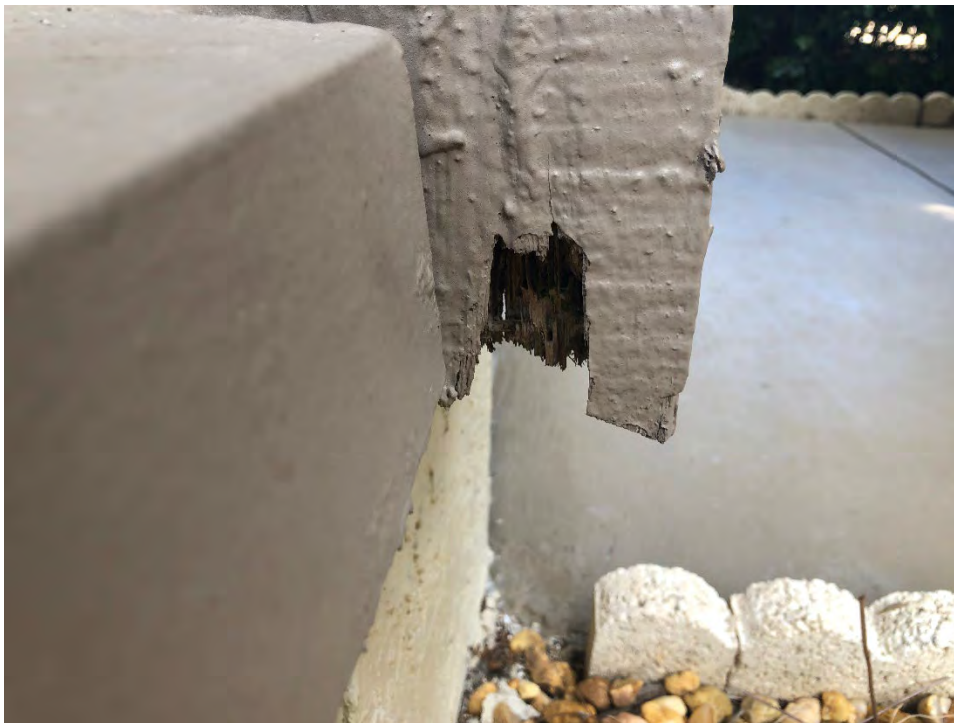
- Multiple areas of wood trim rot were observed along the building exteriors (Refer to Figure E-66 through Figure E-69).
- Balcony concrete slab edge spall was observed at Unit 209 (Refer to Figure E-70).

*Figure E- 67 – Typical Wood Trim Rot*

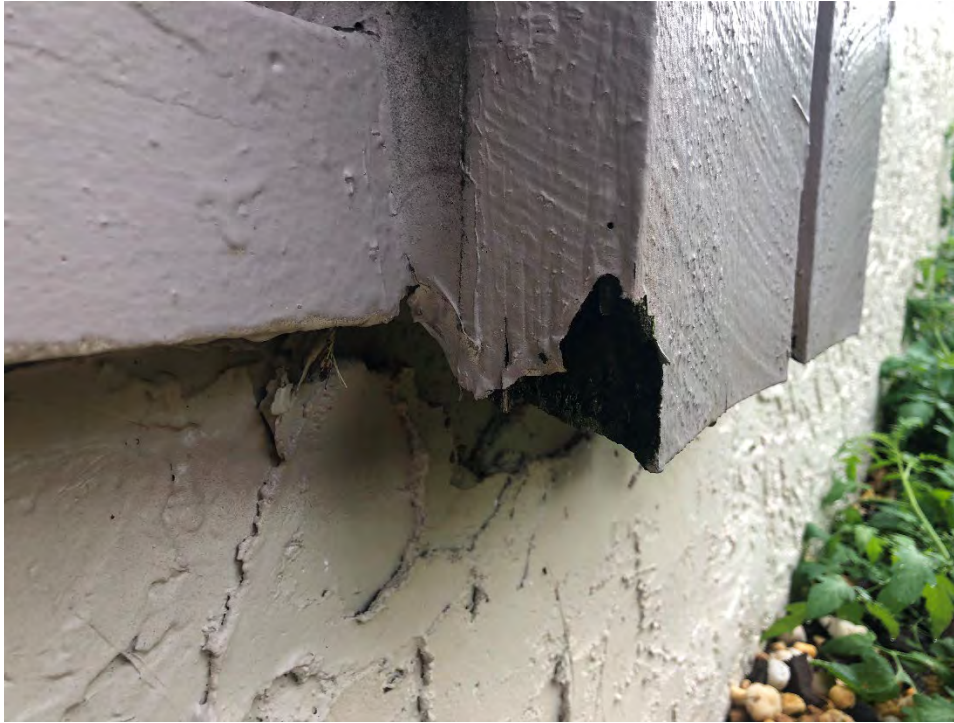
*Figure E- 68 – Typical Wood Trim Rot*

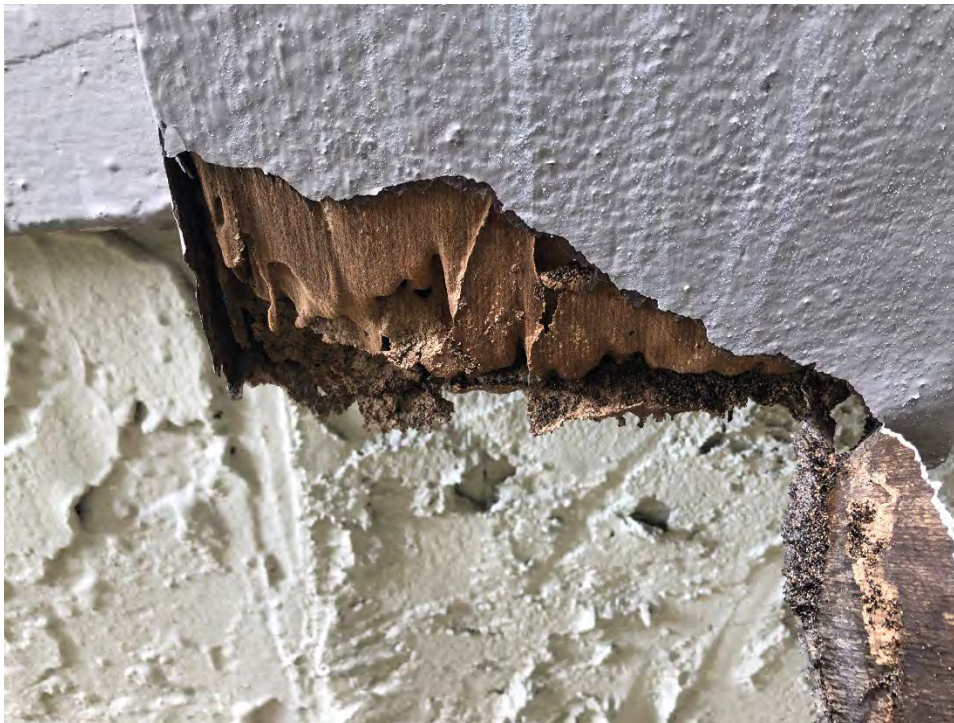
Figure E- 69 – Typical Wood Trim Rot

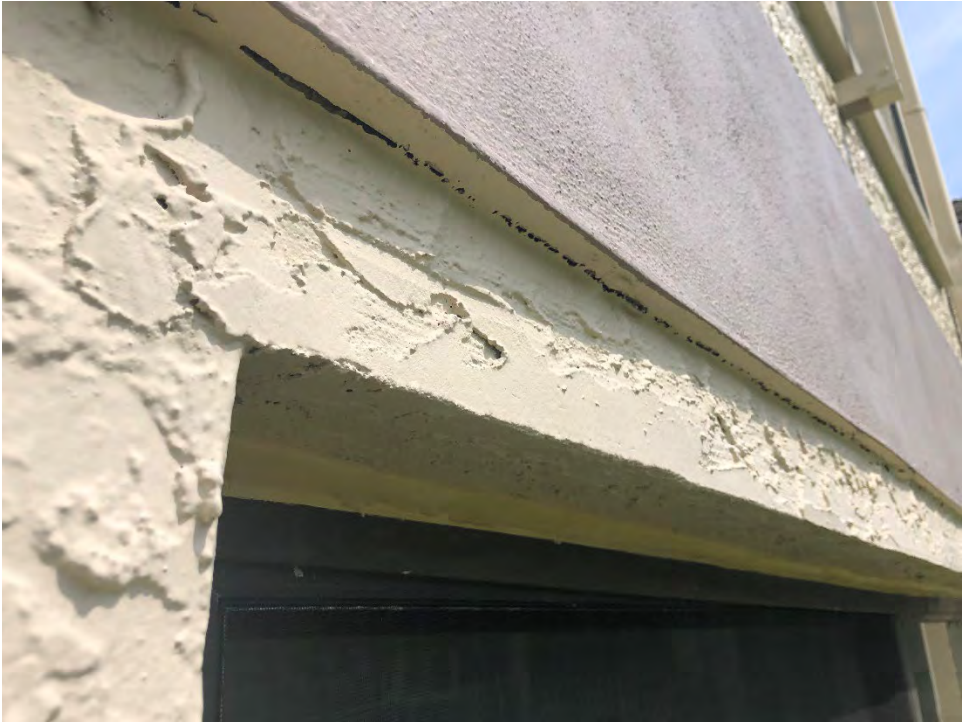
- Multiple separations were observed along stucco banding along the building exteriors (Refer to Figure E-71 through Figure E-73).

Figure E- 71 – Typical Separation at Stucco Banding
