FULL RESERVE STUDY

Palma Del Mar Condominium Association No. 5 of St Petersburg, Inc.

St. Petersburg, Florida

May 3, 2022

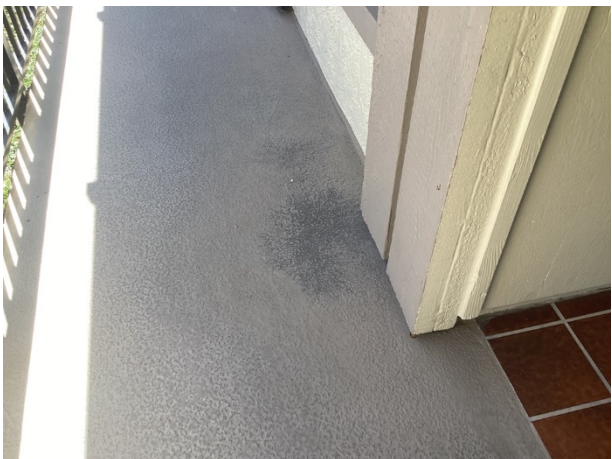
Breezeways – deterioration of the waterproof coating application evident

Useful Life: Capital repairs including a close-up visual inspection, patching of delaminated concrete, routing and filling of cracked concrete, and waterproof coating applications every 8- to 12-years.

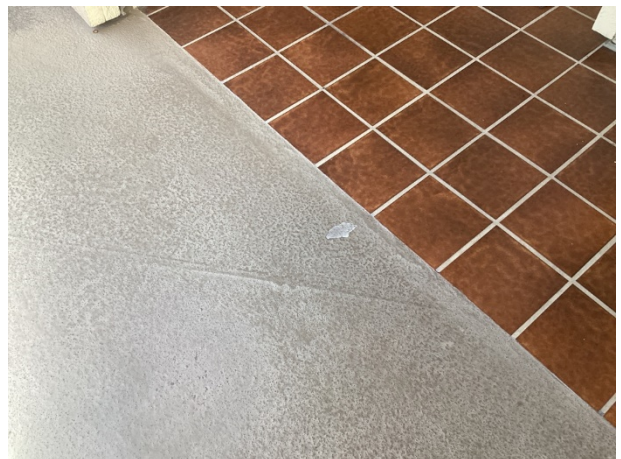
Breezeways – deterioration of the waterproof coating application evident

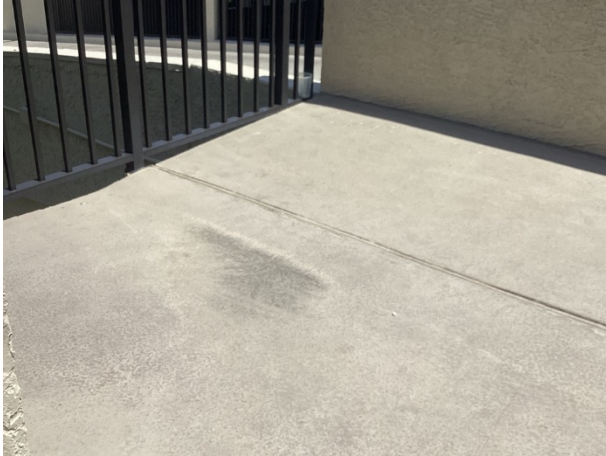
Breezeways – deterioration of the waterproof coating application evident

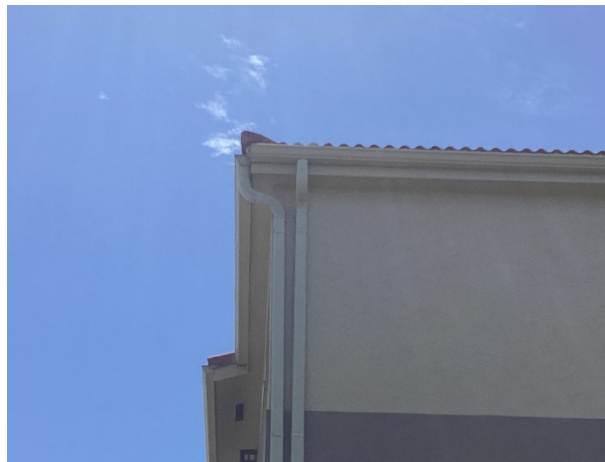
Condition: Fair overall with minor corrosion evident

Gutter and downspout assembly detail

- Repair and seal any leaking seams or end caps
- Verify downspouts discharge away from foundations

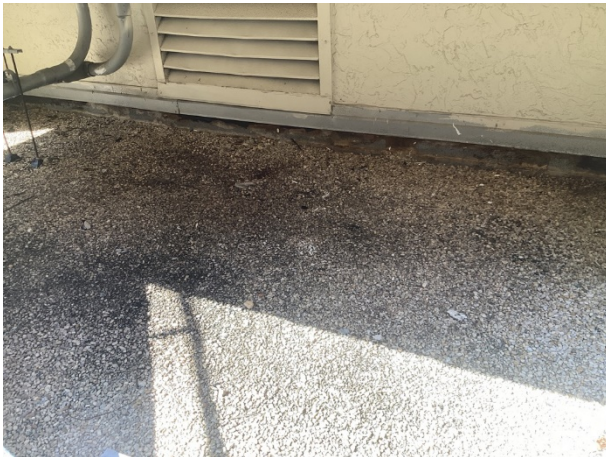
Condition: Fair overall with standing water and granular loss evident. Management and the Board report a minor history of leaks.

Built-up roof – granular loss evident

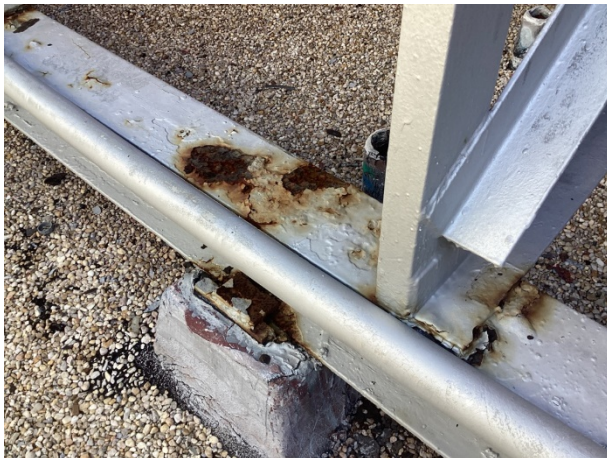
Condition: Fair overall with corrosion evident

Steel structure – corrosion evident

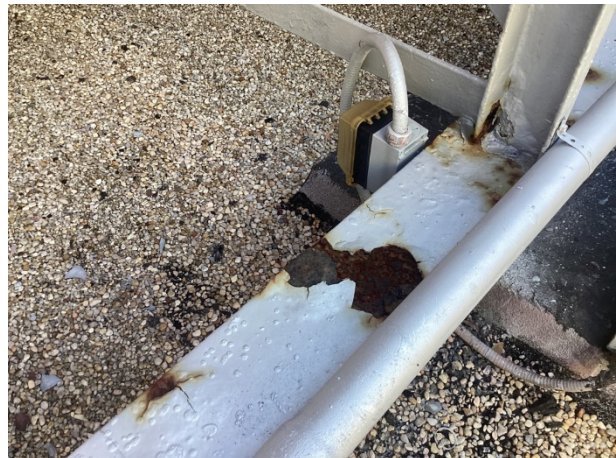
Steel structure – corrosion evident

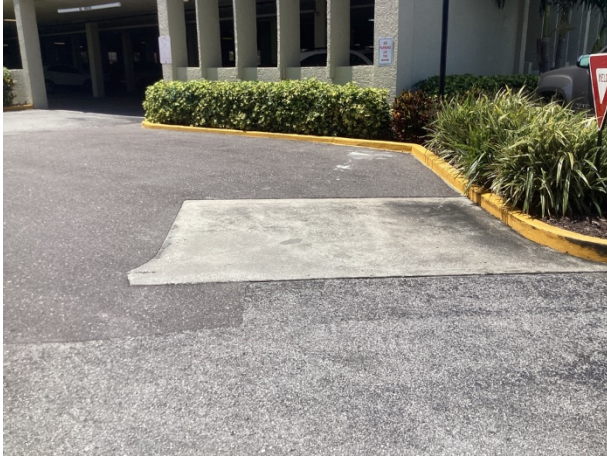
Condition: Fair overall with deterioration of the seal coat application as well as deterioration of the asphalt pavement evident

Asphalt pavement – deterioration of the seal coat application as well as cracks evident

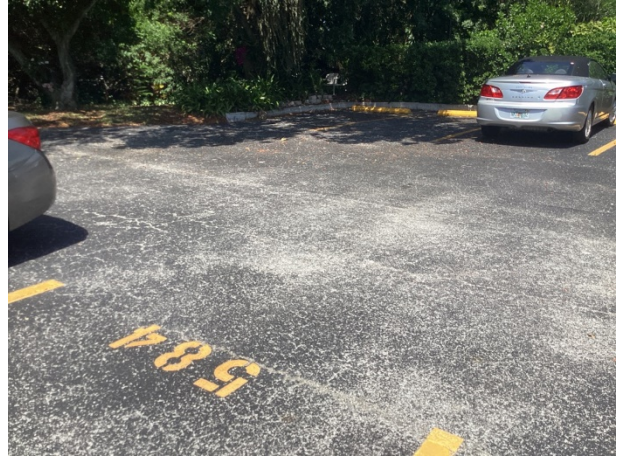
Asphalt pavement – deterioration of the seal coat application evident

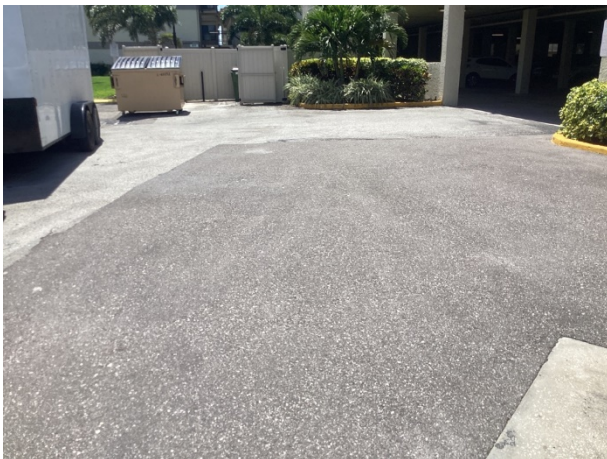
Asphalt pavement – previous patch repairs evident

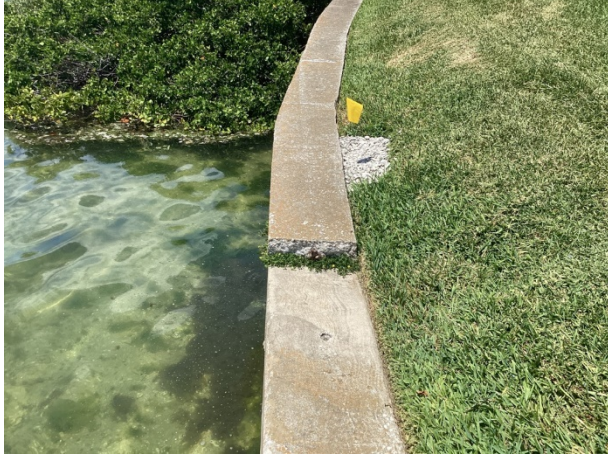
Condition: Fair overall with cracks in the concrete cap evident

Cracks in the concrete cap evident

Useful Life: We recommend the Association conduct inspections and capital repairs every 15 years

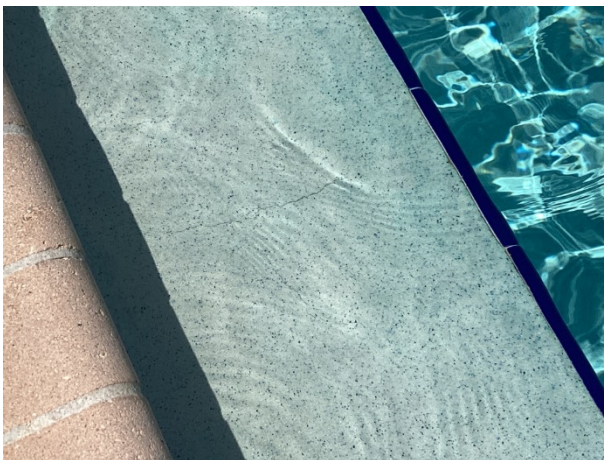
Condition: Good to fair overall with minor cracks evident. We are informed that there are some leaks at the spa and have allocated monies to replace the finishes at the pool in the near term.

Pool finishes – cracks evident

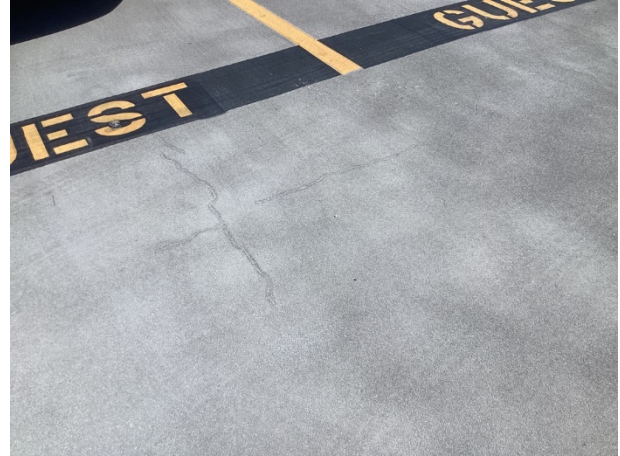
Condition: Good overall isolated cracks and patch repairs evident

Elevated concrete – cracks evident

Useful Life: Repairs to the various concrete surfaces 10- to 15-years

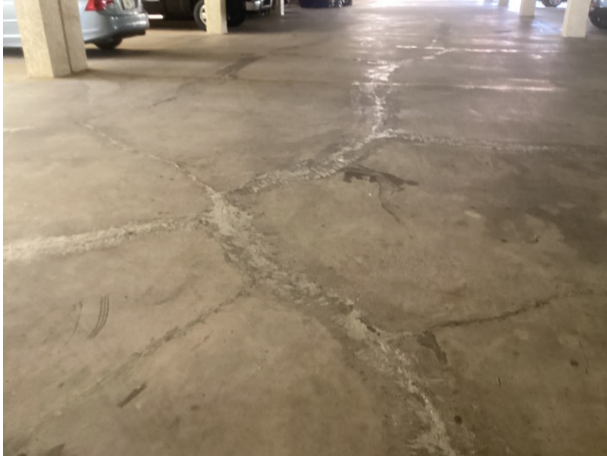
On grade concrete – cracks evident

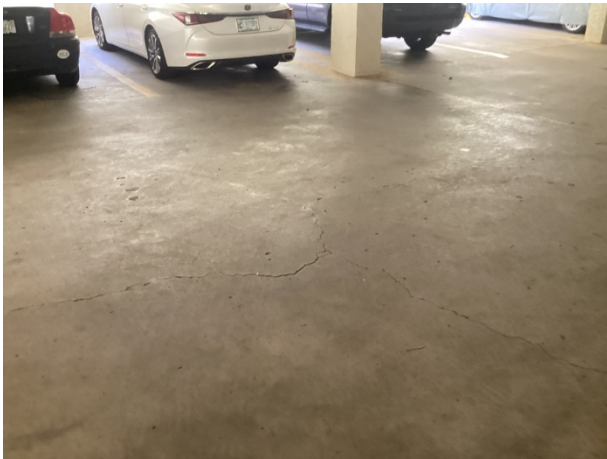
On grade concrete – cracks evident

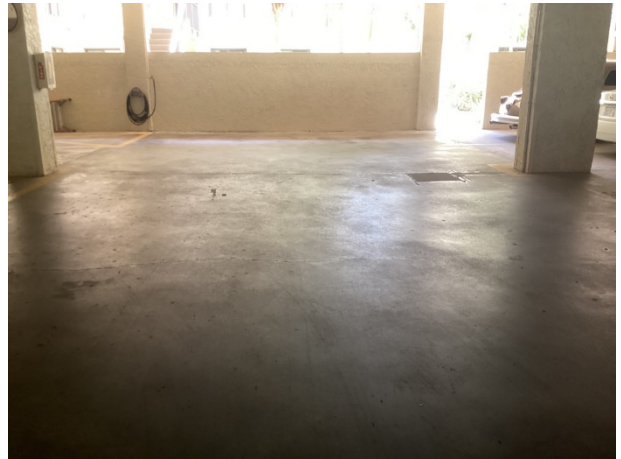
On grade concrete – cracks evident

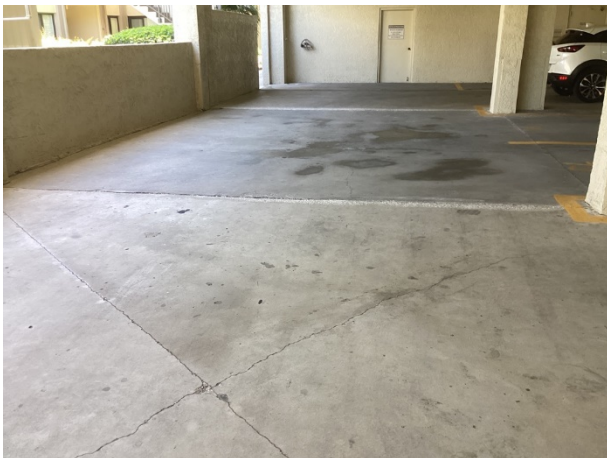
On grade concrete – cracks evident

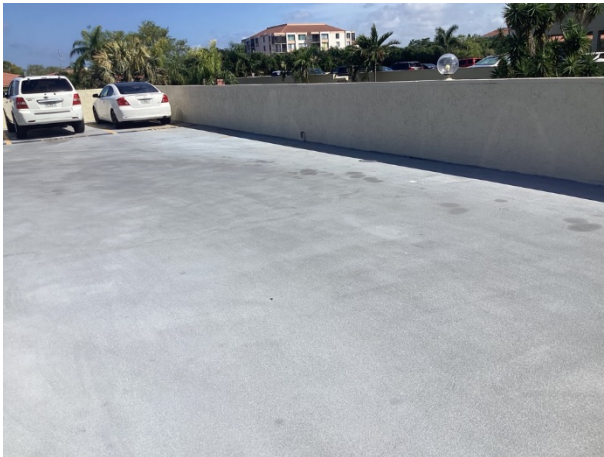
Condition: Good to fair overall with deterioration of the traffic coating evident

Traffic coating – deterioration evident

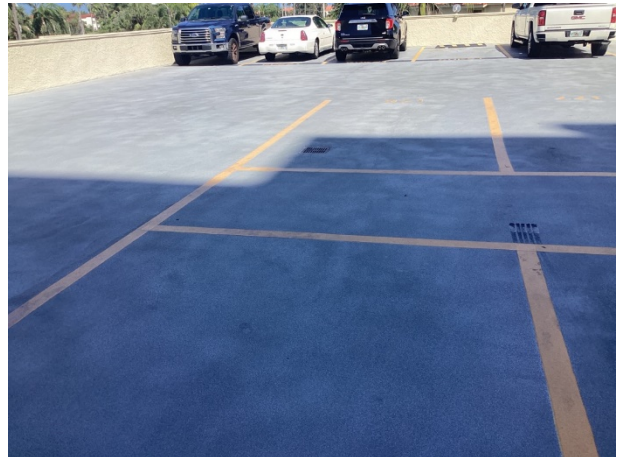
Traffic coating – deterioration evident

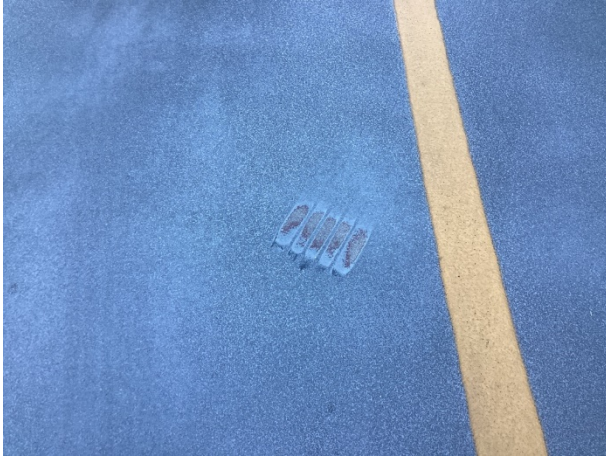
Traffic coating – deterioration evident

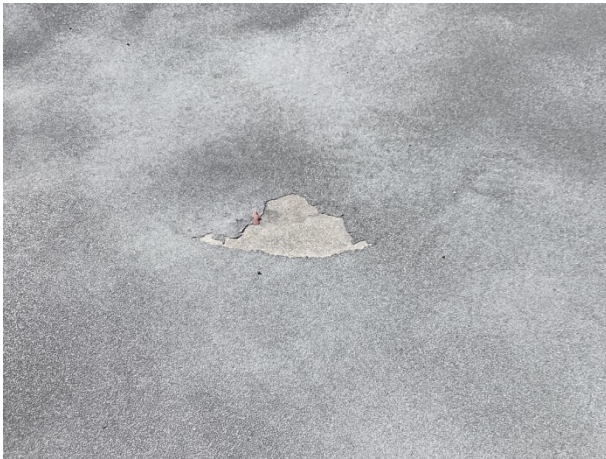
Traffic coating – deterioration evident

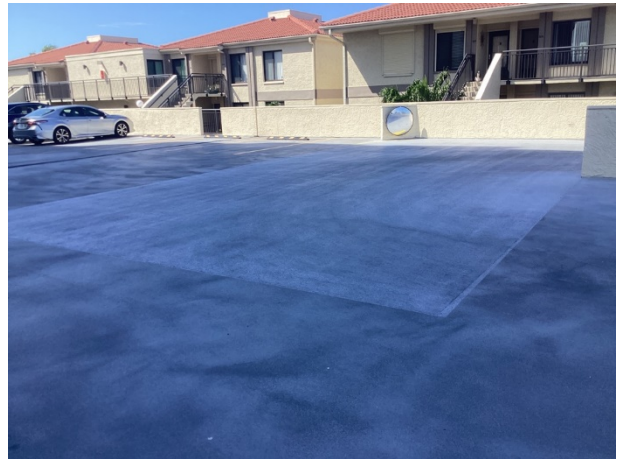
Traffic coating – deterioration evident
