Revised **FULL RESERVE STUDY**

**Palma Del Mar Condominium Association
No. 5 of St Petersburg, Inc.**

**St. Petersburg, Florida
Inspected - May 3, 2022
Revised - December 1, 2022**

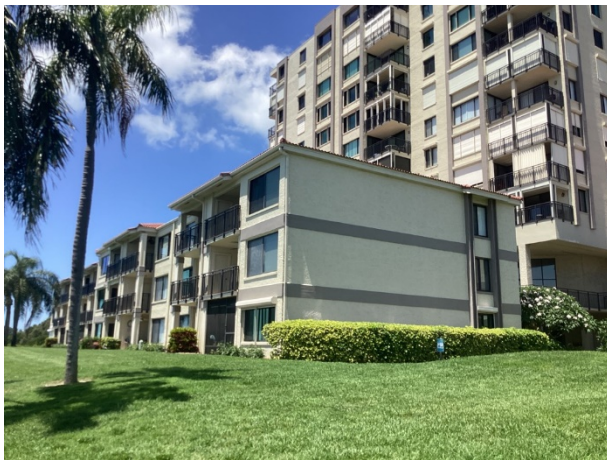
Typical 3-story building

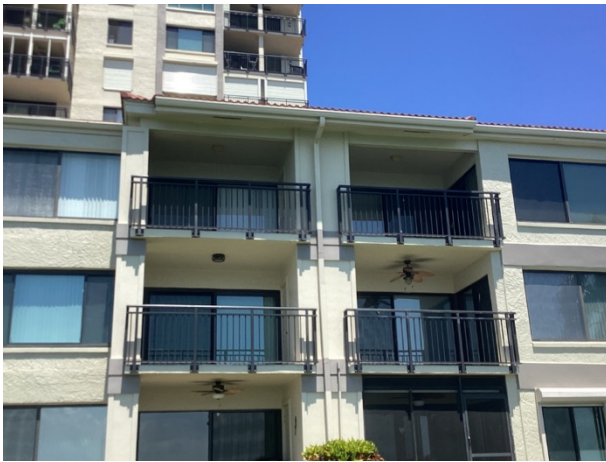
Balconies - overview

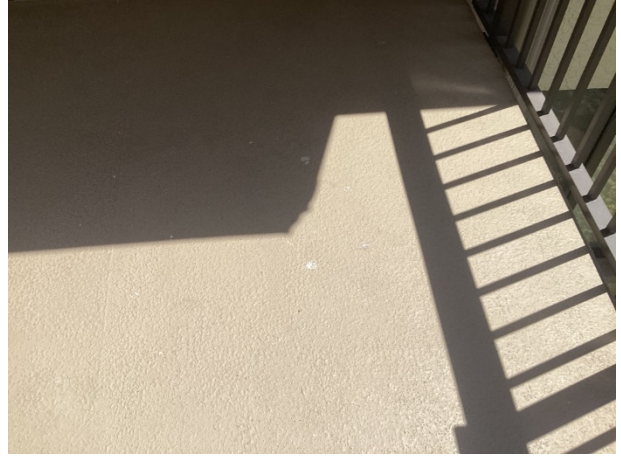
Condition: Fair overall with deterioration of the waterproof coating at the breezeways evident during our noninvasive inspection

Breezeways – deterioration of the waterproof coating application evident

Useful Life: Capital repairs including a close-up visual inspection, patching of delaminated concrete, routing and filling of cracked concrete, and waterproof coating applications every 8- to 12-years.

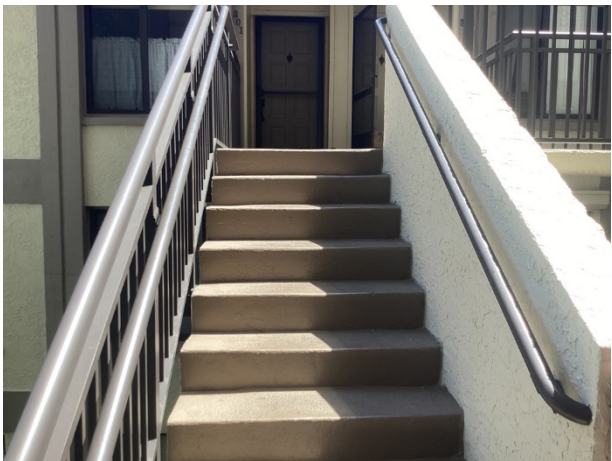
Staircases - overview

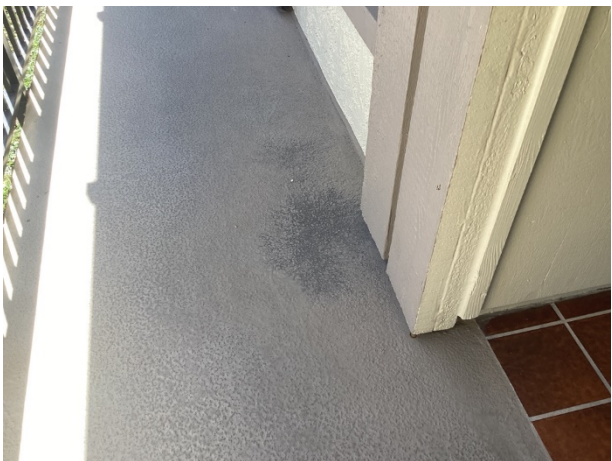
Breezeways – deterioration of the waterproof coating application evident

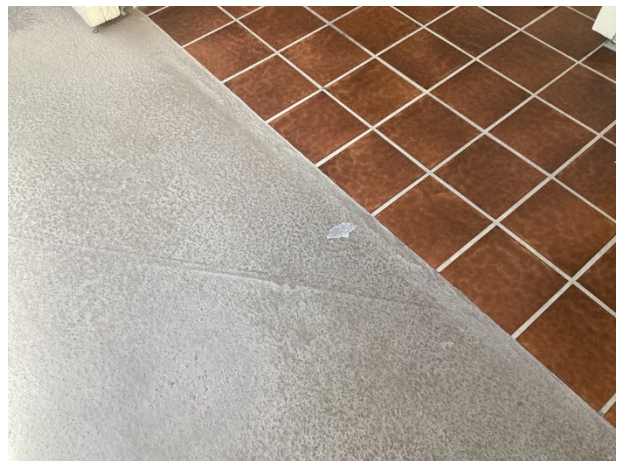
Breezeways – deterioration of the waterproof coating application evident

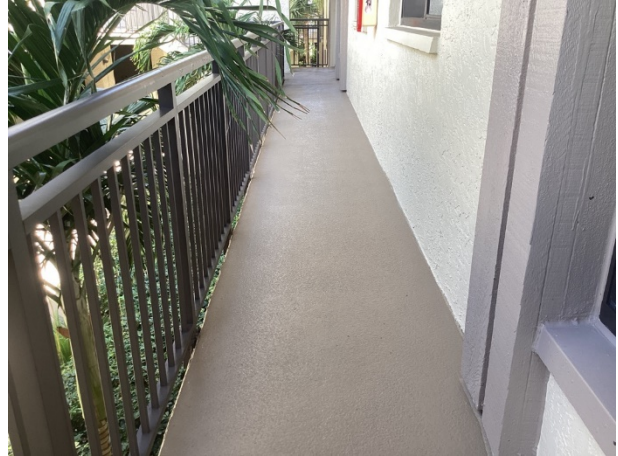
Breezeways – deterioration of the waterproof coating application evident

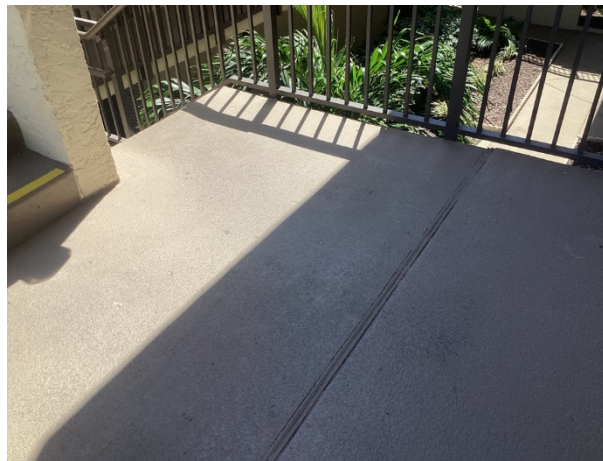
Breezeways – overview

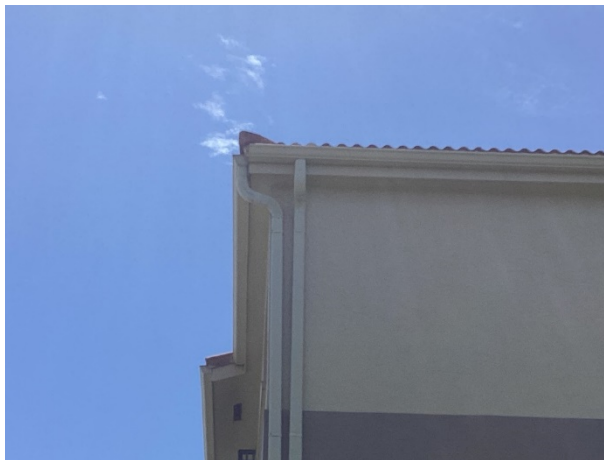
Condition: Fair overall with minor corrosion evident

Gutter and downspout assembly detail

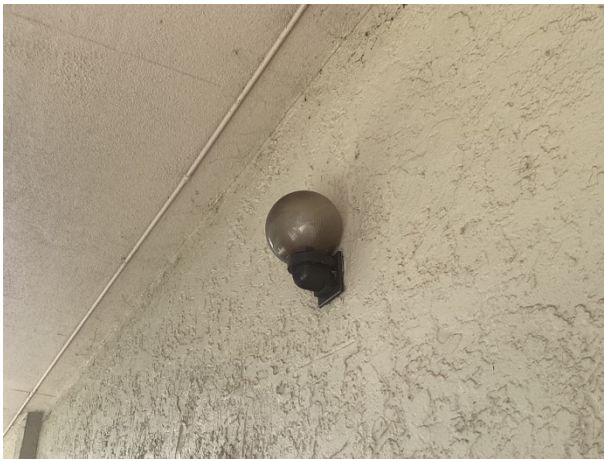
Light fixtures – globe fixture

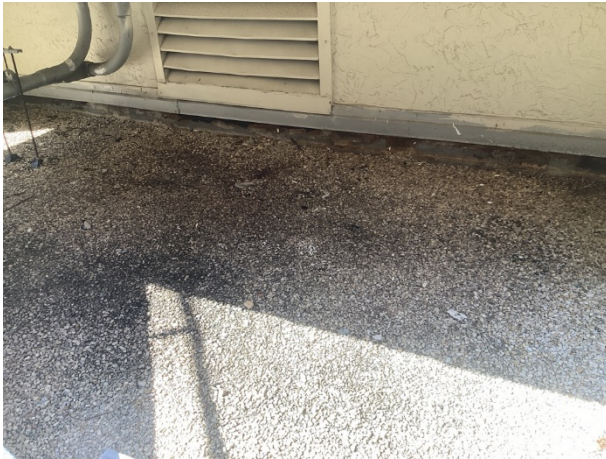
Condition: Fair overall with standing water and granular loss evident. Management and the Board report a minor history of leaks.

Built-up roof – granular loss evident

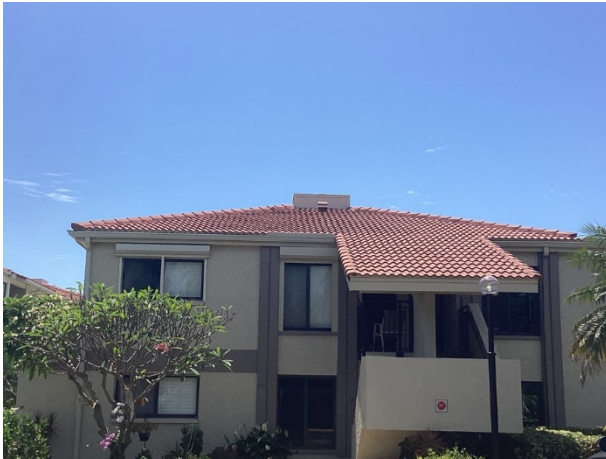
Concrete tile roofs – villas configuration

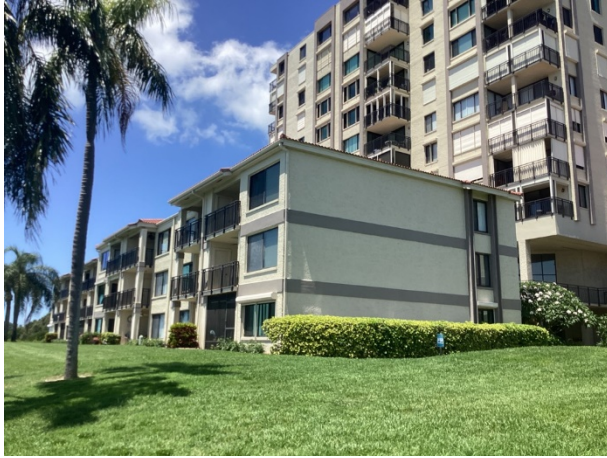
Paint finishes – villas - overview

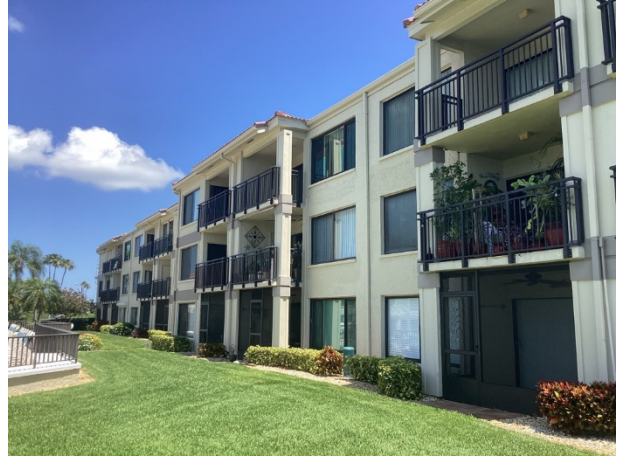
Paint finishes – villas - overview

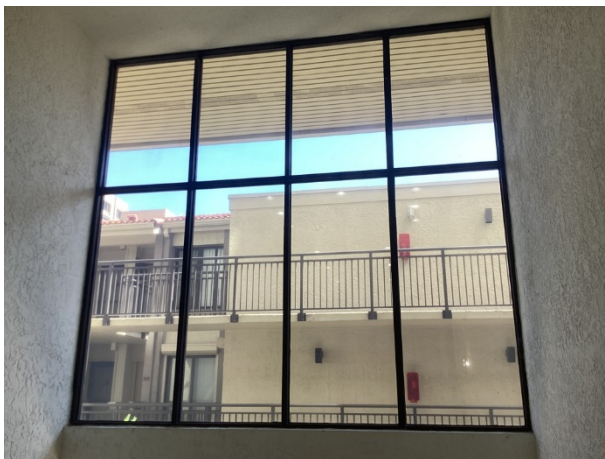
Storefront windows - overview

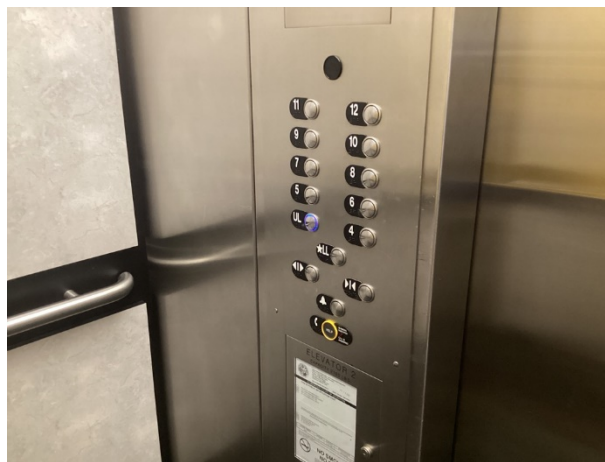
Elevator cab finishes

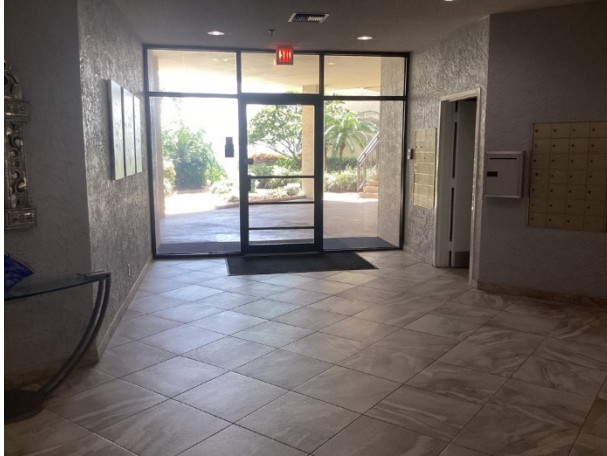
Tile floor coverings - overview

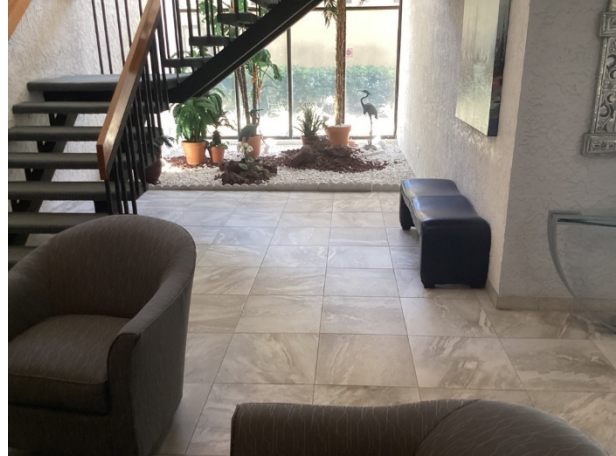
Tile floor coverings - overview

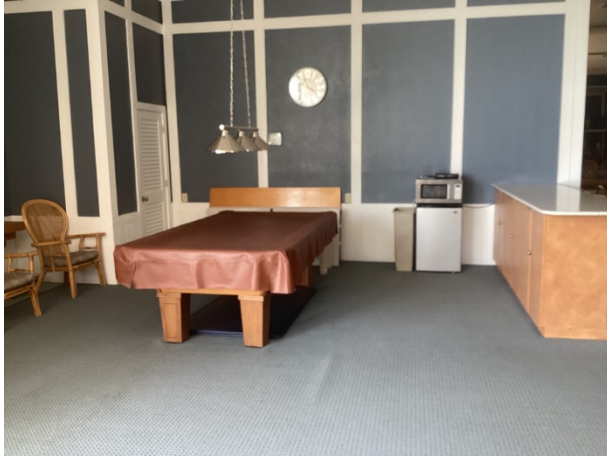
Social room renovation - overview

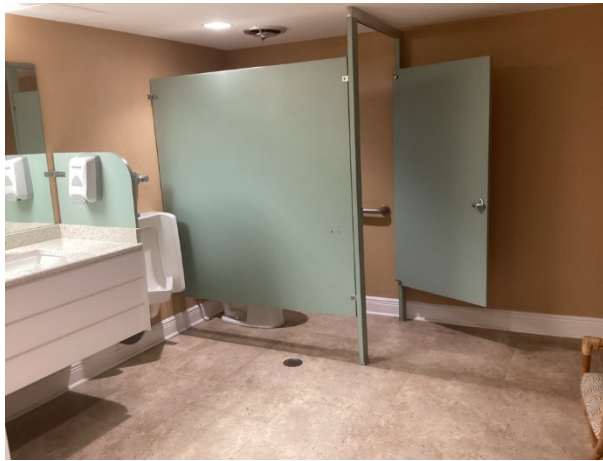
Rest rooms - typical

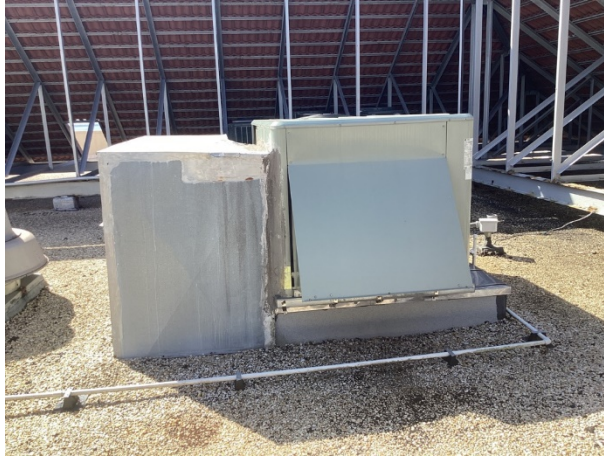
Condition: Reported satisfactory with operational deficiencies

Roof top unit

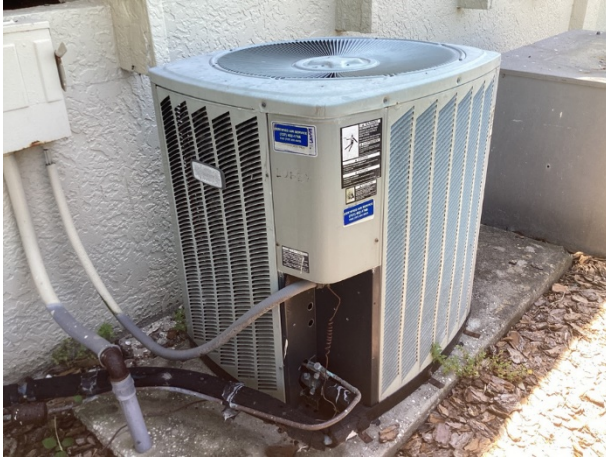
Condition: Reported satisfactory with operational deficiencies

Split systems – overview

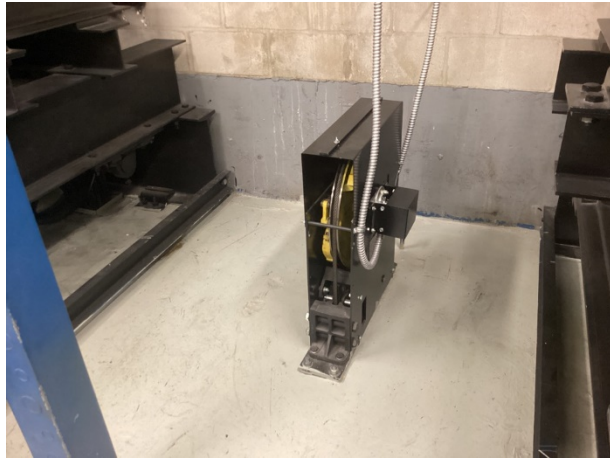
Elevator equipment - hoists

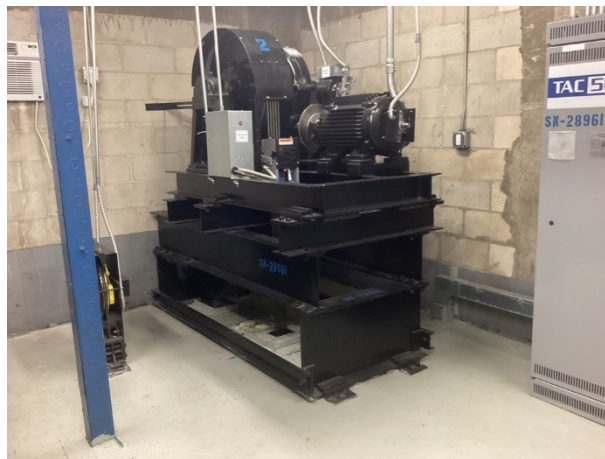
Elevator equipment - hoists

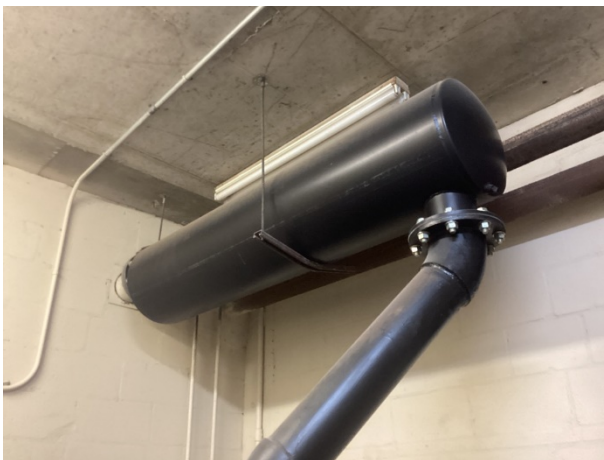
Diesel generator

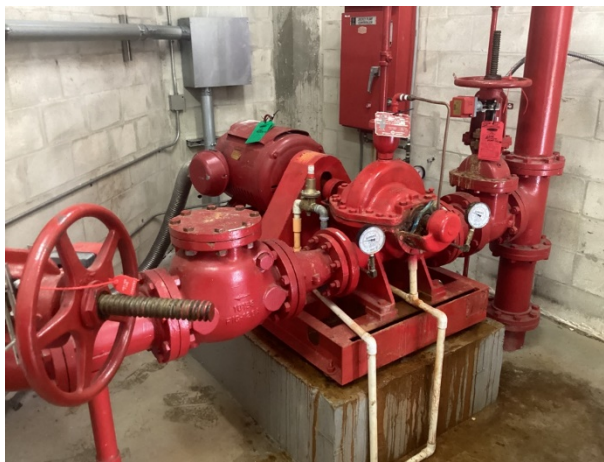
Fire pump - overview

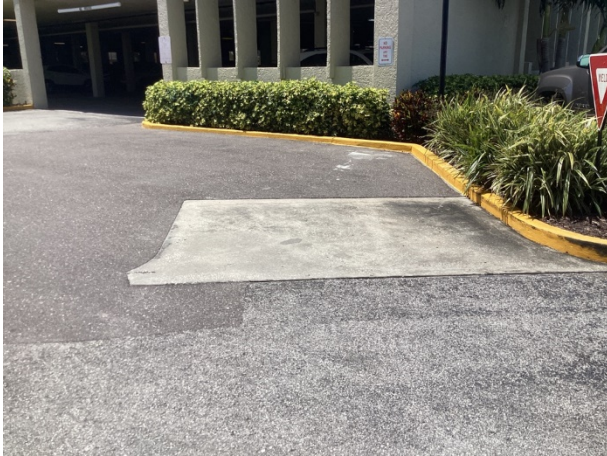
Condition: Fair overall with deterioration of the seal coat application as well as deterioration of the asphalt pavement evident

Asphalt pavement – deterioration of the seal coat application as well as cracks evident

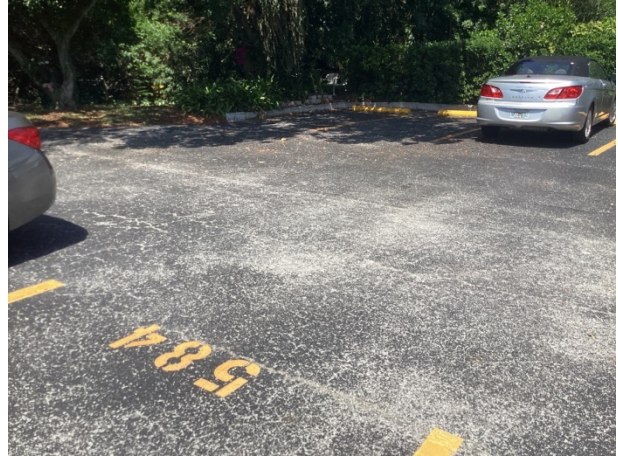
Asphalt pavement – deterioration of the seal coat application evident

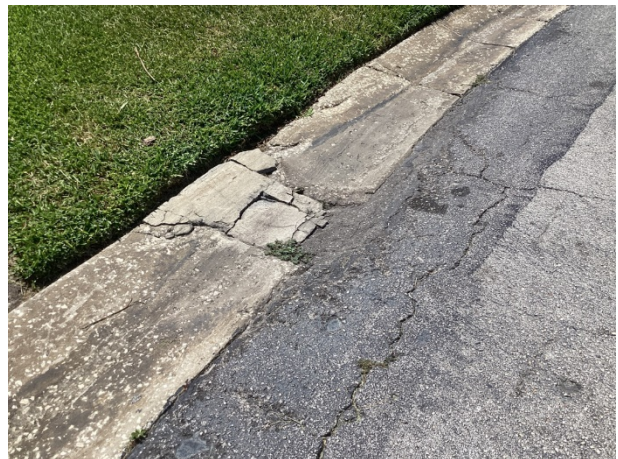
Asphalt pavement – cracks evident

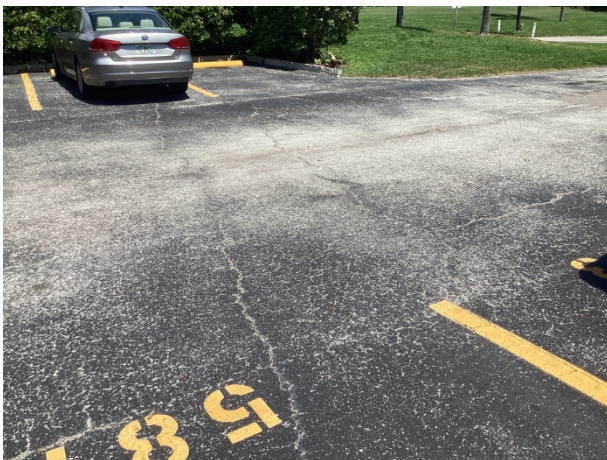
Asphalt pavement – deterioration of the seal coat application as well as cracks evident

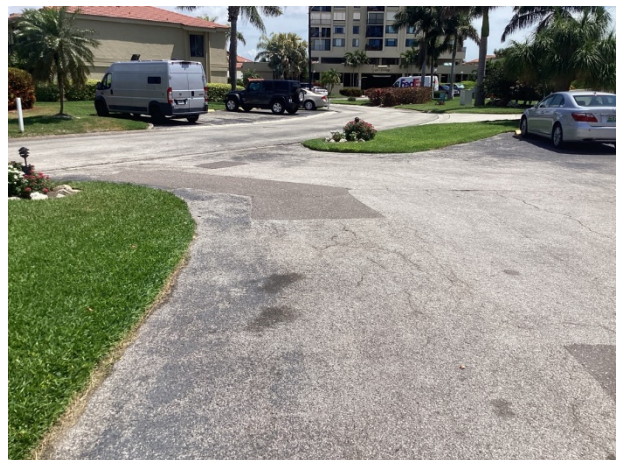
Asphalt pavement – deterioration of the seal coat application as well as cracks evident

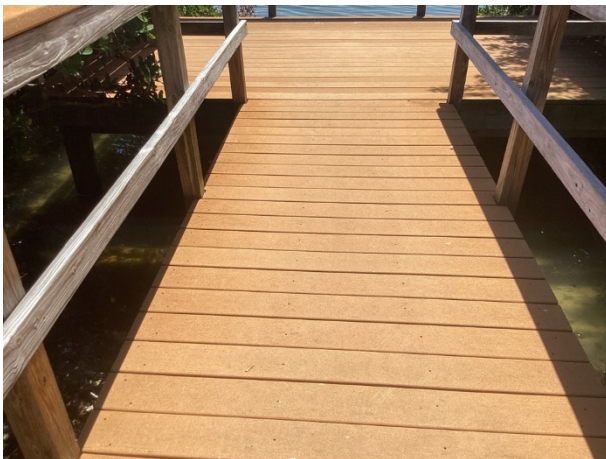
Fishing pier – composite deck boards

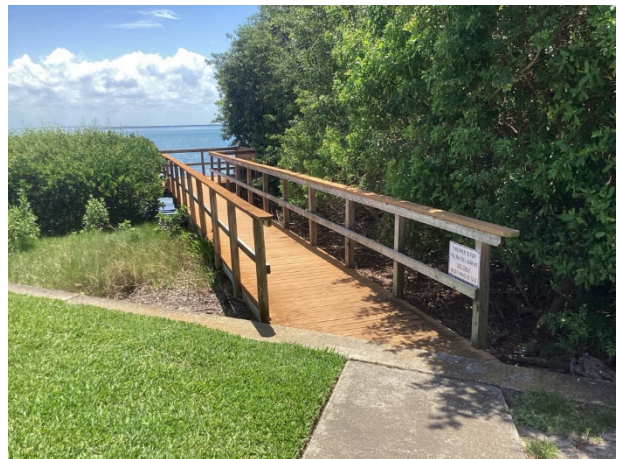
Fishing pier – overview

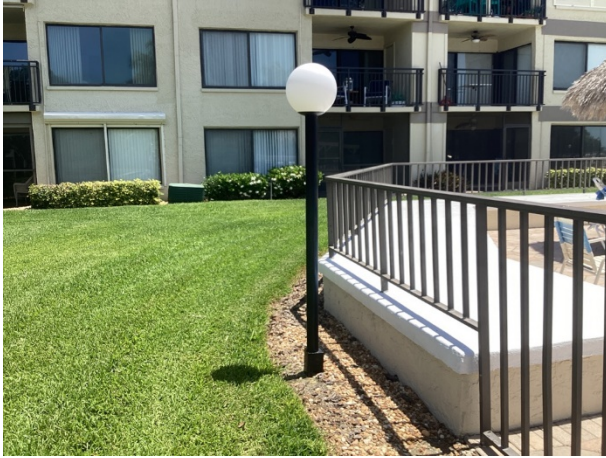
Light pole and fixture

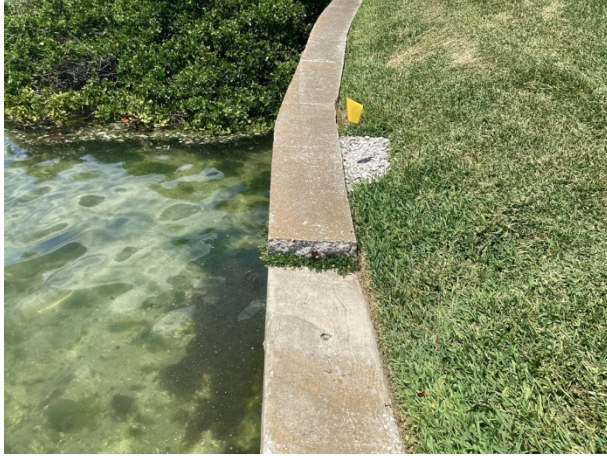
Condition: Fair overall with cracks in the concrete cap evident

Cracks in the concrete cap evident

Useful Life: We recommend the Association conduct inspections and capital repairs every 15 years

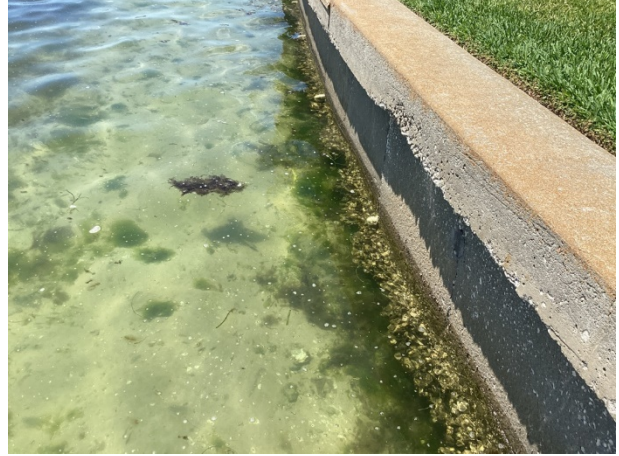
Concrete seawall - overview

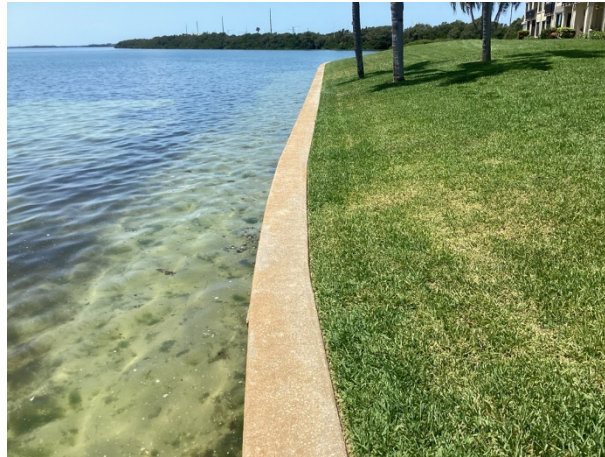
Concrete seawall - overview

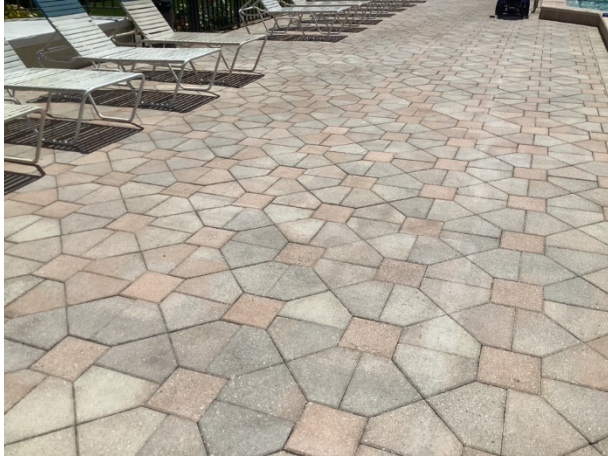
Deck pavers - overview

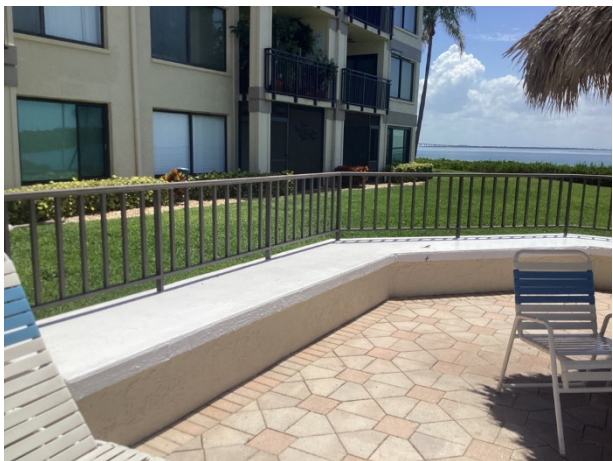
Pool fences - overview

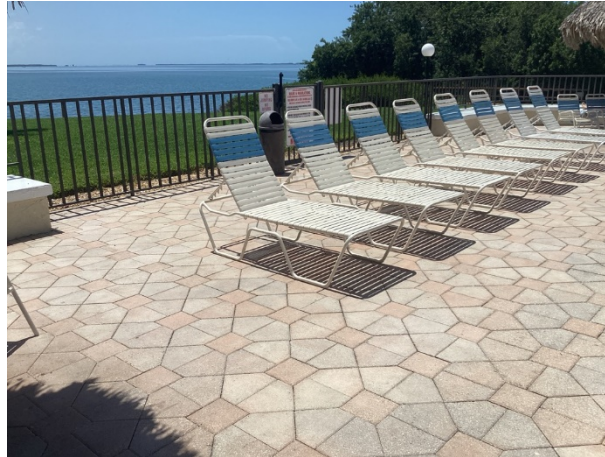
Pool furniture overview

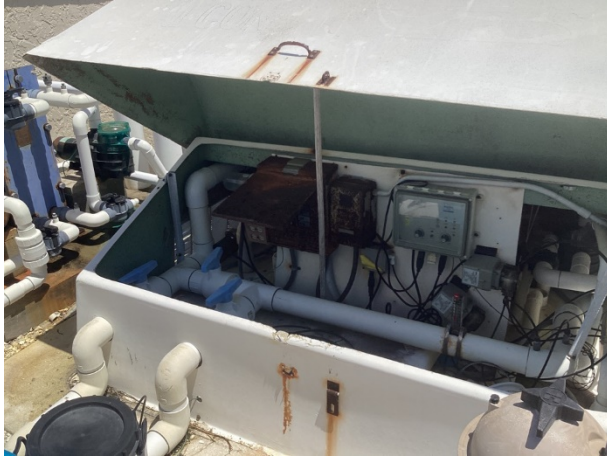
Pool mechanical equipment – overviews

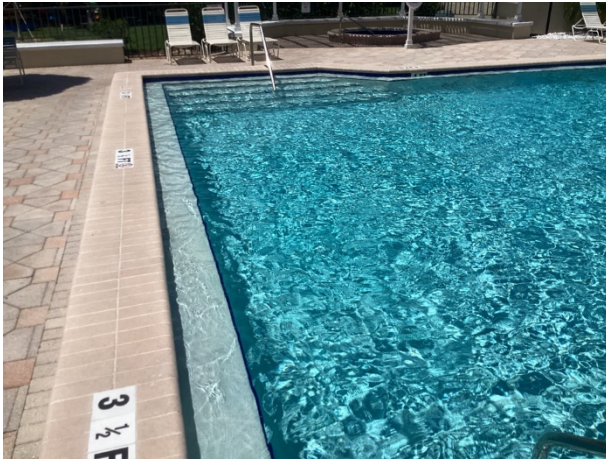
Pool finishes – overview

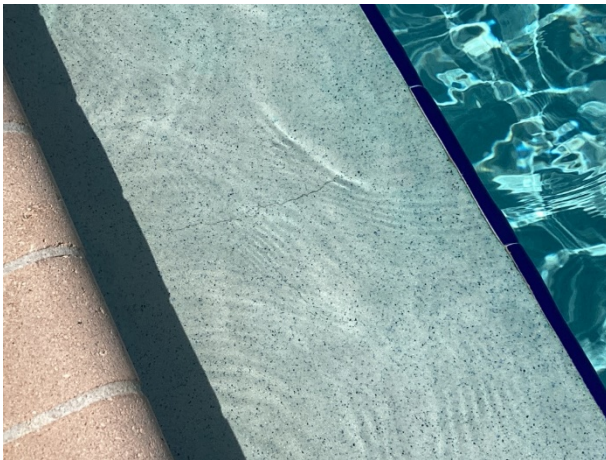
Condition: Good to fair overall with minor cracks evident. We are informed that there are some leaks at the spa and have allocated monies to replace the finishes at the pool in the near term.

Pool finishes – cracks evident

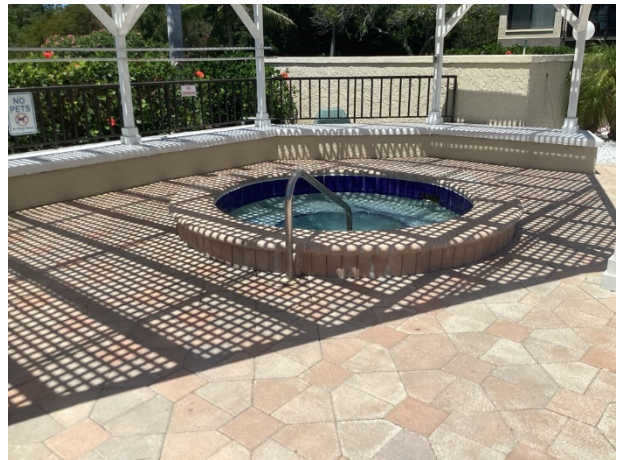
Spa finishes - overview

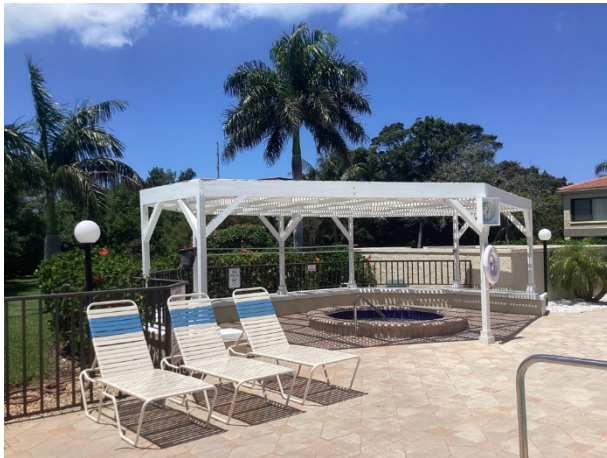
Shade structure - overview

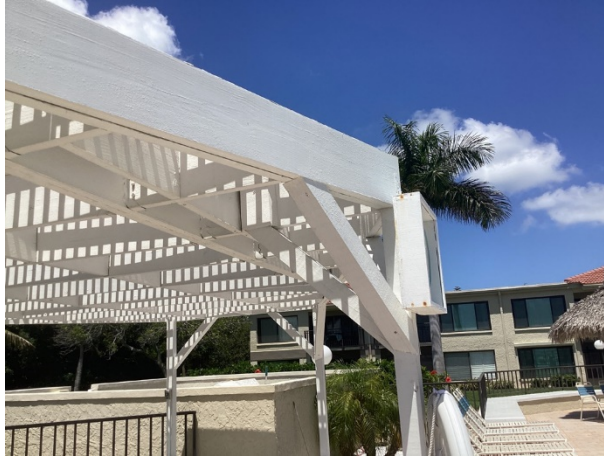
Shade structure – support detail

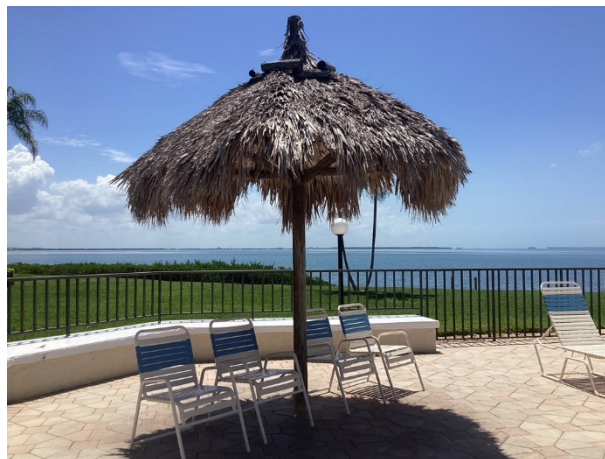
Condition: Fair overall. Based on information provided by the Association, we have accelerated the replacement of the tiki huts.

Tiki huts

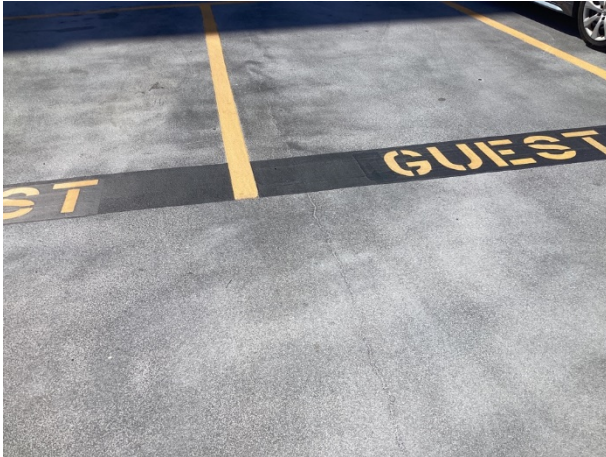
Elevated concrete - overview

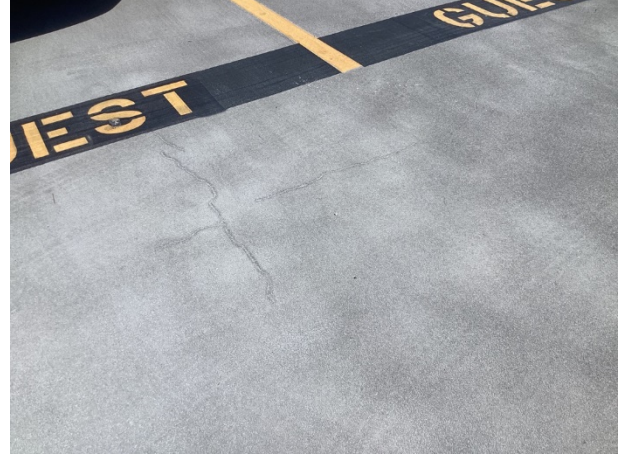
Elevated concrete – cracks evident

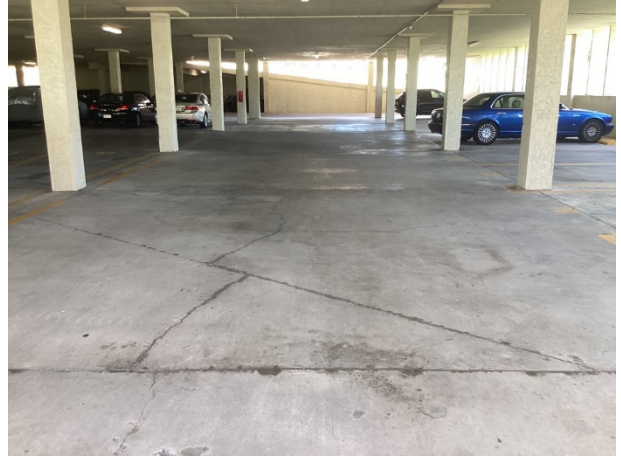
On grade concrete – cracks evident

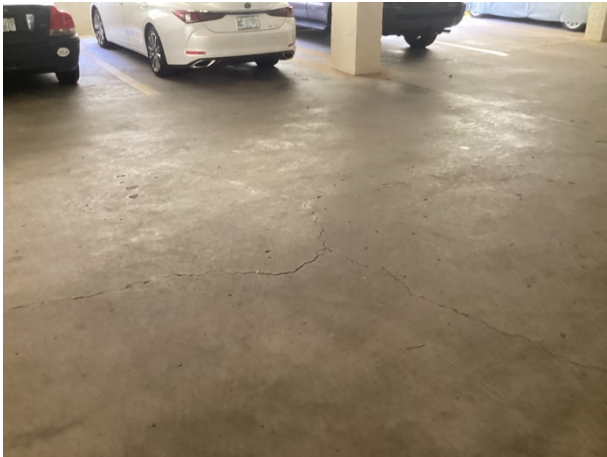
On grade concrete – cracks evident

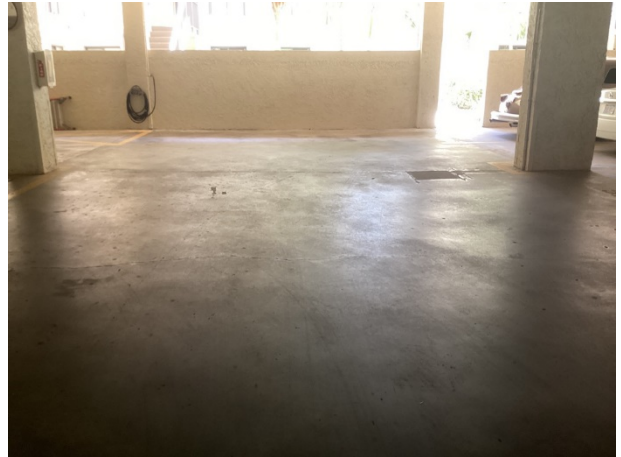
On grade concrete – cracks evident

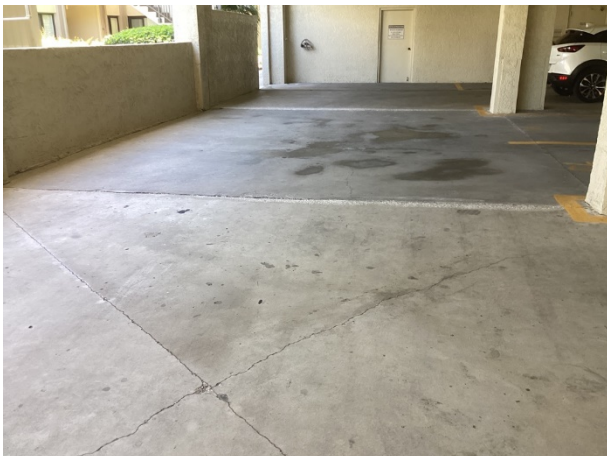
On grade concrete – cracks evident

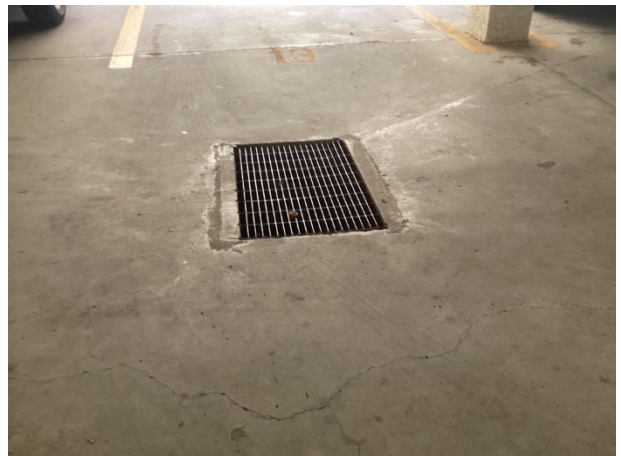
On grade concrete – drainage detail

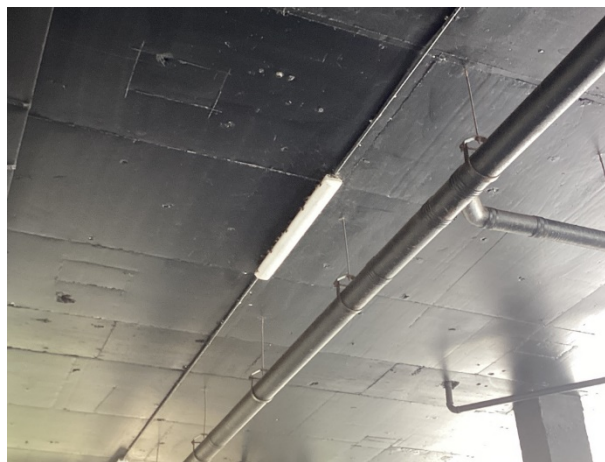
Garage light fixtures

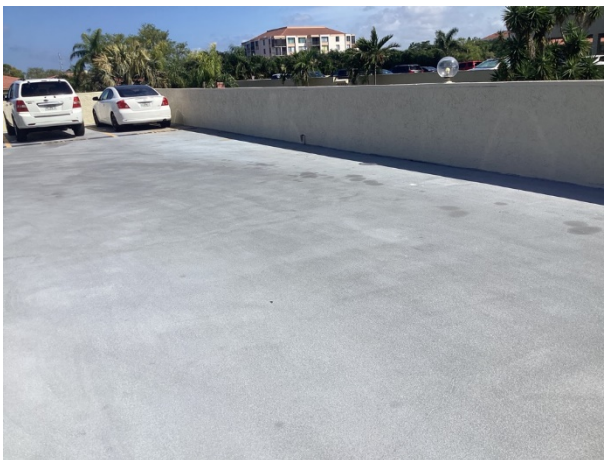
Condition: Good to fair overall with deterioration of the traffic coating evident

Traffic coating – deterioration evident

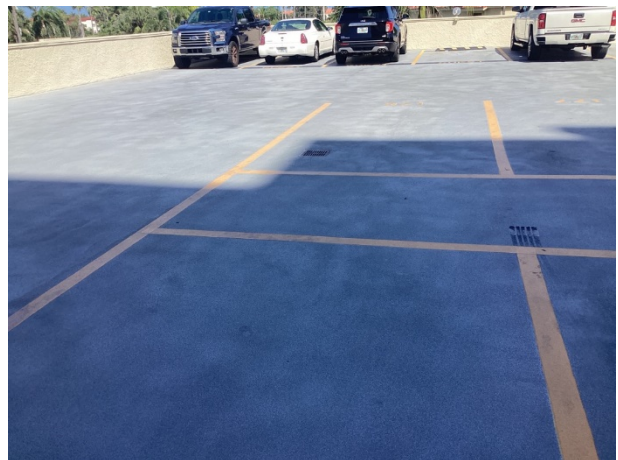
Traffic coating – deterioration evident

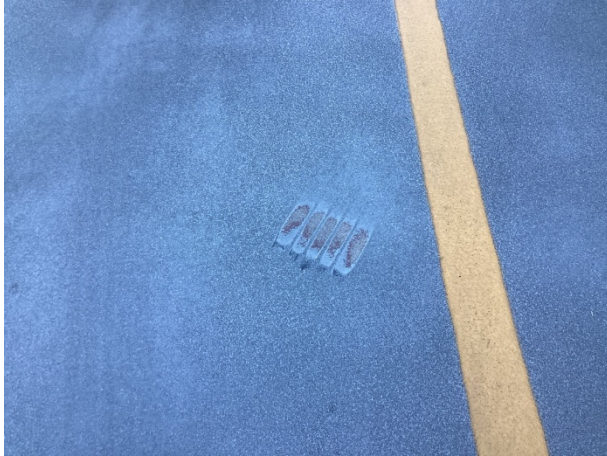
Traffic coating – deterioration evident

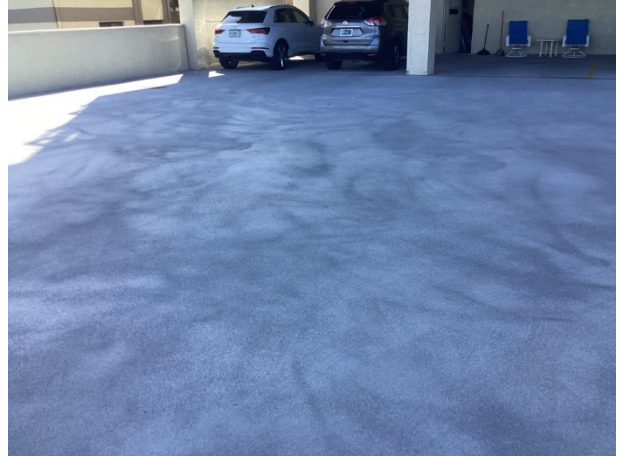
Traffic coating – deterioration evident

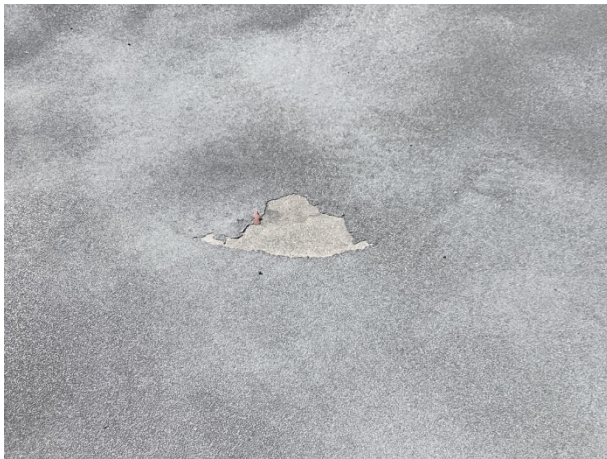
Traffic coating – deterioration evident

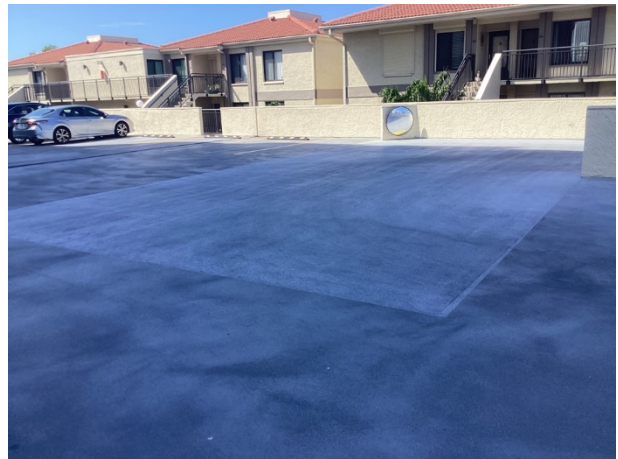
Traffic coating – deterioration evident
