# Palma Del Mar Condominium No. 5 of St Petersburg, Inc.

November 30, 2023 • St. Petersburg, FL

**STRUCTURAL INTEGRITY  
RESERVE STUDY**

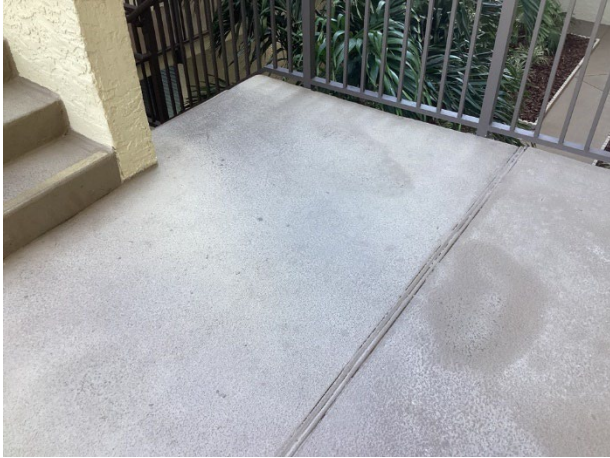
**Condition:** Fair overall with deterioration of the waterproof coating at the breezeways evident during our noninvasive inspection. We assume that the waterproof coating applications at the breezeways will be in good condition upon completion of the ongoing restoration project.

**Breezeways – deterioration of the waterproof coating applications evident**

**Useful Life:** Capital repairs including a close-up visual inspection, patching of delaminated concrete, routing and filling of cracked concrete, and waterproof coating applications every 8- to 12-years.

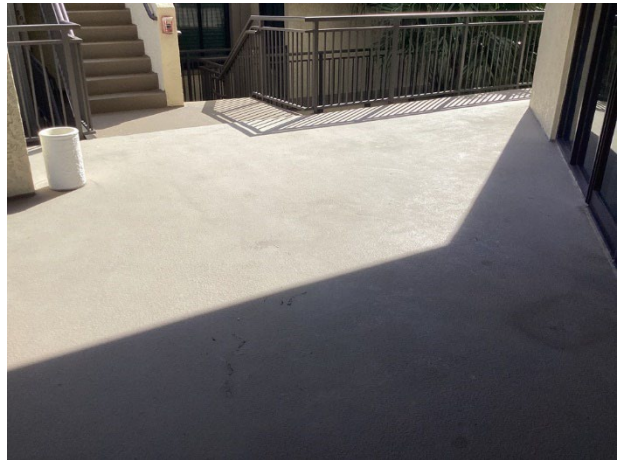
**Breezeways – deterioration of the waterproof coating applications evident**

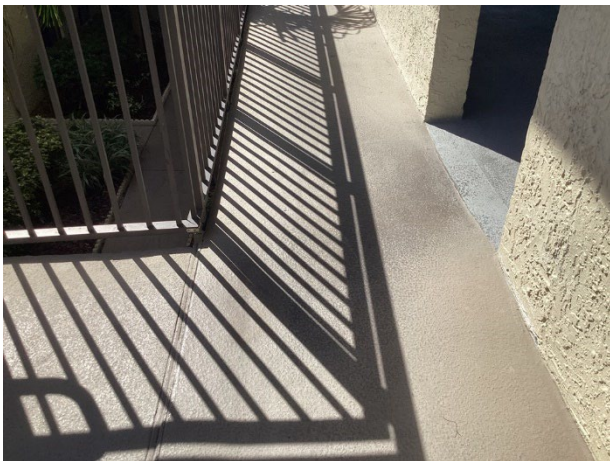
**Breezeways – deterioration of the waterproof coating applications evident**

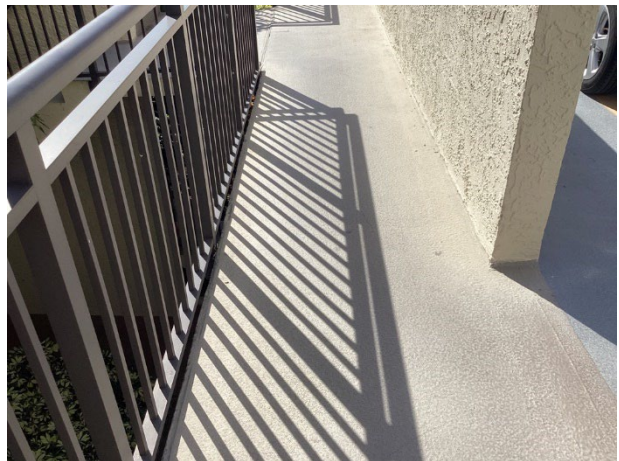
**Breezeways – deterioration of the waterproof coating applications evident**

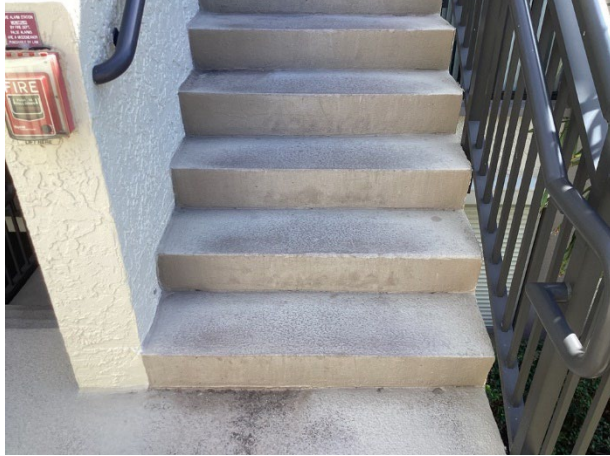
**Breezeways – deterioration of the waterproof coating applications evident**

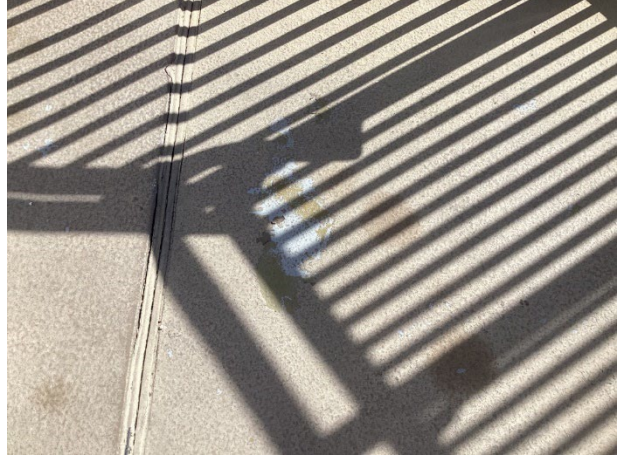
**Breezeways – deterioration of the waterproof coating applications evident**

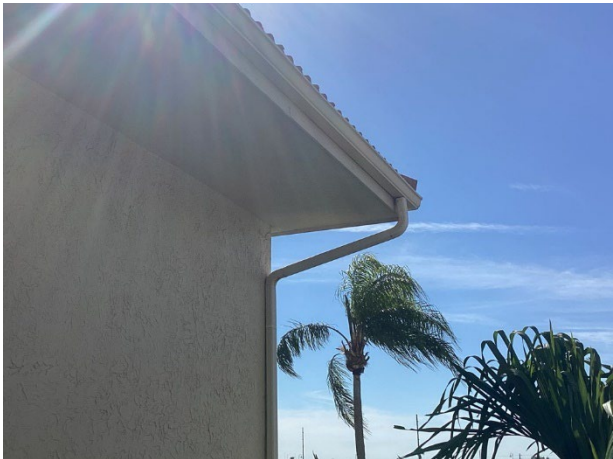
**Condition:** Fair overall with minor corrosion evident

Gutters and downspouts - overview

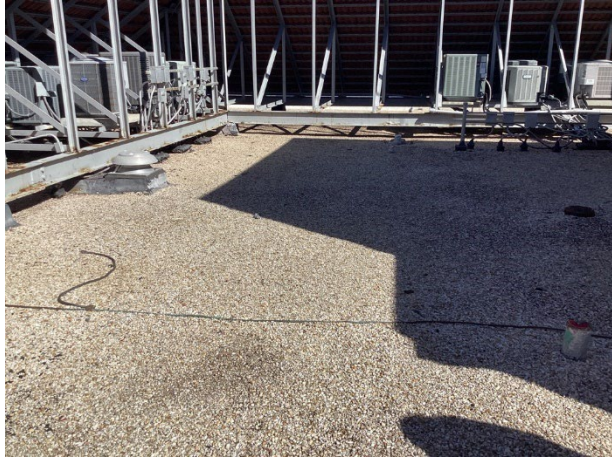
**Condition:** Fair overall with granular loss evident. Management and the Board report a history of leaks and have request that we depict replacement in the near term.

**Built-up roof - overview**

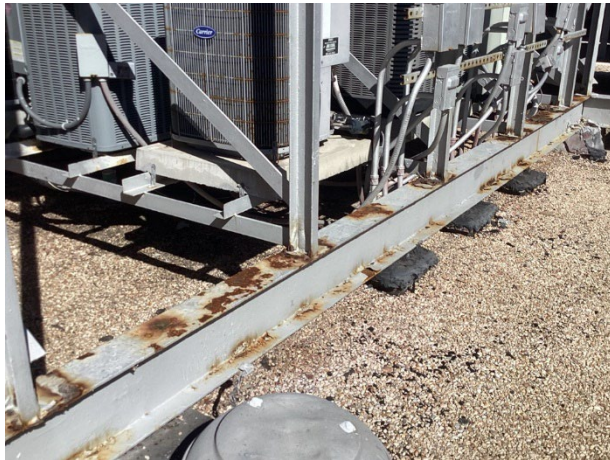
**Condition:** Fair overall with corrosion evident. We are informed that the connection points are in need of inspection and welding in order to re-establish the connection. We depict these repairs in the near term.

**Steel structure – corrosion evident**

**Useful Life:** Inspections and capital repairs every 10 years to be done in conjunction with roof replacement projects

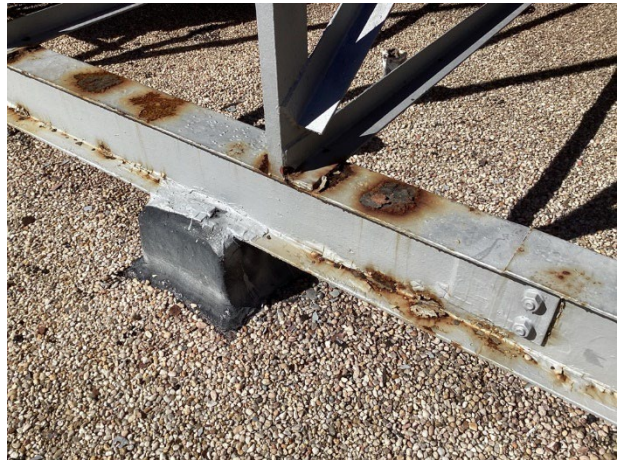
**Steel structure – corrosion evident**

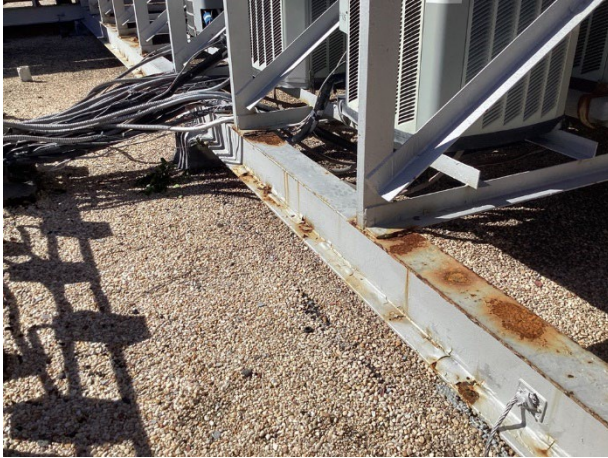
**Steel structure – corrosion evident**

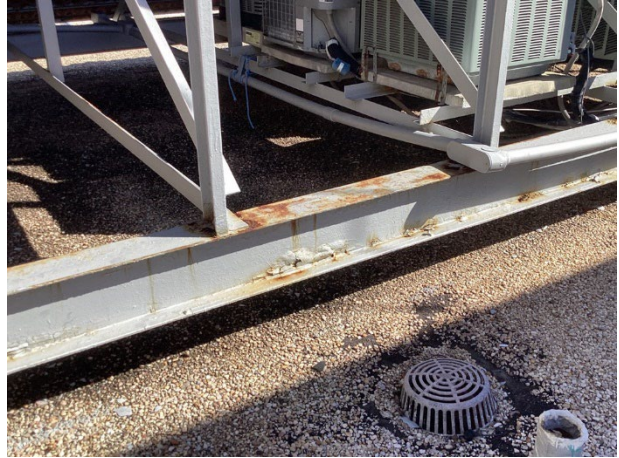
**Steel structure – corrosion evident**

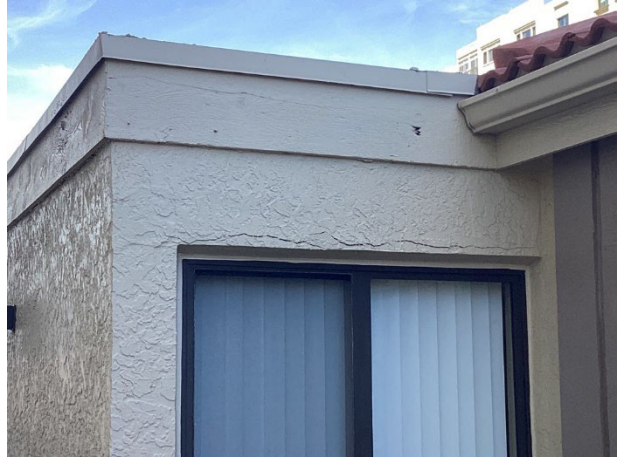
**Condition:** The paint finishes throughout the community are in good to fair condition overall with deterioration of the paint finishes and cracks evident

**Paint finish applications – Villas – paint finish deterioration evident**

**Useful Life:** We recommend inspections, repairs and paint finish applications every five- to seven-years.

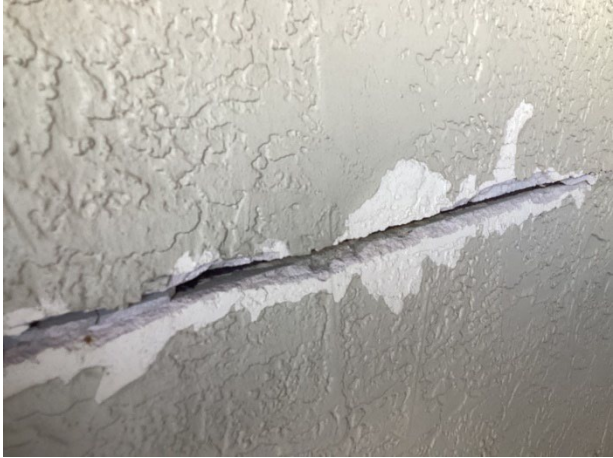
**Paint finish applications – Tower – cracks evident**

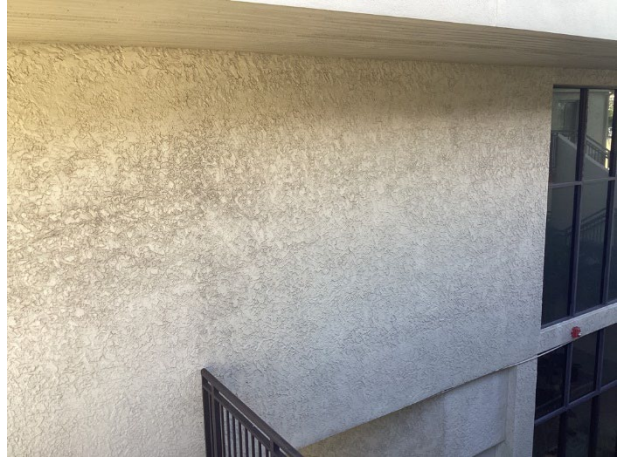
**Paint finish applications – Tower – paint finish deterioration evident**

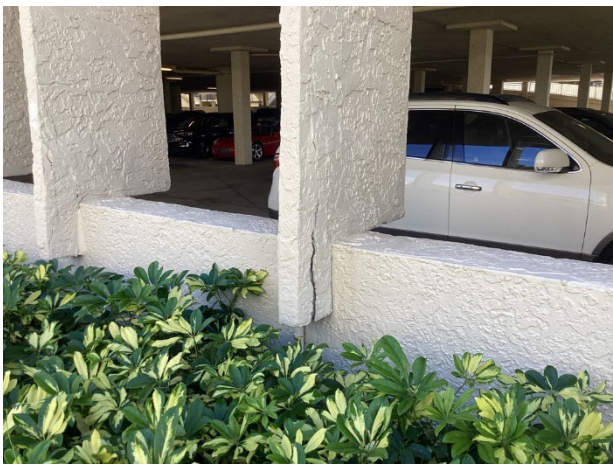
**Paint finish applications – Garage – cracks evident**

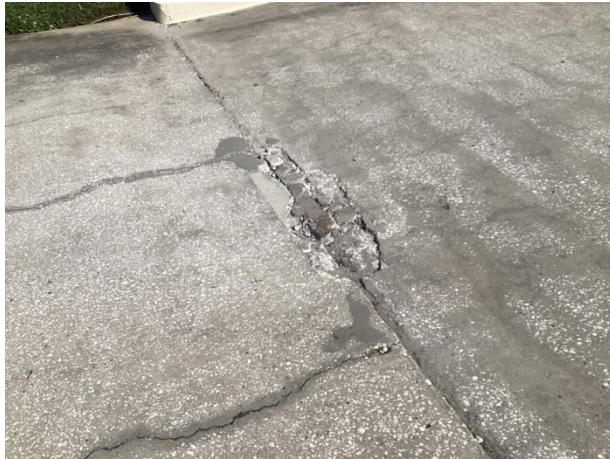
- The elevated structural concrete utilizes a protective traffic coating.
- Knee walls in good condition without deterioration evident
- Exposed to salt air due to proximity to the Gulf of Mexico
- No major evidence of water infiltration
- Minor spalling and cracks evident

**Elevated concrete – spalling evident**

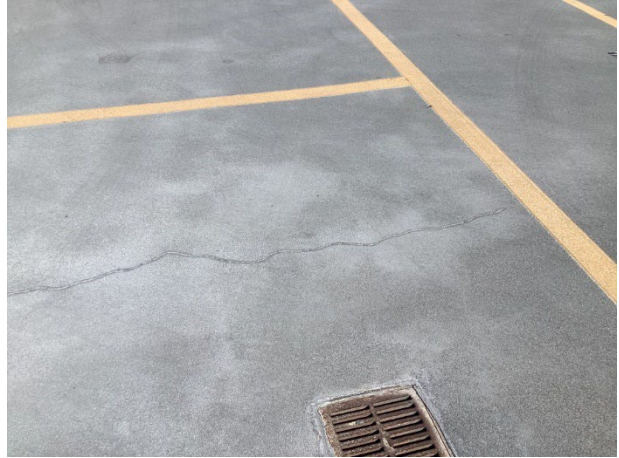
**Elevated concrete – cracks evident**

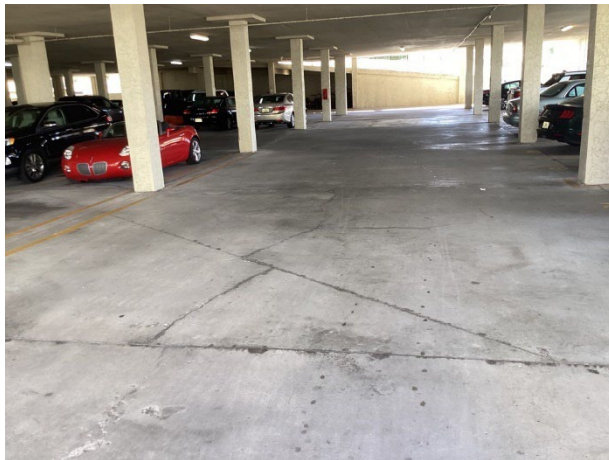
**On-grade concrete – cracks evident**

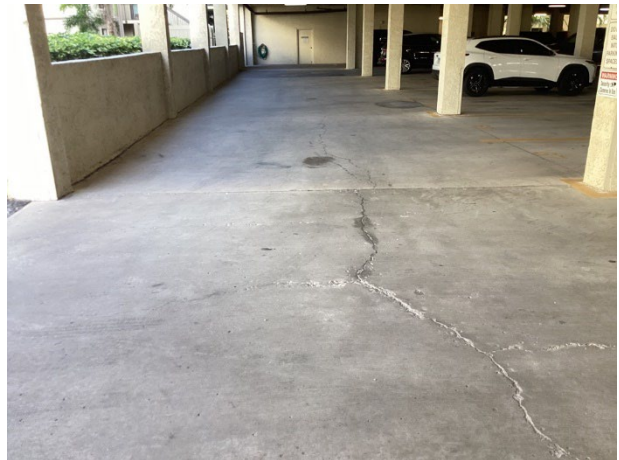
**On-grade concrete – cracks evident**

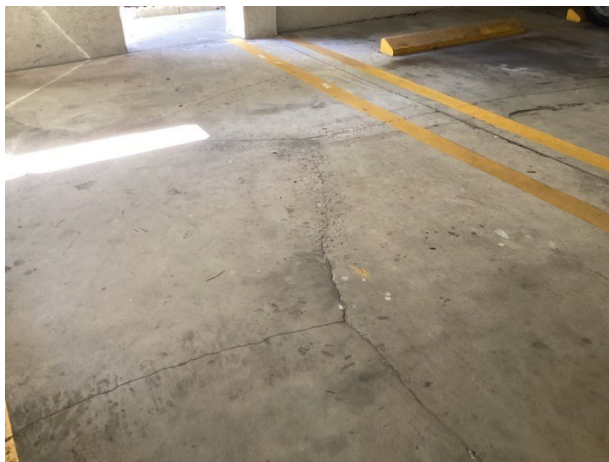
**On-grade concrete – cracks evident**

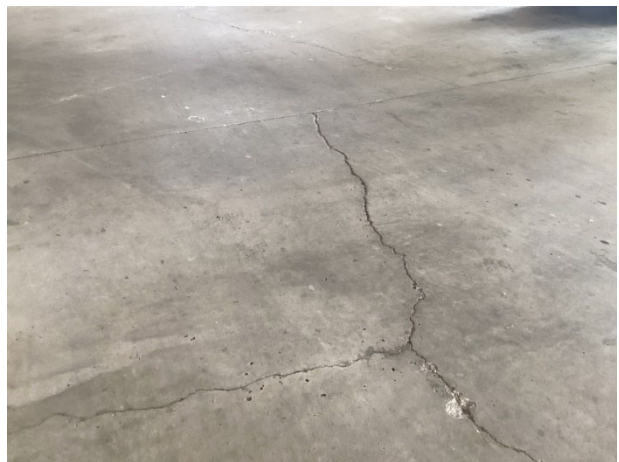
**On-grade concrete – cracks evident**

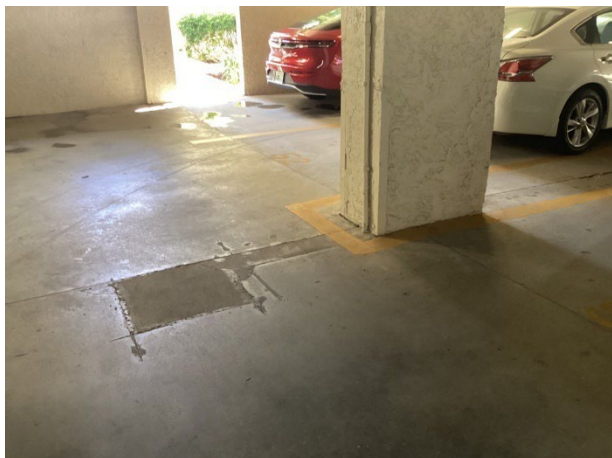
**On-grade concrete – previous repairs evident**

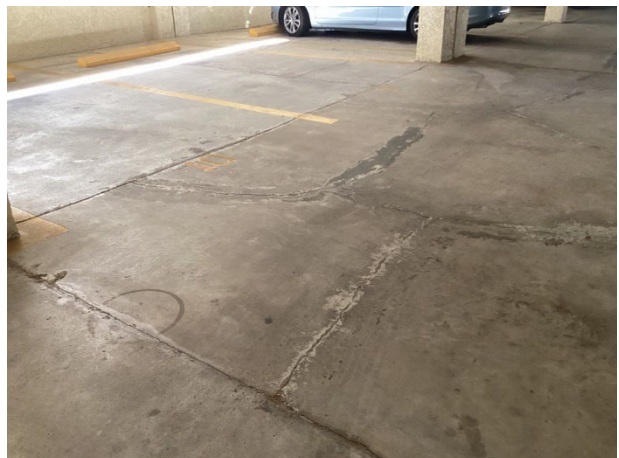
**On-grade concrete – cracks evident**

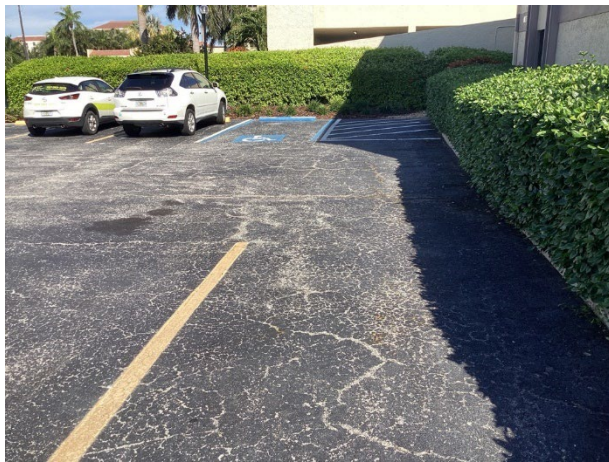
**Condition:** Fair overall with seal coat deterioration as well as alligator cracks evident

Asphalt pavement – alligator cracks evident

**Useful Life:** 15- to 20-years with the benefit of timely patching and seal coat applications to be funded through the Operating Budget

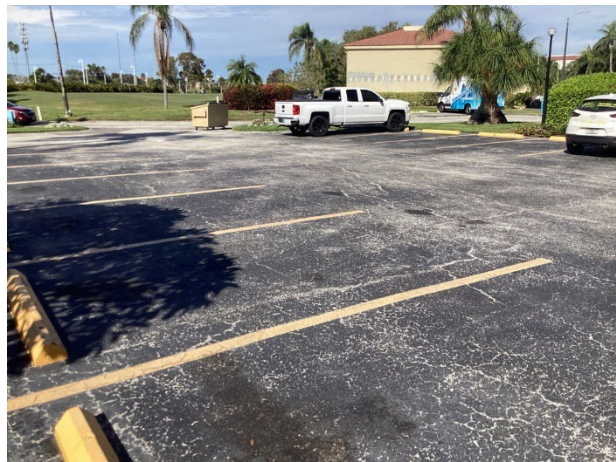
Asphalt pavement – alligator cracks evident

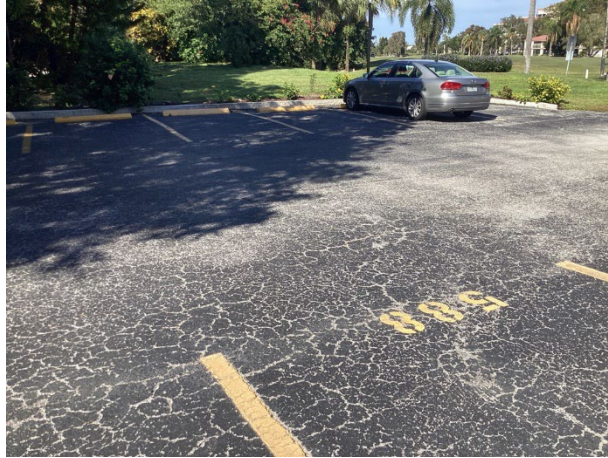
**Asphalt pavement – alligator cracks evident**

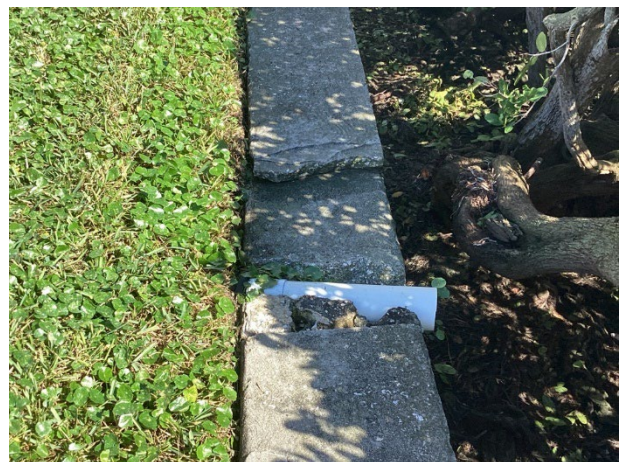
**Condition:** Fair overall with cracks in the concrete cap evident

Seawall – cap deterioration evident

**Useful Life:** We recommend the Association conduct inspections and capital repairs every 15 years

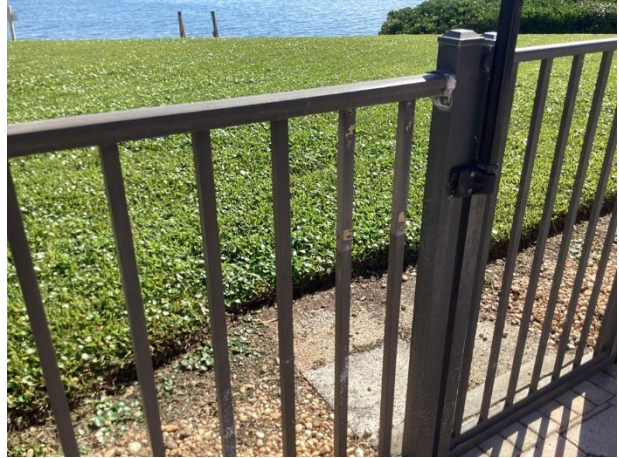
**Condition:** Good to fair overall with deterioration of the finishes evident

**Fences – finish deterioration evident**
