Windstorm Mitigation Report (OIR-B1-1802)

Palma Del Mar Condominium Association No. 5 Of St. Petersburg, Inc.
6372 Palma Del Mar Blvd S, Units 109-312
St. Petersburg, FL 33715

As of 2/28/2023 | FPAT File# MUD2319128

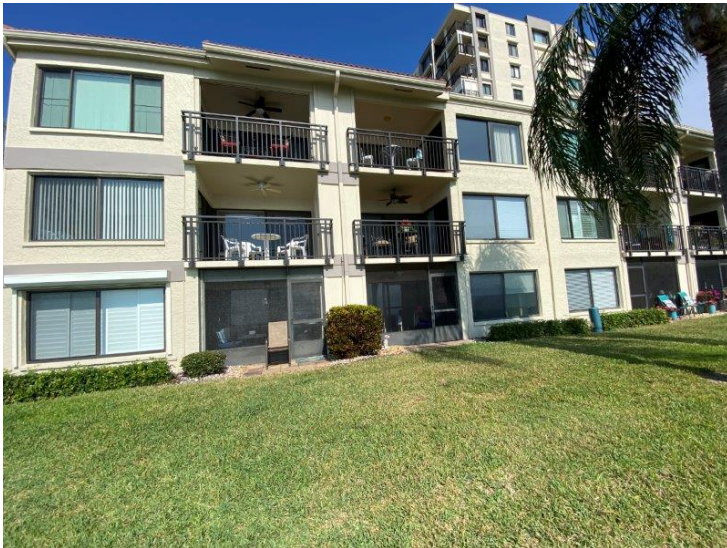
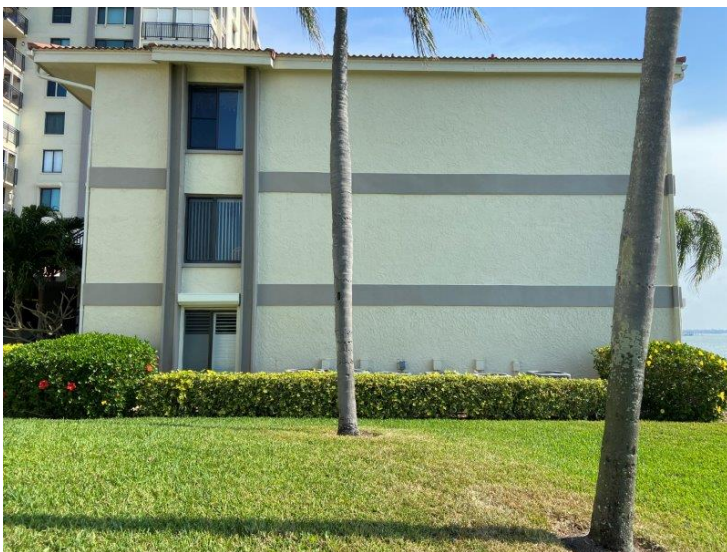
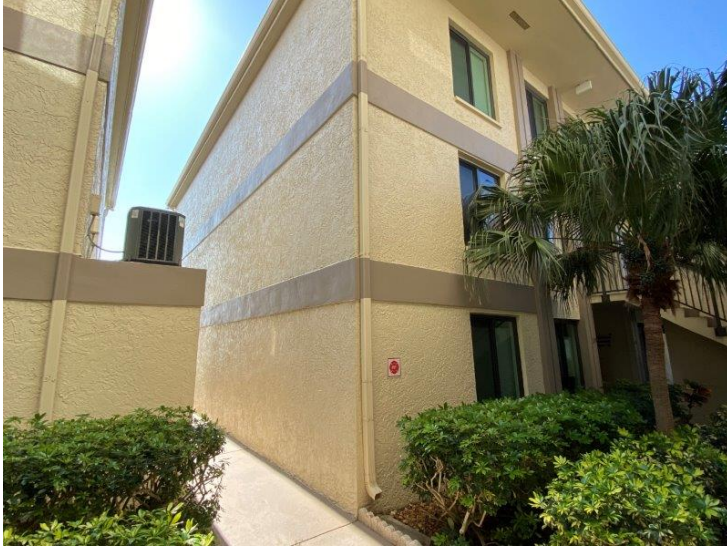
Exterior Elevation

- 4. Roof to Wall Attachment:** **Toe Nails**
Comments: Inspection verified embedded straps fastened with less than three nails.
- 5. Roof Geometry:** **Other Roof**
Comments: Inspection verified a combination of 33% flat and 67% hip roof shapes, refer to attached photographs.

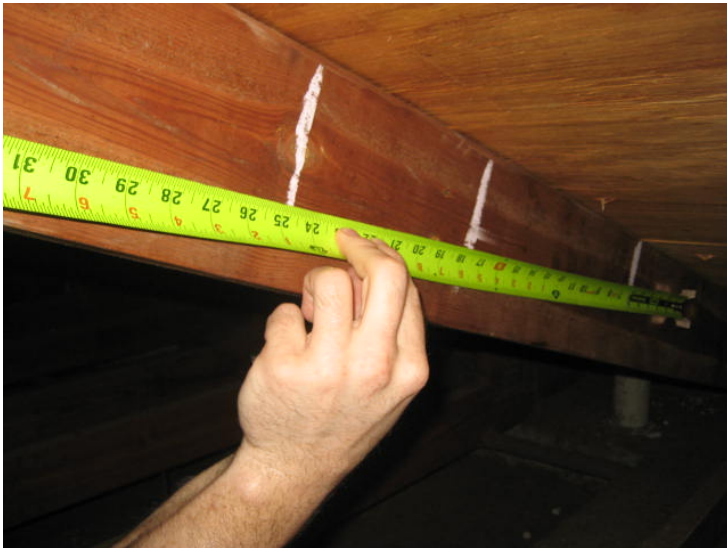
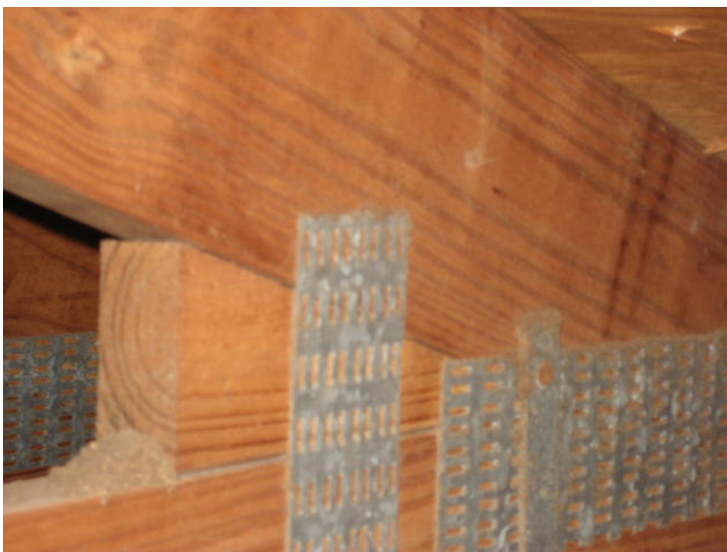
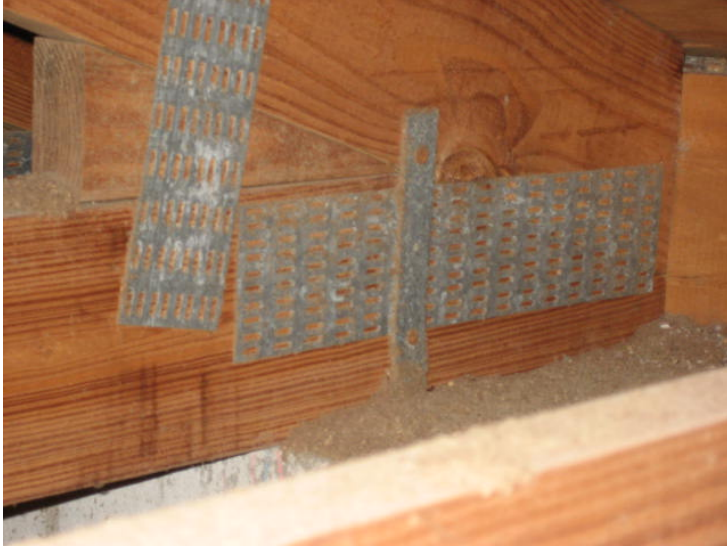
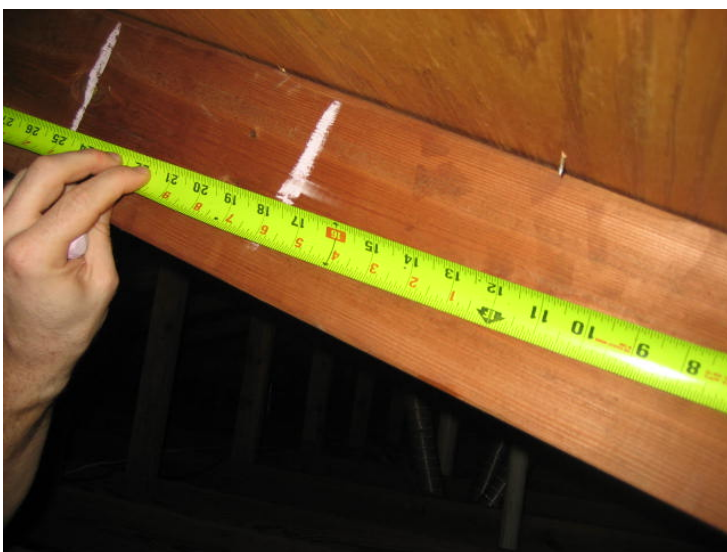
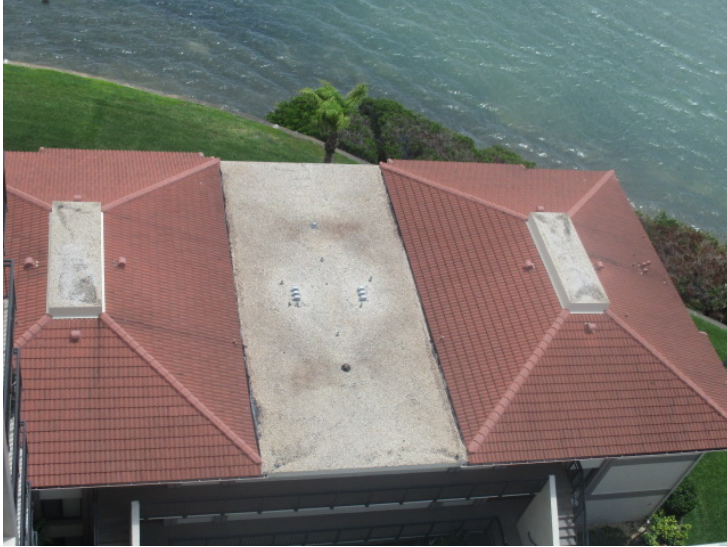
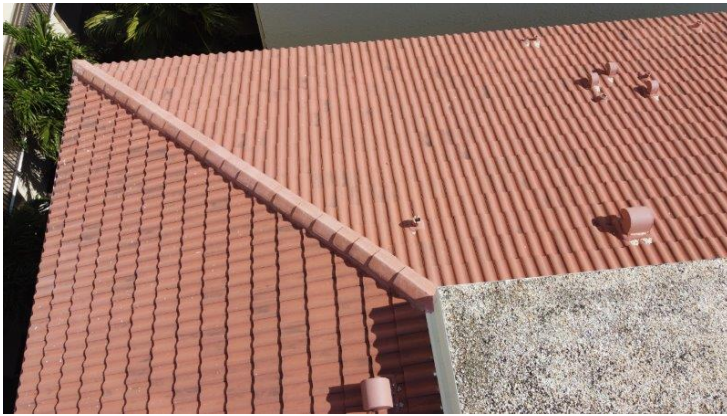
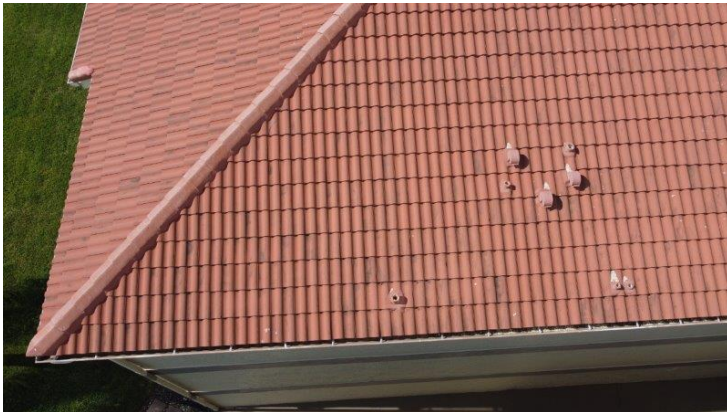
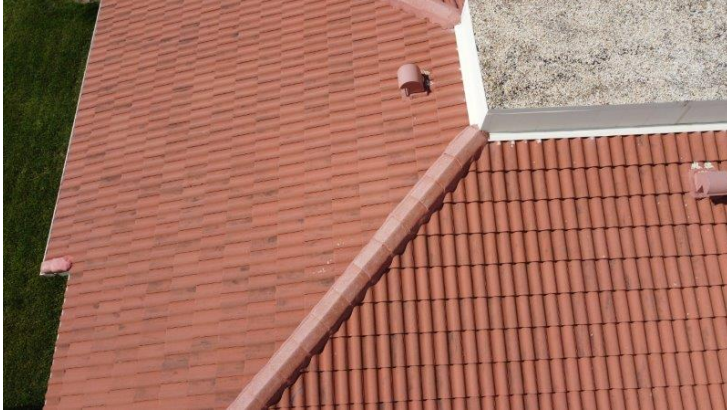
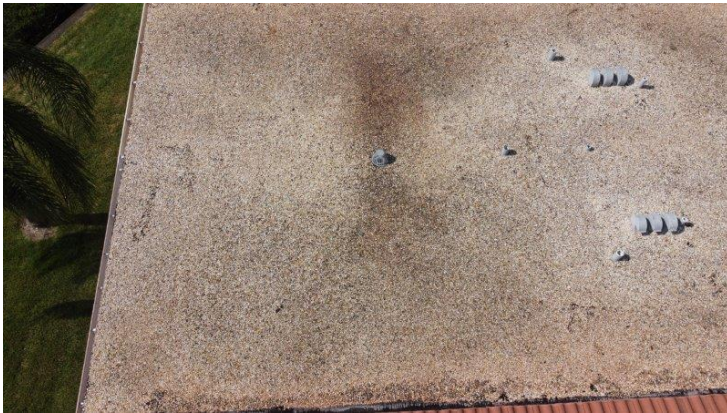
Roof Construction

- 2. Roof Covering:** **One or more roof coverings do not meet the minimum requirements**
Comments: This building has multiple types of roof coverings. The concrete tile roof was replaced in 2006. The roof permit was confirmed and the permit number is 06-10000789. The tar & gravel roof is of unknown age. No permit information was found with the local Building Department. This roof was verified as not meeting the requirements outlined on the mitigation affidavit.

- 3. Roof Deck Attachment:** **Level B**
Comments: Inspection verified 3/4" plywood roof deck attached with 8d nails at a minimum of 6" on the edge & 12" in the field.

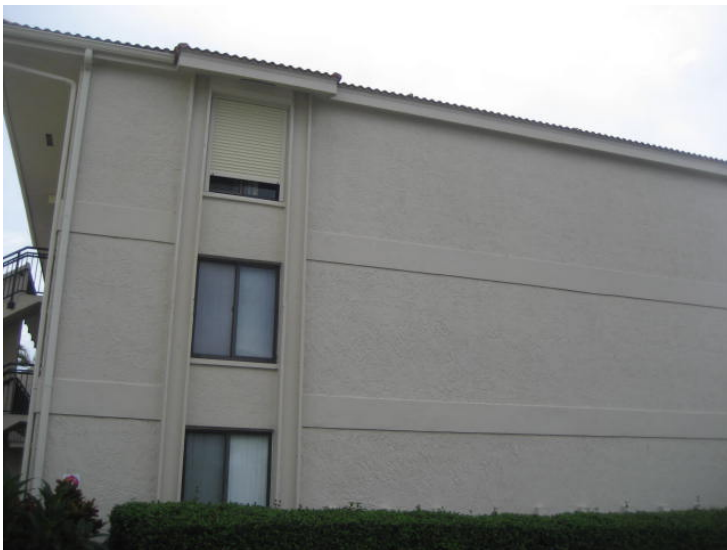
Opening Protection

- 6. SWR:** **No**
Comments: No SWR verified.
- 7. Opening Protection:** **None or Some Glazed Openings**
Comments: Inspection verified some opening protection. Not all glazed openings were protected with impact resistant coverings.
