Windstorm Mitigation Report (OIR-B1-1802)

Palma Del Mar Condominium Association No. 5 Of St. Petersburg, Inc.
6372 Palma Del Mar Blvd S, Units 113-316
St. Petersburg, FL 33715

As of 2/28/2023 | FPAT File# MUD2319128

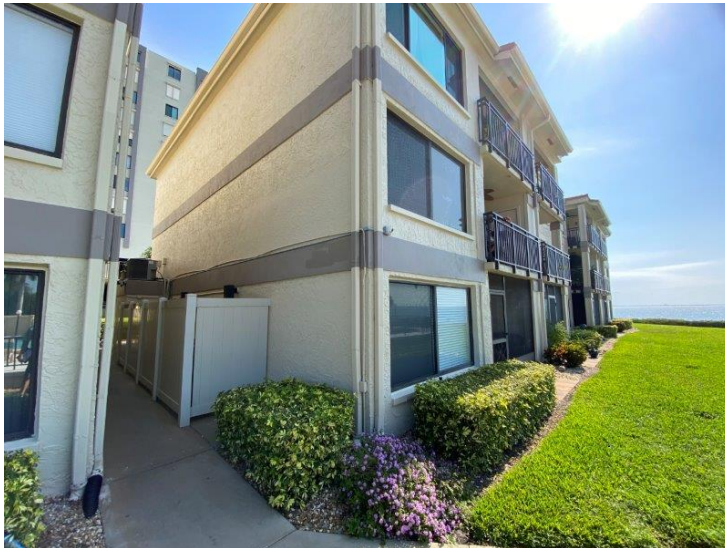
Exterior Elevation

- 5. Roof Geometry:** **Other Roof**
Comments: Inspection verified a combination of 33% flat and 67% hip roof shapes, refer to attached photographs.
- 6. SWR:** **No**
Comments: No SWR verified.

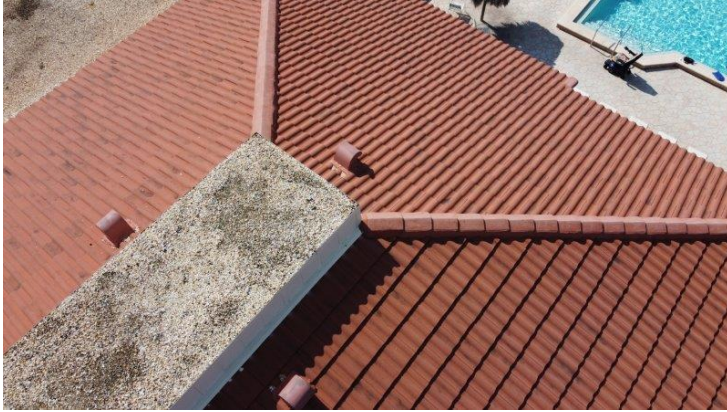
Roof Construction

- 2. Roof Covering:** **One or more roof coverings do not meet the minimum requirements**
Comments: This building has multiple types of roof coverings. The concrete tile roof was replaced in 2006. The roof permit was confirmed and the permit number is 06-10000788. The tar & gravel roof is of unknown age. No permit information was found with the local Building Department. This roof was verified as not meeting the requirements outlined on the mitigation affidavit.
