Windstorm Mitigation Report (OIR-B1-1802)

Palma Del Mar Condominium Association No. 5 Of St. Petersburg, Inc.
6372 Palma Del Mar Blvd S, Units 117-320
St. Petersburg, FL 33715

As of 2/28/2023 | FPAT File# MUD2319128

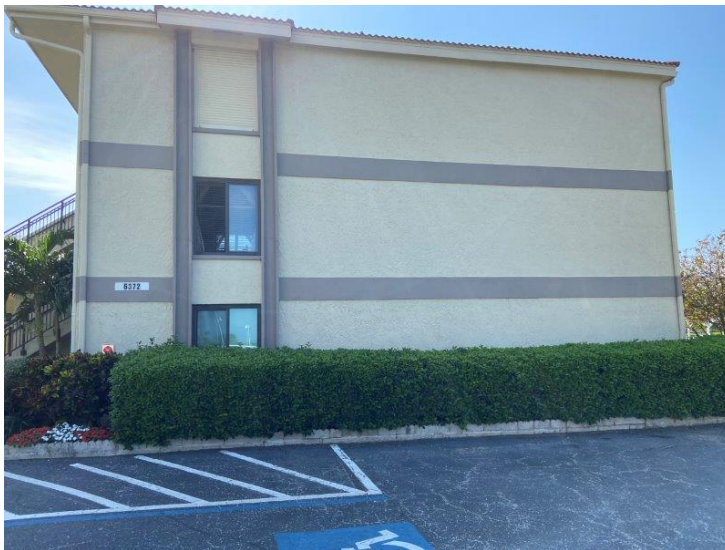
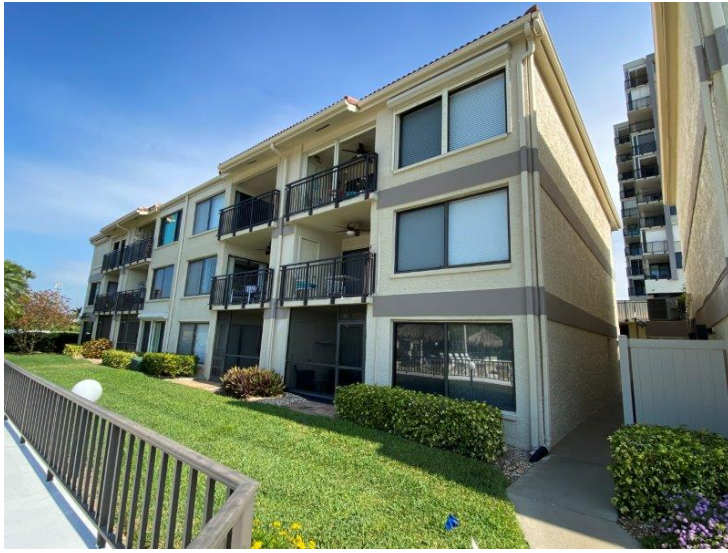
Exterior Elevation

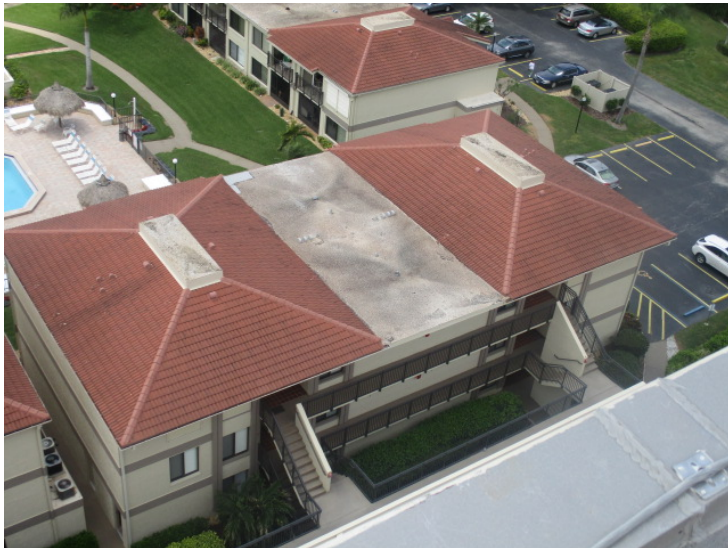
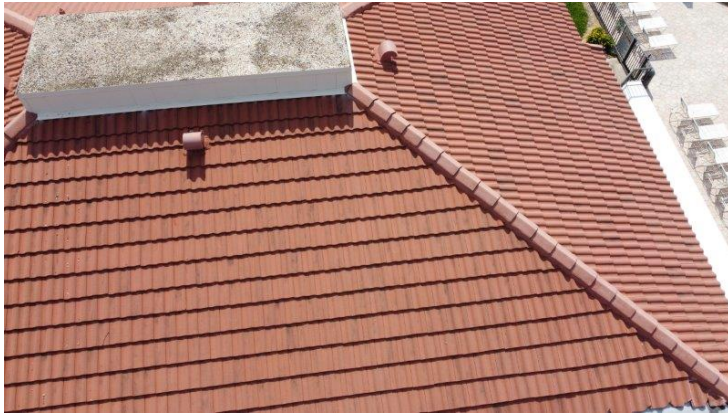
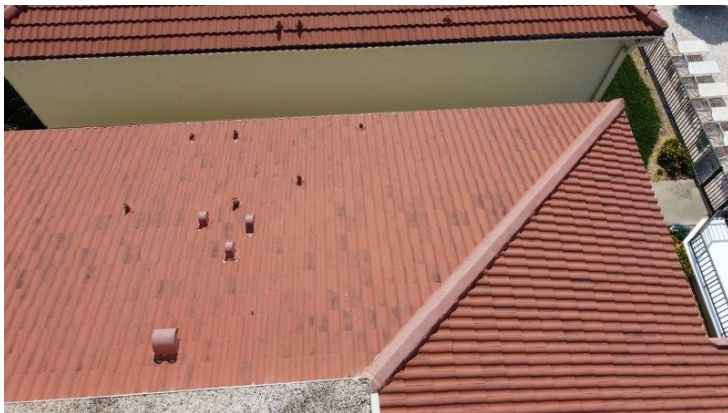
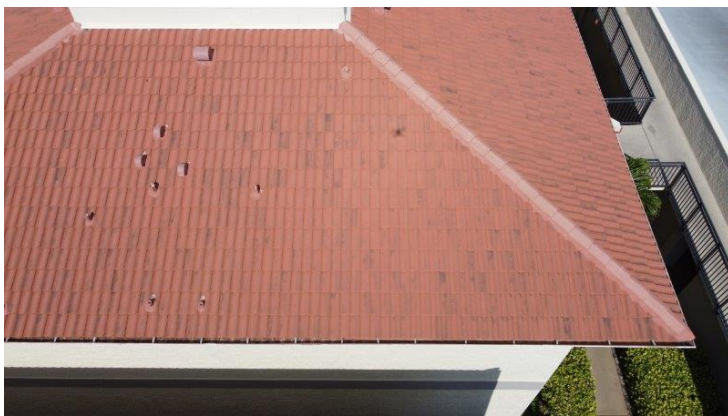
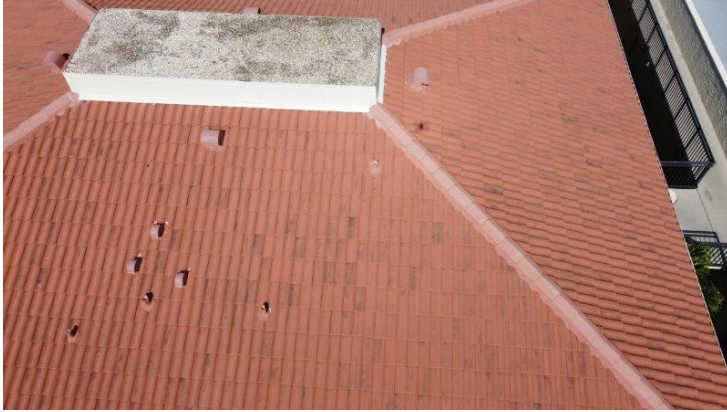
- 2. Roof Covering:** **One or more roof coverings do not meet the minimum requirements**
Comments: This building has multiple types of roof coverings. The concrete tile roof was replaced in 2006. The roof permit was confirmed and the permit number is 06-10000785. The tar & gravel roof is of unknown age. No permit information was found with the local Building Department. This roof was verified as not meeting the requirements outlined on the mitigation affidavit.

- 5. Roof Geometry:** **Other Roof**
Comments: Inspection verified a combination of 33% flat and 67% hip roof shapes, refer to attached photographs.
- 6. SWR:** **No**
Comments: No SWR verified.

Roof Construction

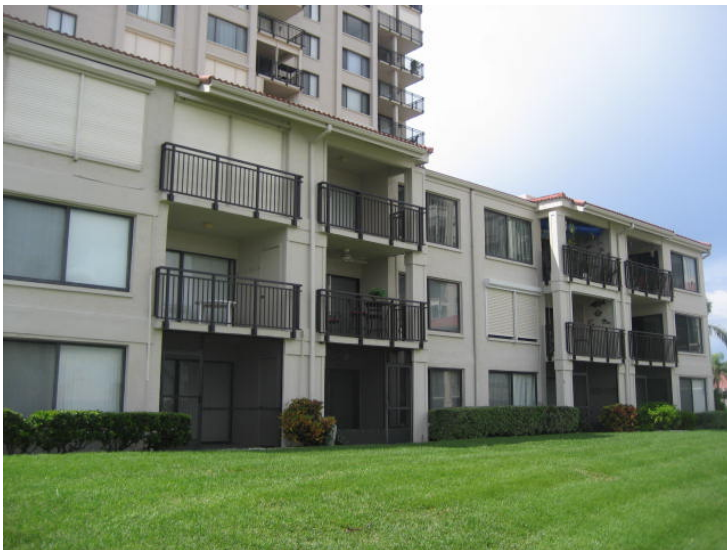
- 7. Opening Protection:** **None or Some Glazed Openings**
Comments: Inspection verified some opening protection. Not all glazed openings were protected with impact resistant coverings.

Opening Protection
