## CONDITION SURVEY REPORT

**PALMA DEL MAR 5**

**CONDOMINIUM**

**6372 PALMA DEL MAR BLVD. S.**

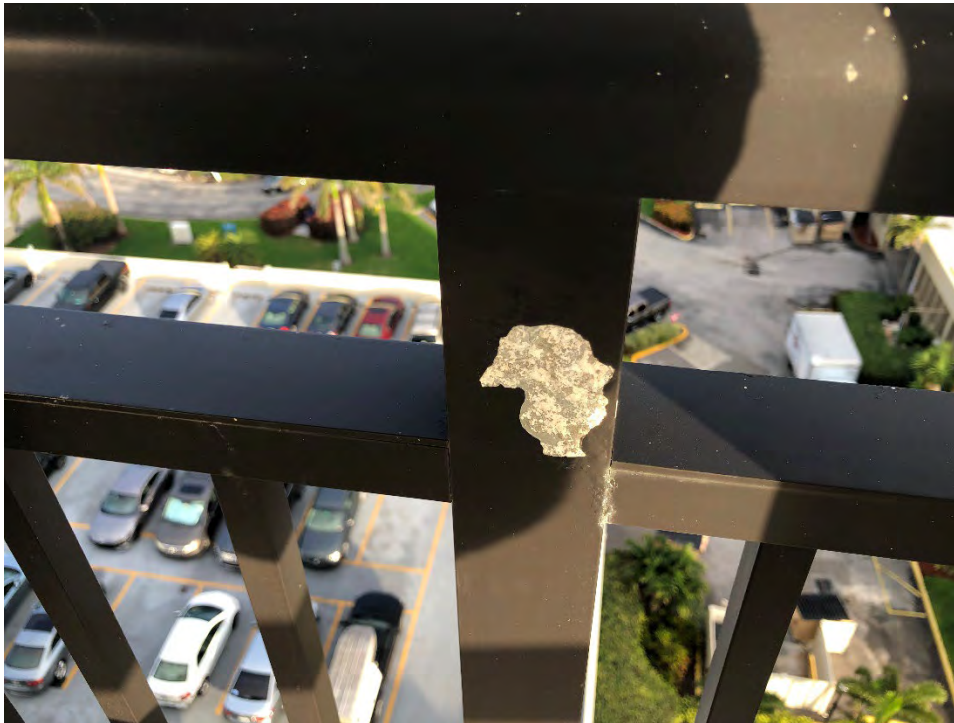
- Areas of peeling paint and/or oxidization were observed on guardrails components (Refer to Figure A-4 through Figure A-7).
- Areas of delaminated and/or cracked floor tile finishes were observed on Units 1201, 1106, 901, 801, and 501.

Figure A- 4 – Typical Tower Guardrail Peeling Paint/Oxidization

1. Surface preparation and painting of areas of peeling painting and/or oxidization on aluminum guardrail components. It should be noted that painting of these oxidizing railings will be an ongoing maintenance item.

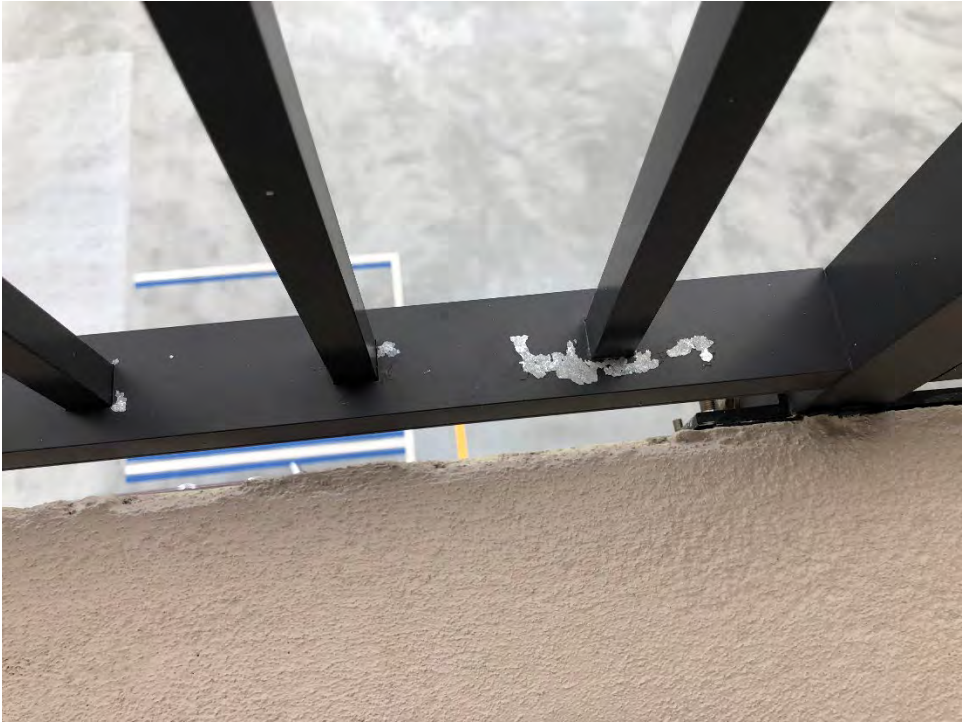
Figure A- 5 – Typical Tower Guardrail Peeling Paint/Oxidization

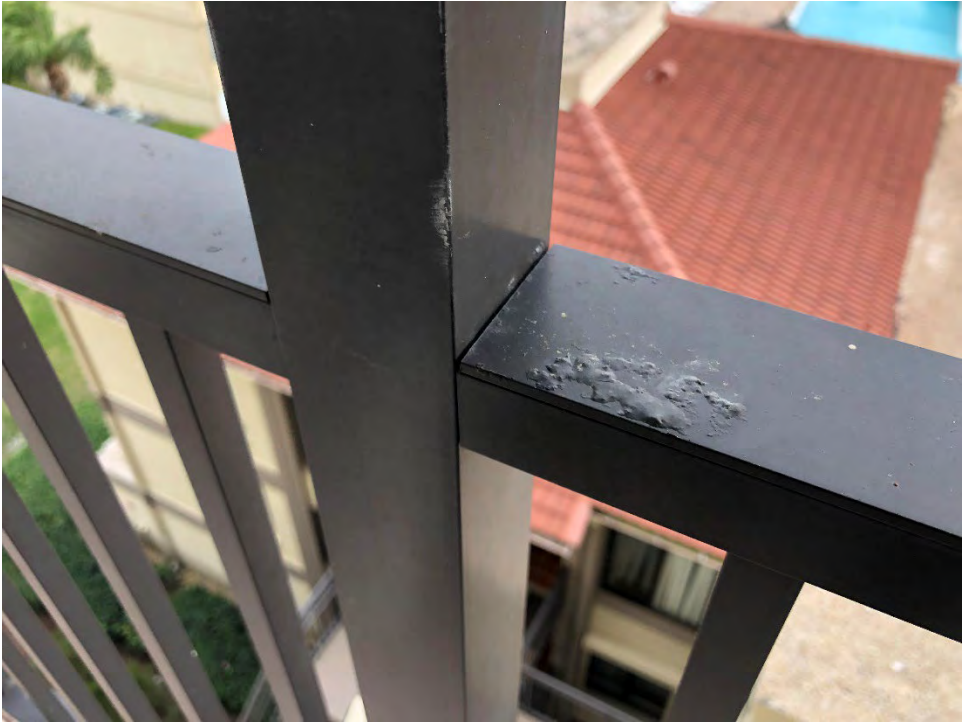
Figure A- 6 – Typical Tower Guardrail Peeling Paint/Oxidization

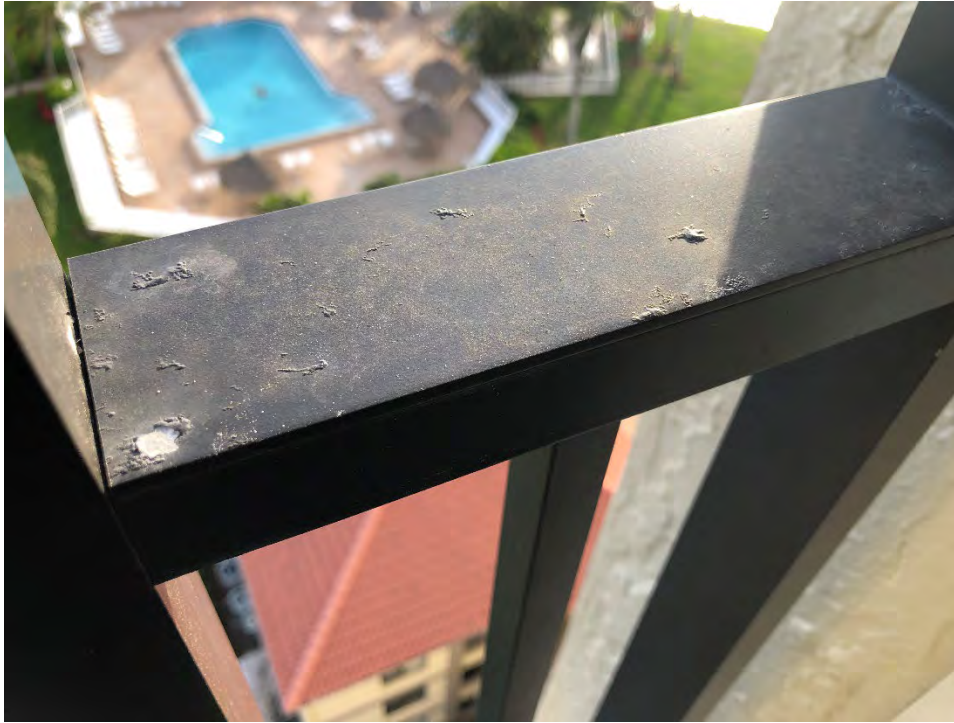
*Figure A- 7 – Typical Tower Guardrail Peeling Paint/Oxidization*

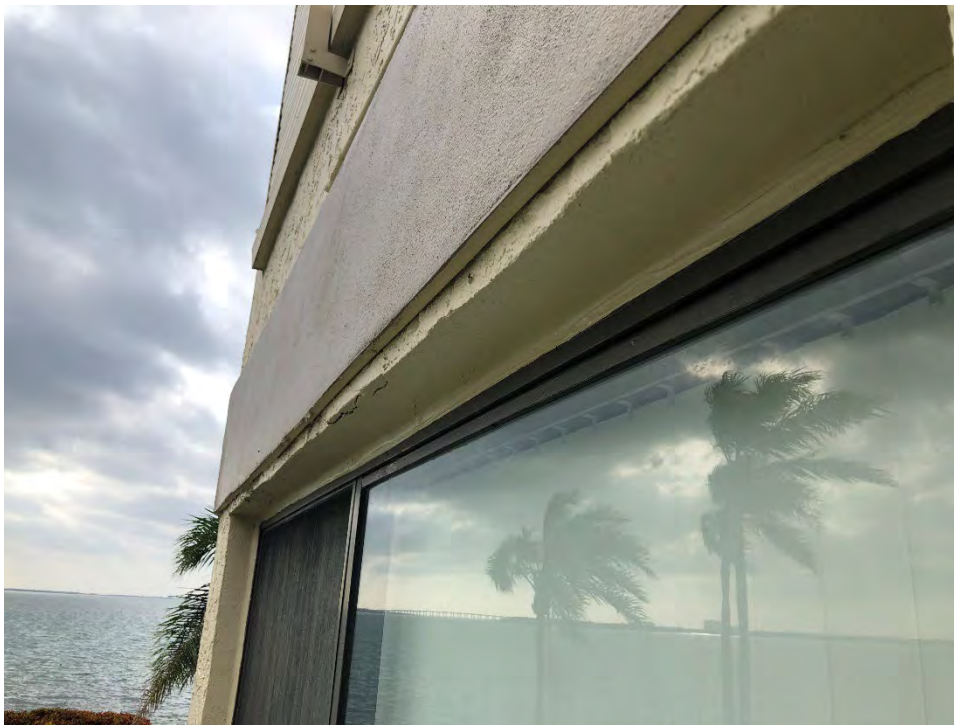
*Figure A- 14 – Unit 204 Concrete Lintel Spall*

2. Concrete repair for spalls and cracks on concrete surfaces.
3. Repair of delaminated and/or cracked exterior wall stucco finishes.
4. Installation of a pedestrian grade waterproofing deck membrane as preventative maintenance to all elevated balcony concrete slab surfaces to slow further corrosion and concrete deterioration. Waterproofing membrane installation should include the following:

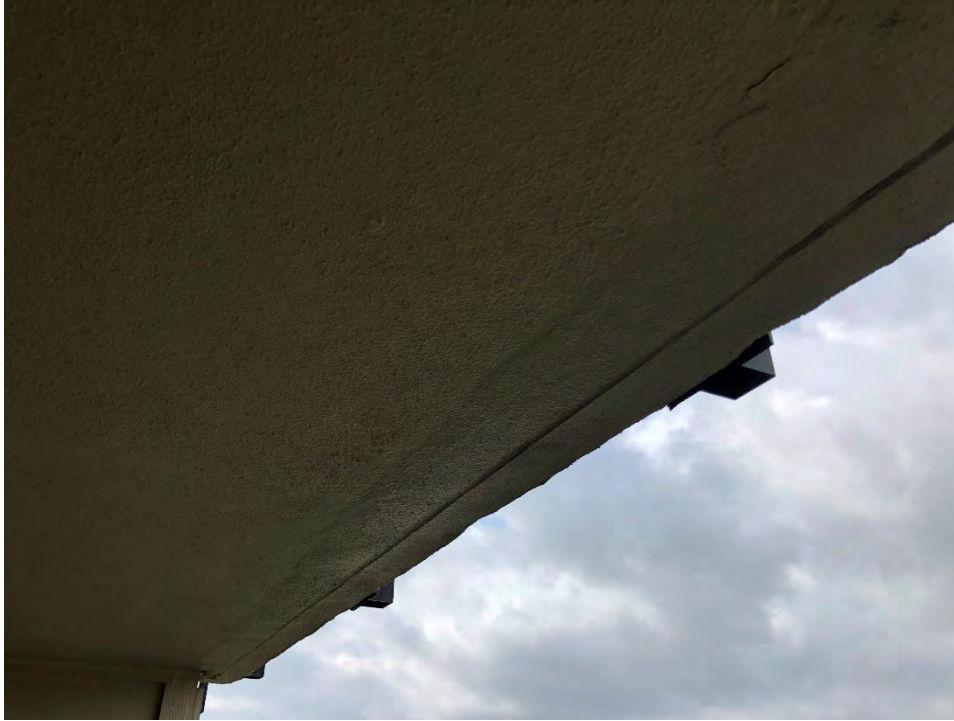
- The guardrails appear to be designed to be approximately 43 inches high, which is above the current building code minimum height requirement of 42 inches (Refer to Figure A-13).
- Areas of delaminated floor tile finishes were observed on Units 309, 220, and 208.
- Concrete lintel spall was observed at the south window opening of Unit 204 (Refer to Figure A-14).
- Areas of delaminated exterior stucco ceiling and wall finishes were observed at Unit 318, 220, and 218 (Refer to Figure A-15).

*Figure A- 15 – Unit 220 Delaminated Exterior Ceiling Stucco Finishes*

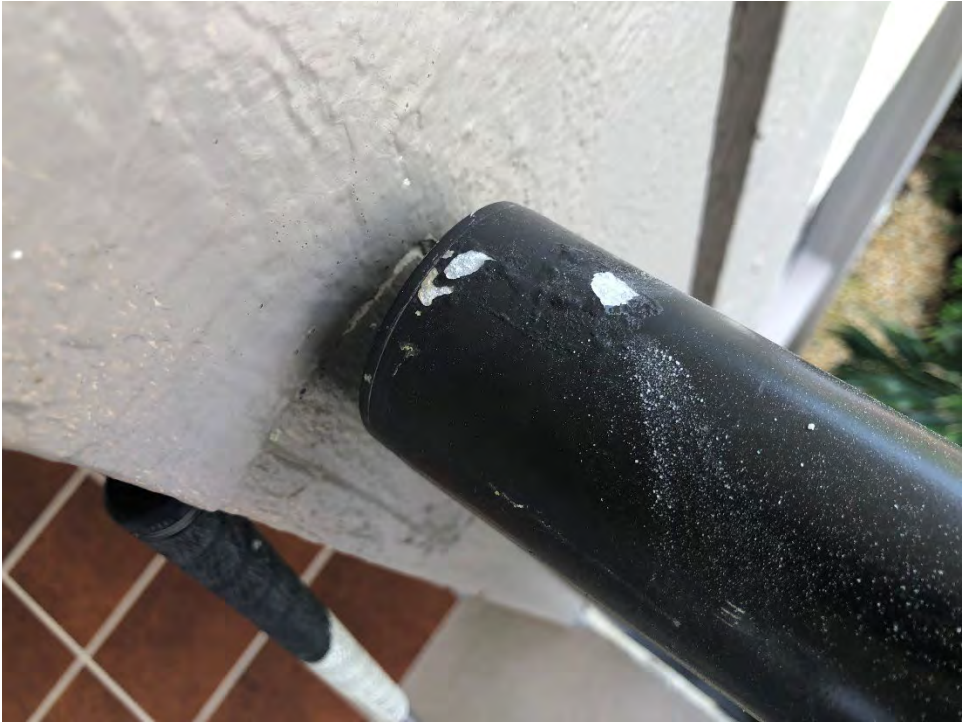
- Localized areas of peeling paint and/or oxidization were observed on guardrails components (Refer to Figure B-9 and Figure B-10).
- Deteriorated waterproofing membrane top coating were observed on the west end of the walkways and stairways with the east end appearing to have been recently recoated (Refer to Figure B-11).

Figure B- 9 – Typical Guardrail Peeling Paint/Oxidization

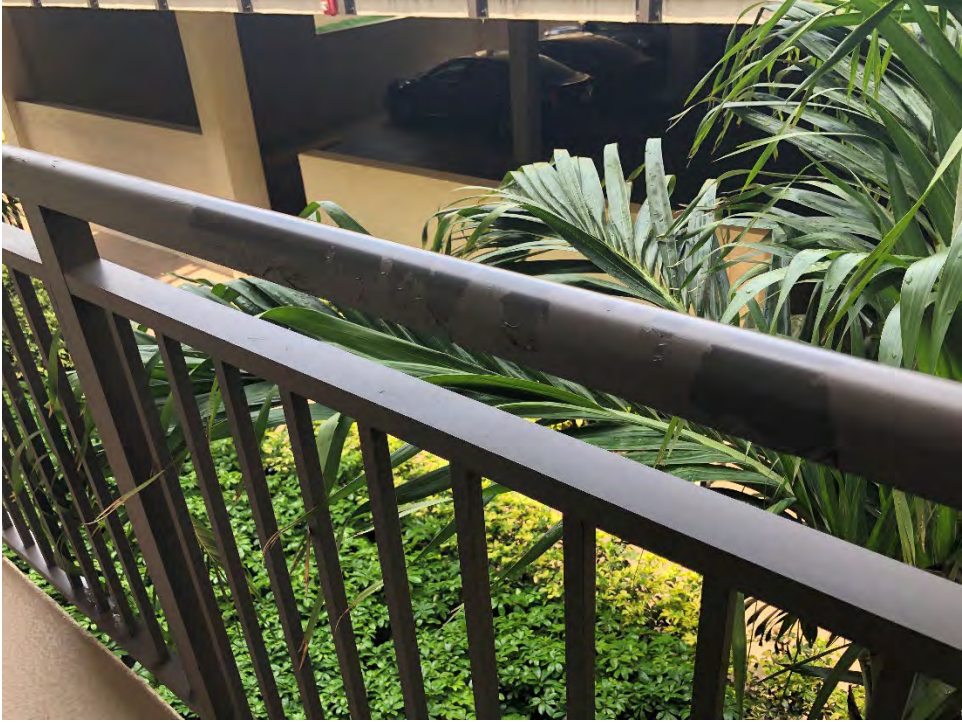
Figure B- 10 – Typical Guardrail Peeling Paint

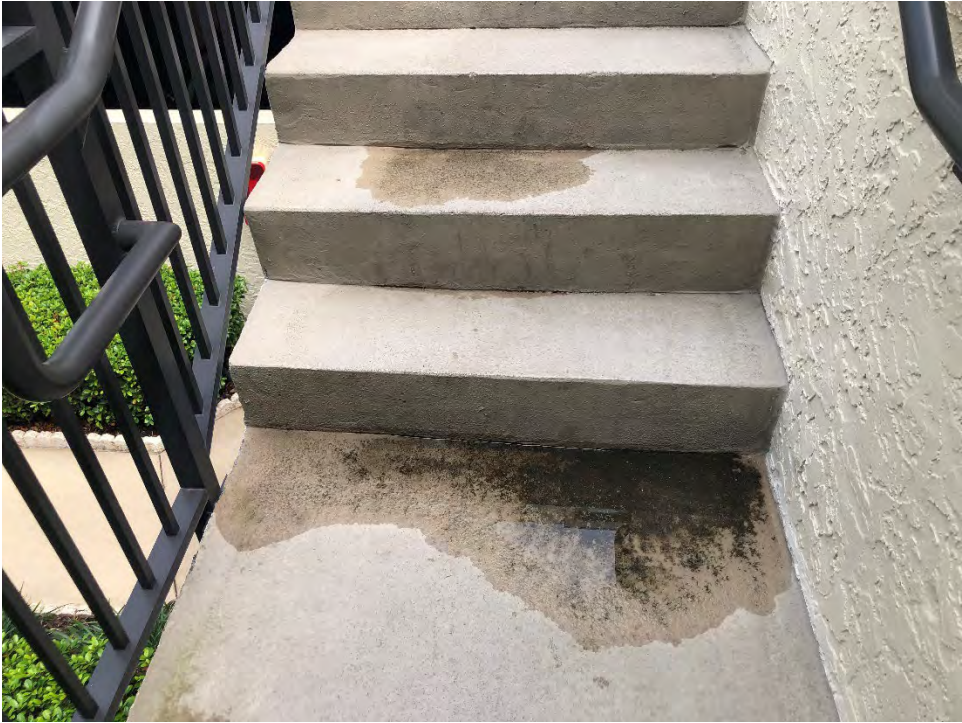
- Multiple areas of ponding water and/or ponding water stains were observed on the walkways and stairways (Refer to Figure B-12 through Figure B-14).
- Areas of deteriorated and/or failed expansion joints were observed along the walkways with portions having vertical displacement (Refer to Figure B-15 and Figure B-16).

Figure B- 12 – Ponding Water

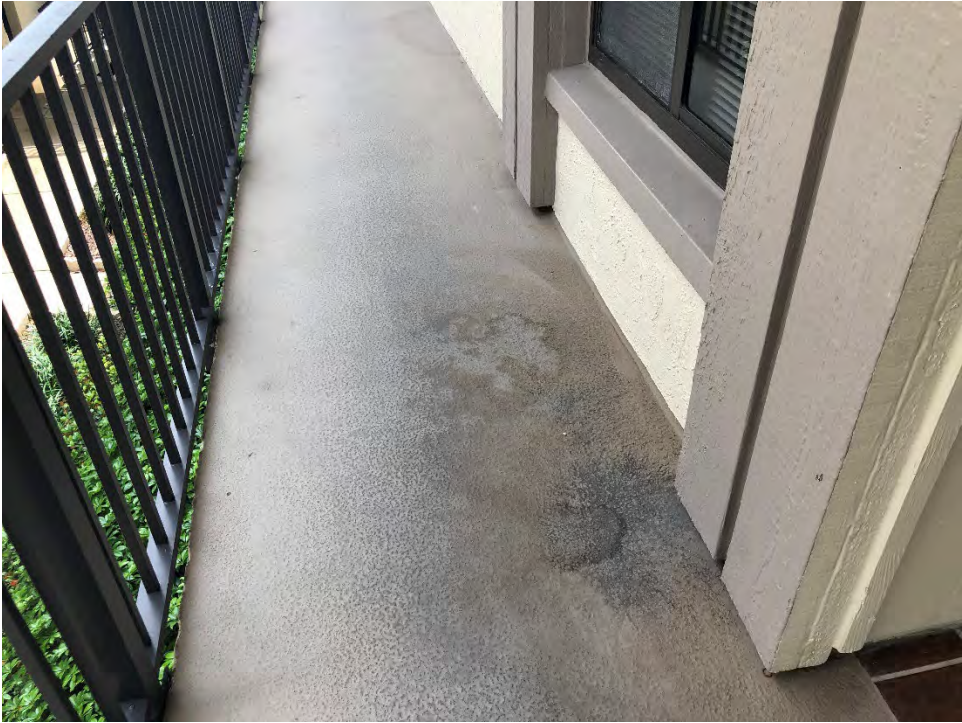
Figure B- 13 – Ponding Water

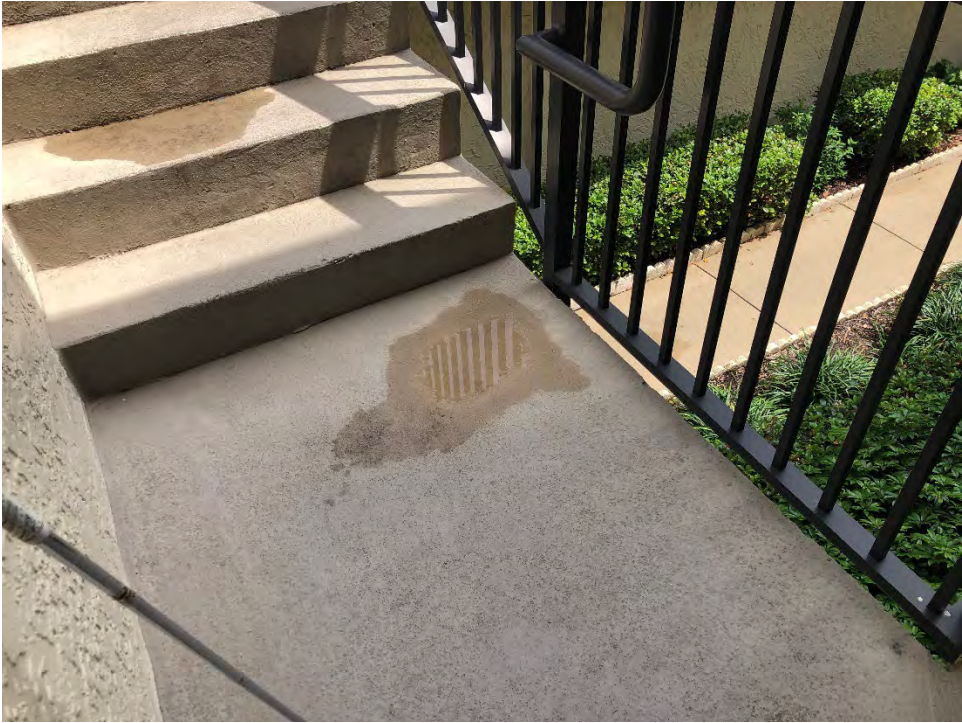
Figure B- 14 – Ponding Water

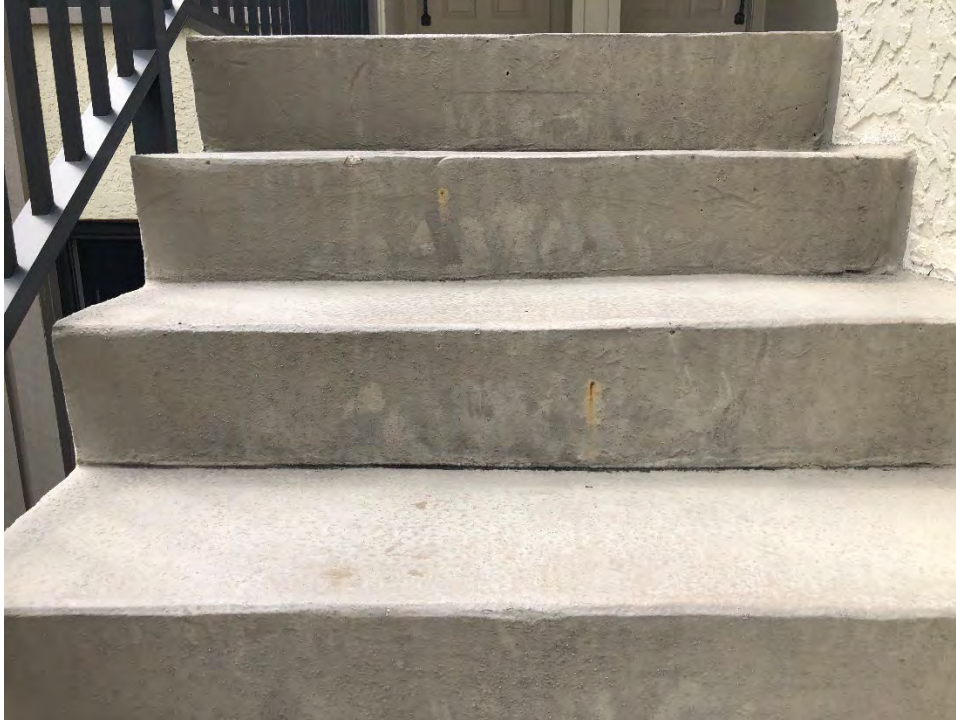
- Loose guardrail bottom rail connections were observed at walkway expansion joints (Refer to Figure B-17 and Figure B-18).
- Localized areas of floor staining were observed along stairways (Refer to Figure B-19).

Figure B- 19 – Floor Staining

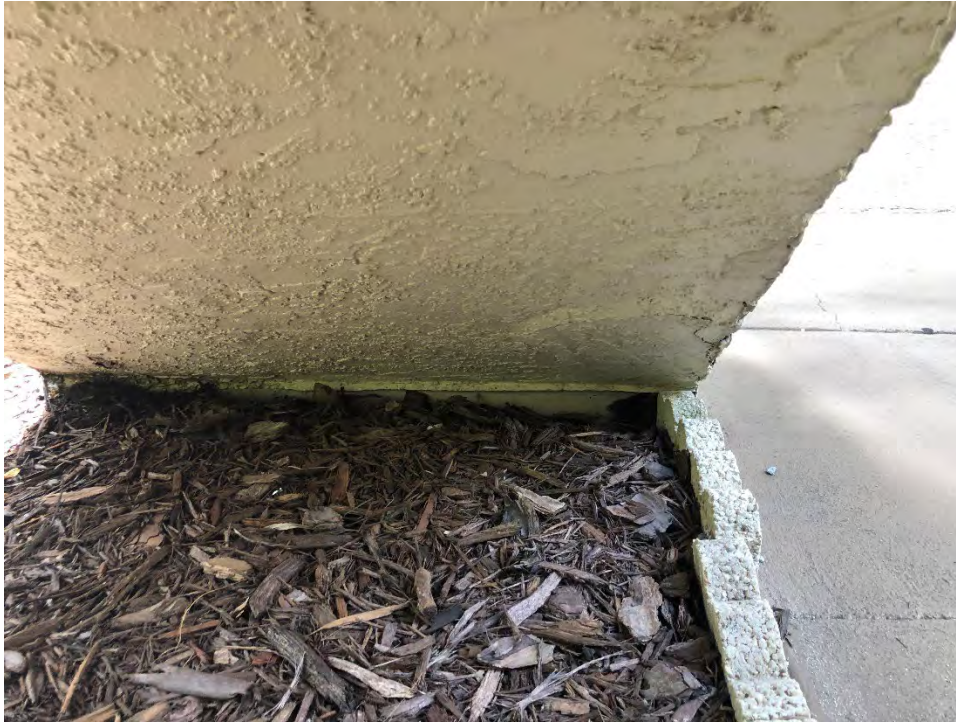
*Figure B- 23 – Concrete Spall*

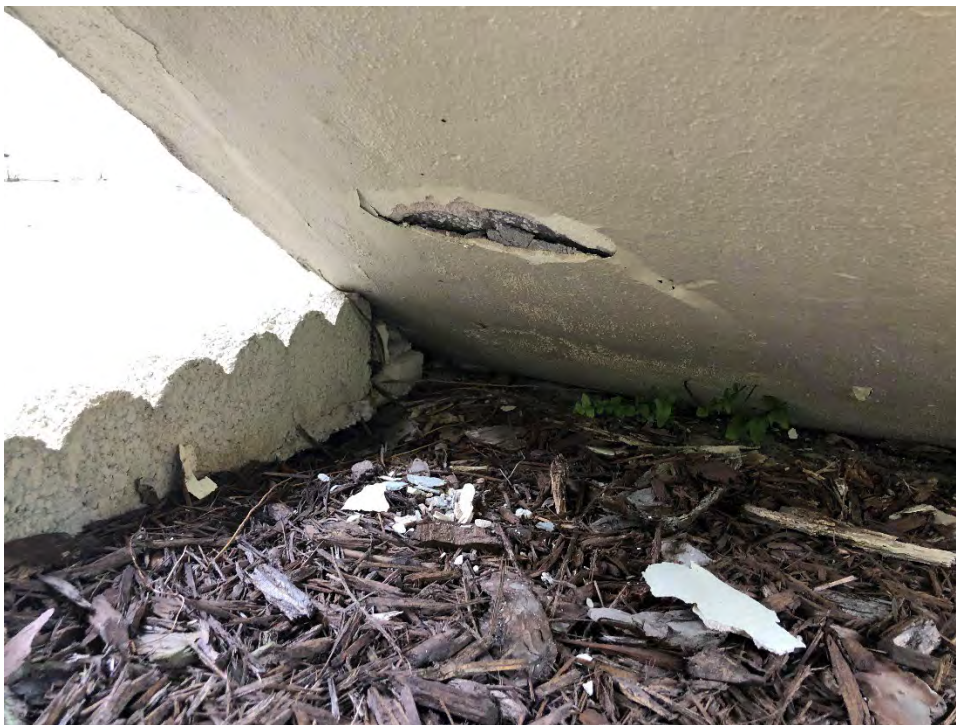
*Figure B- 24 – Concrete Spall*

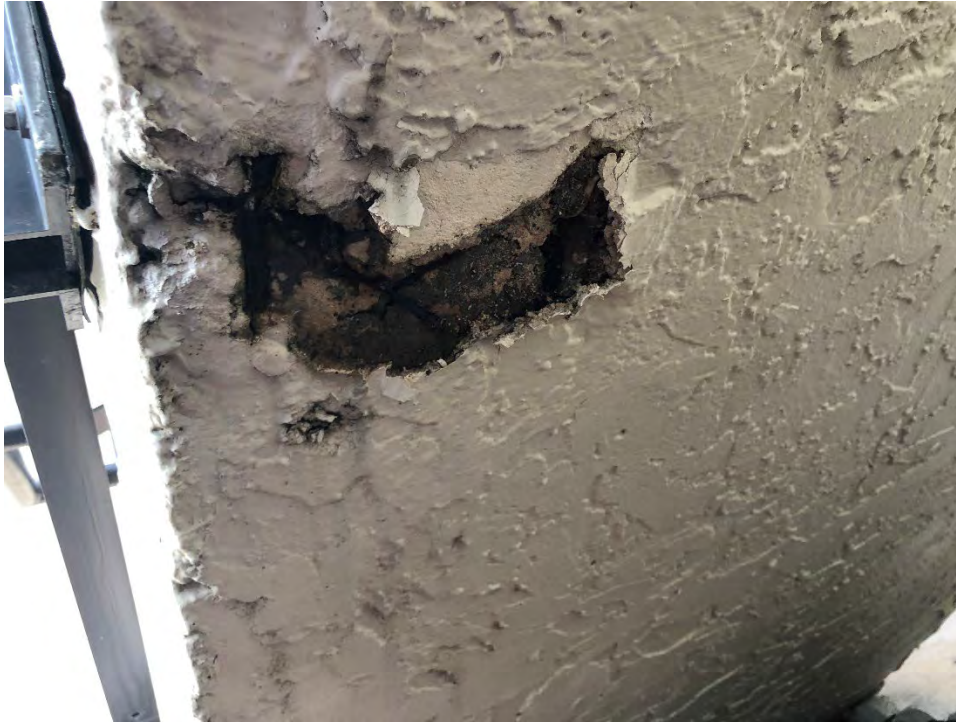
*Figure B- 25 – Concrete Spall*

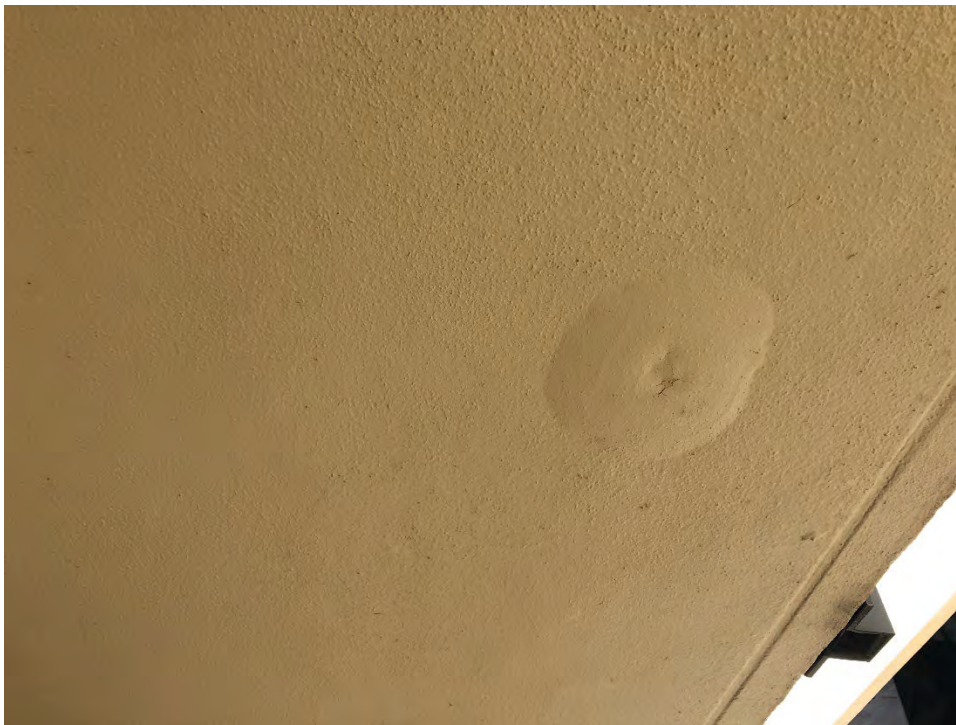
*Figure B- 26 – Blistering Paint Coatings*

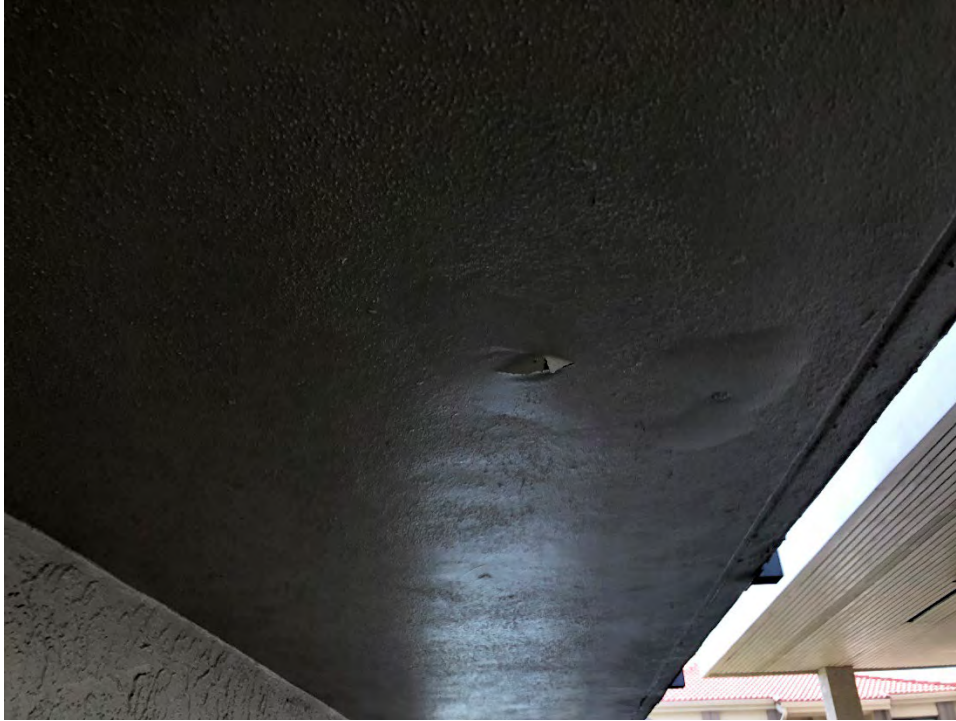
*Figure B- 27 – Blistering Paint Coatings*

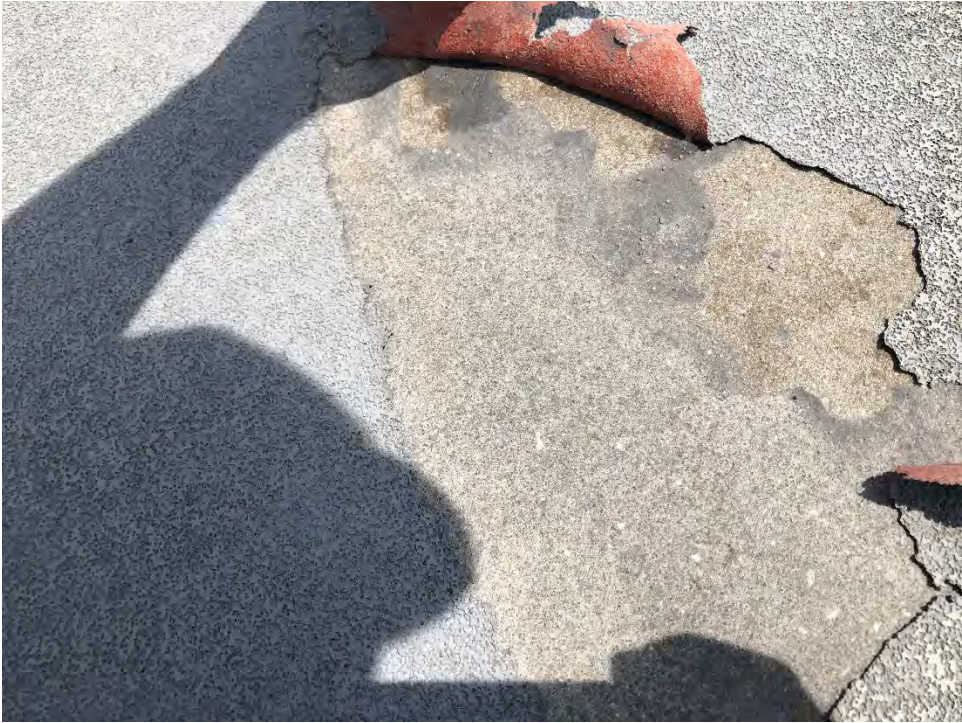
Figure D- 5 – Peeling Waterproofing Membrane

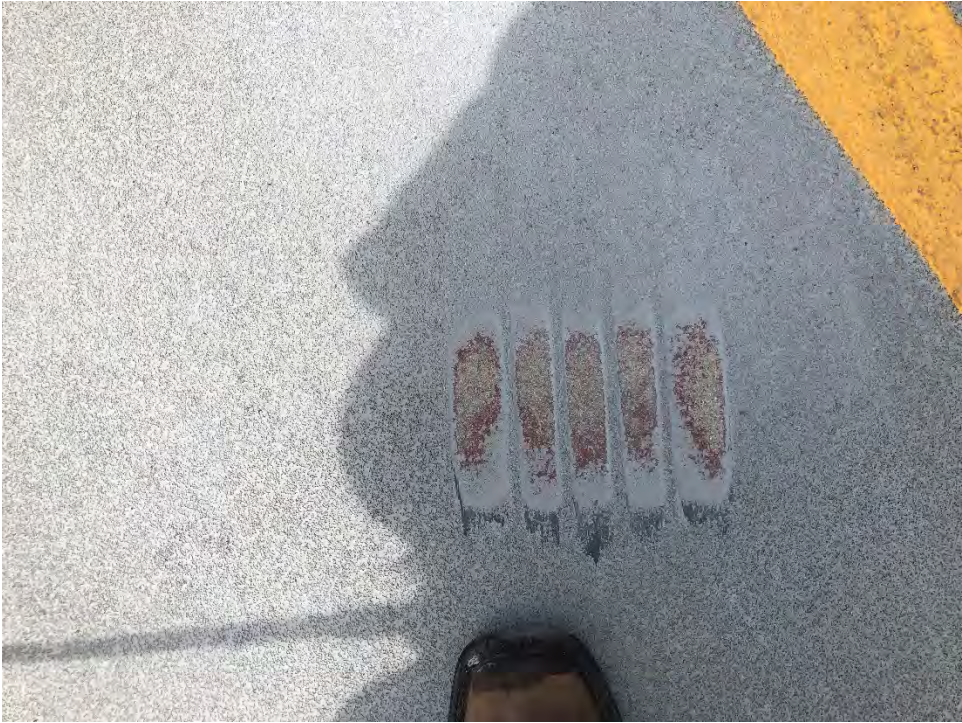
Figure D- 6 – Scraped Waterproofing Membrane

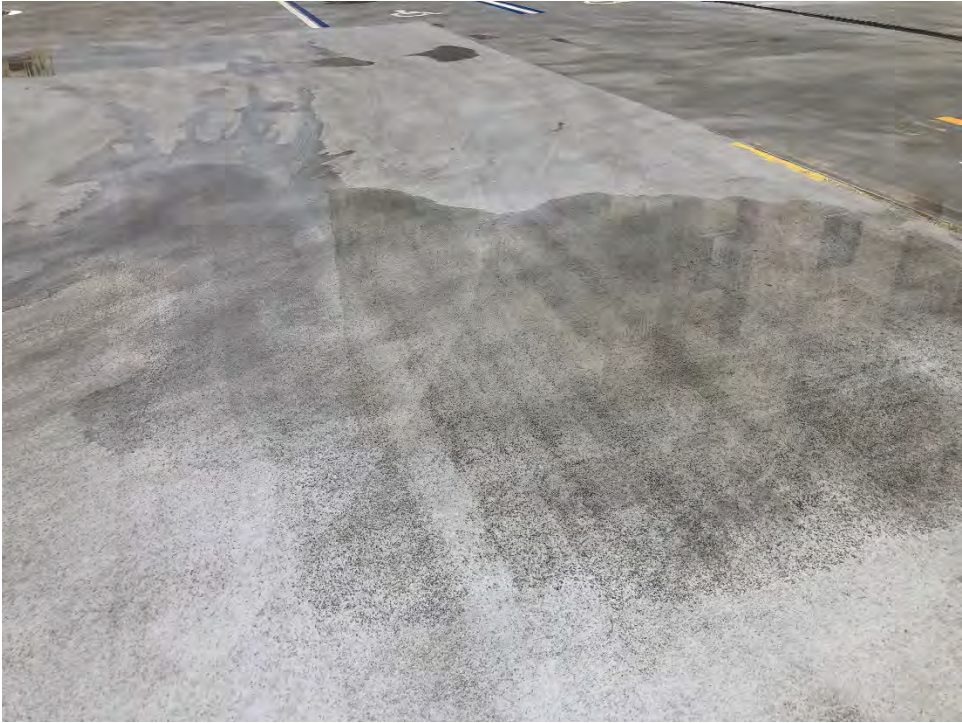
Figure D- 7 – Ponding Water

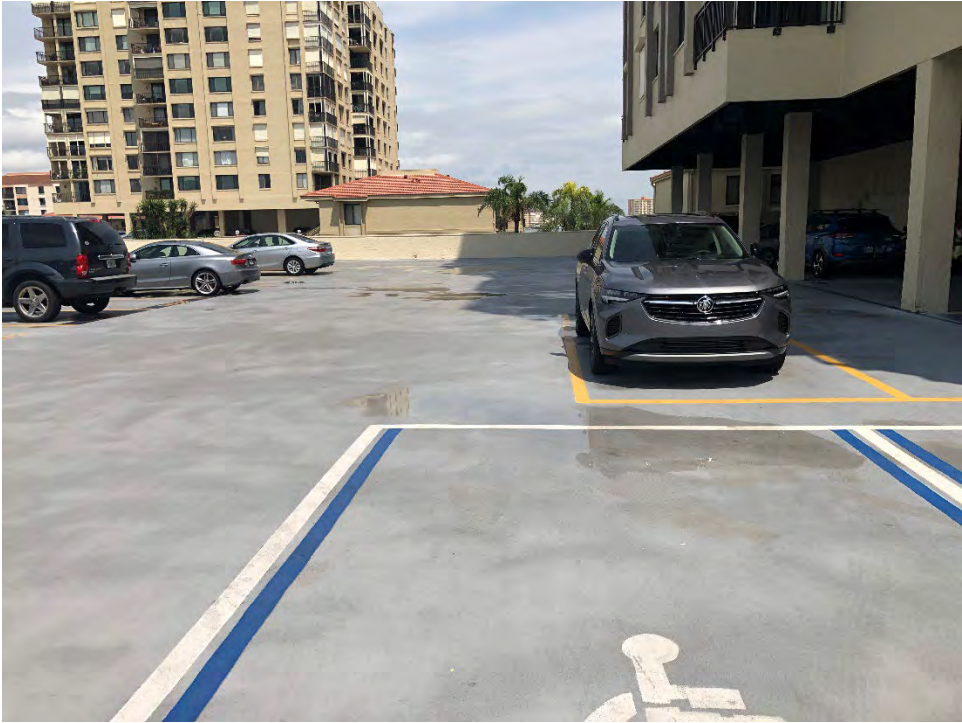
Figure D- 8 – Ponding Water

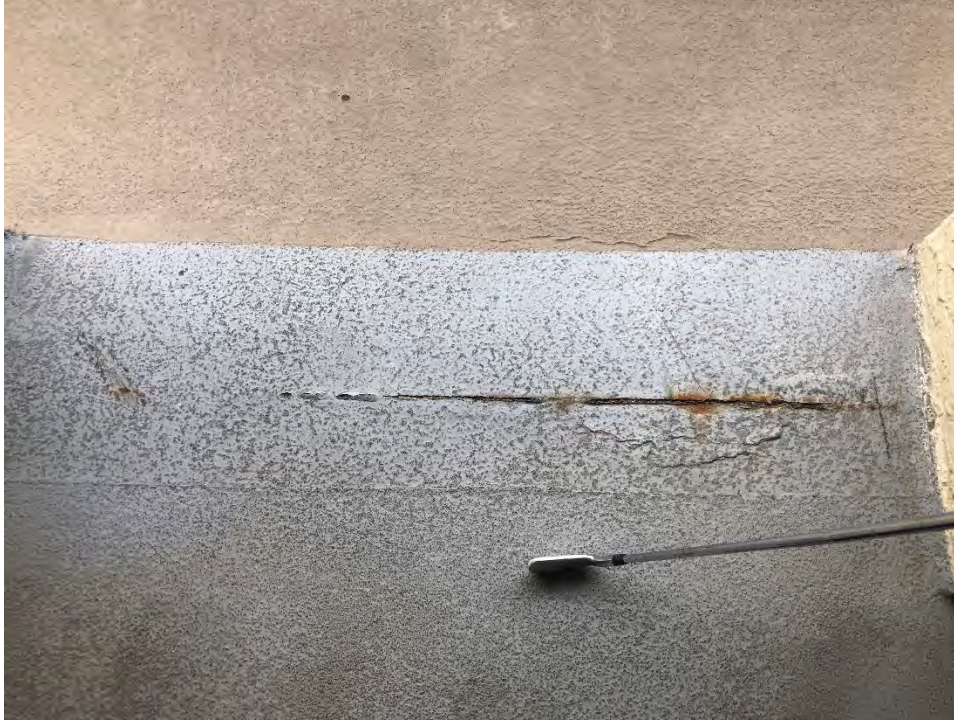
*Figure D- 17 – Concrete Spall*

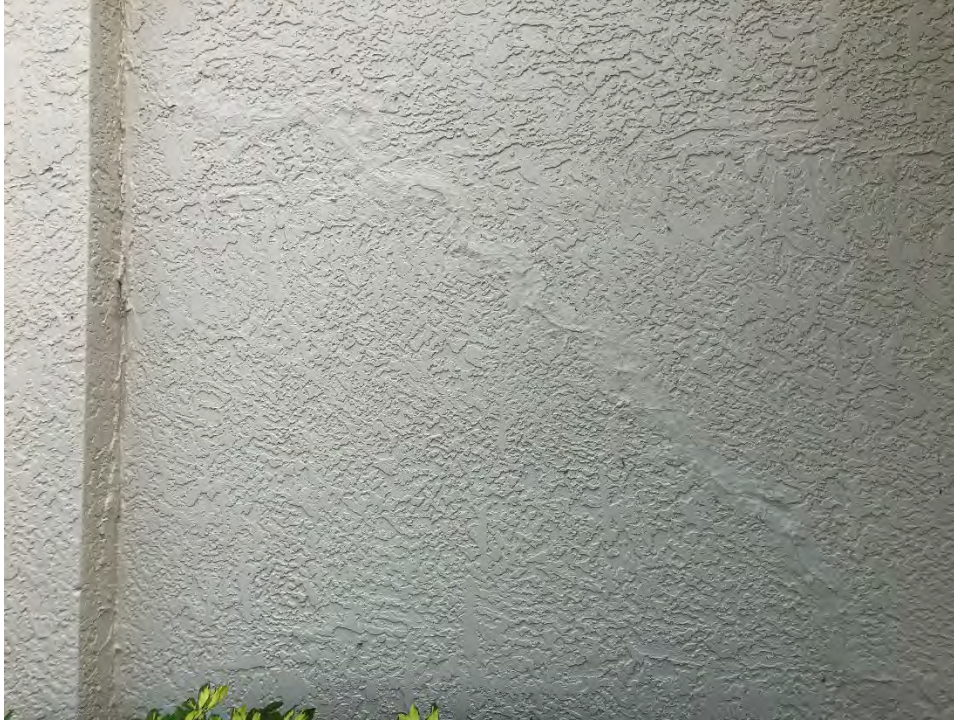
*Figure D- 23 – Exterior Wall Crack*

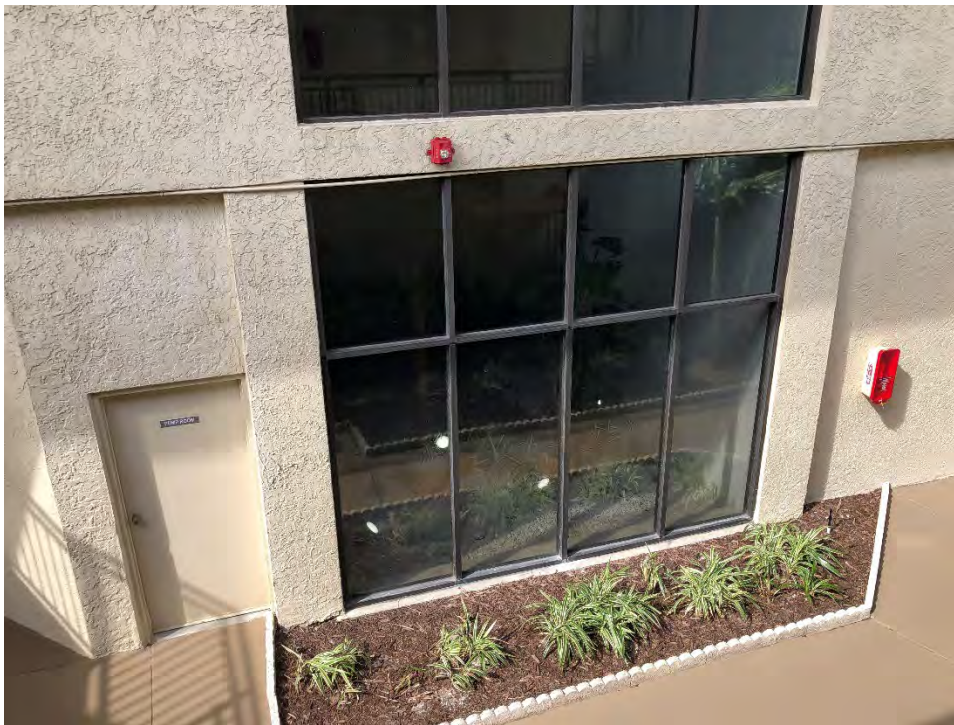
*Figure E- 8 – Typical Storefront Windows*

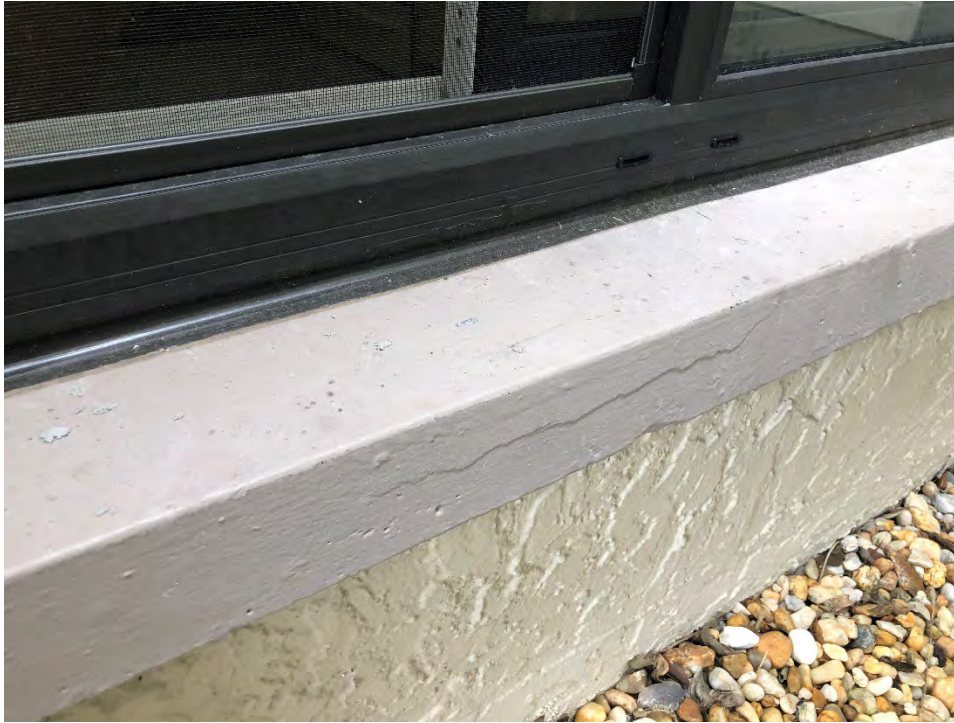
Figure E- 32 – East Elevation (Units 21 - 24)

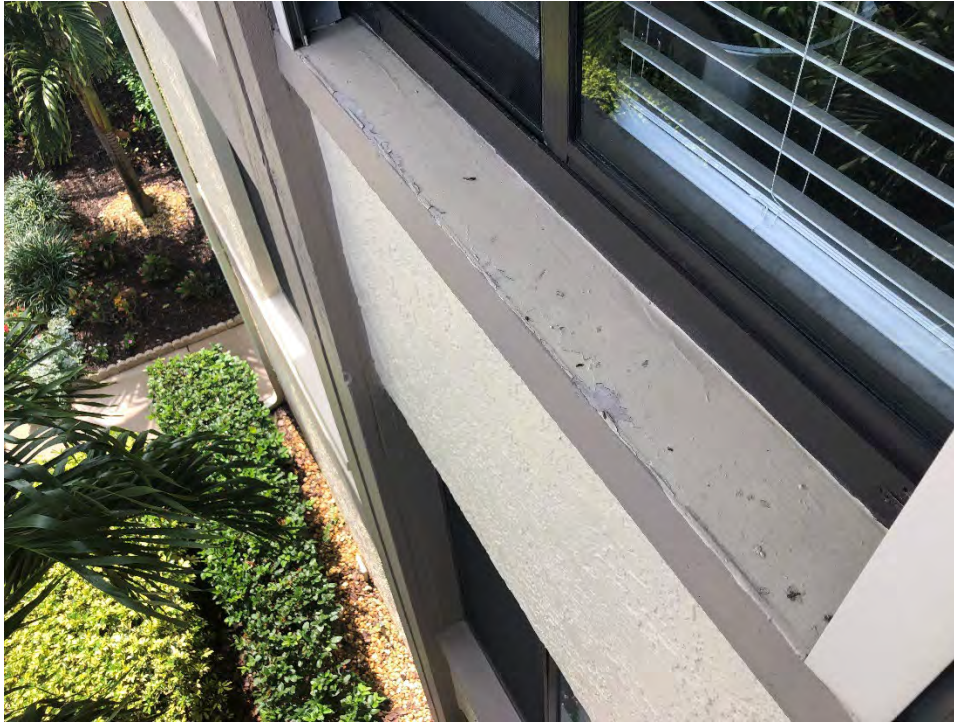
Figure E- 64 – Blistering Exterior Paint Coatings

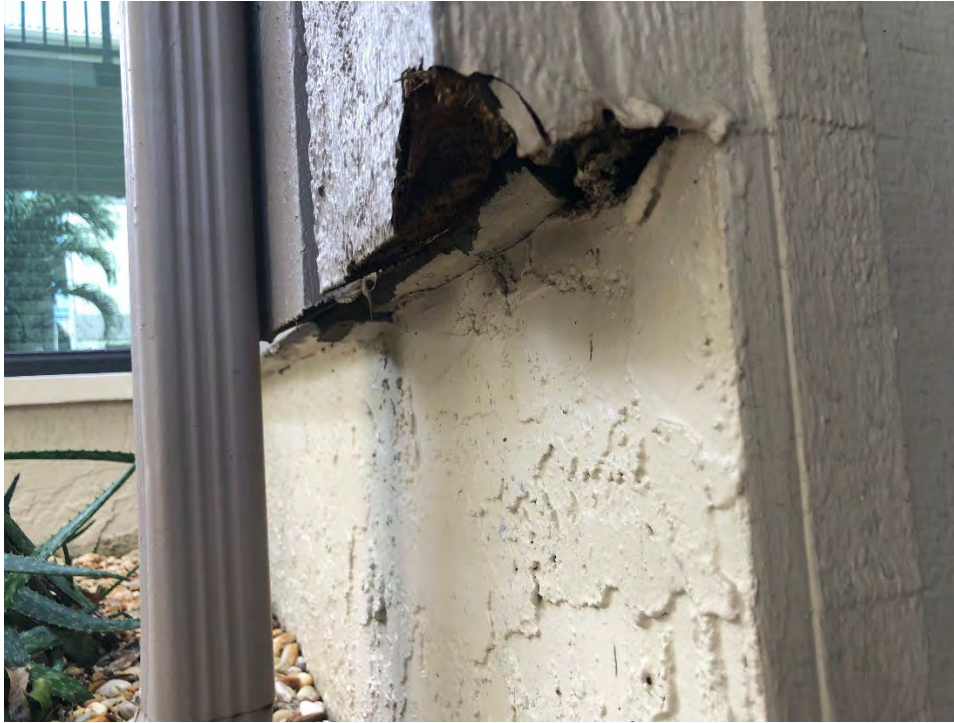
*Figure E- 68 – Typical Wood Trim Rot*

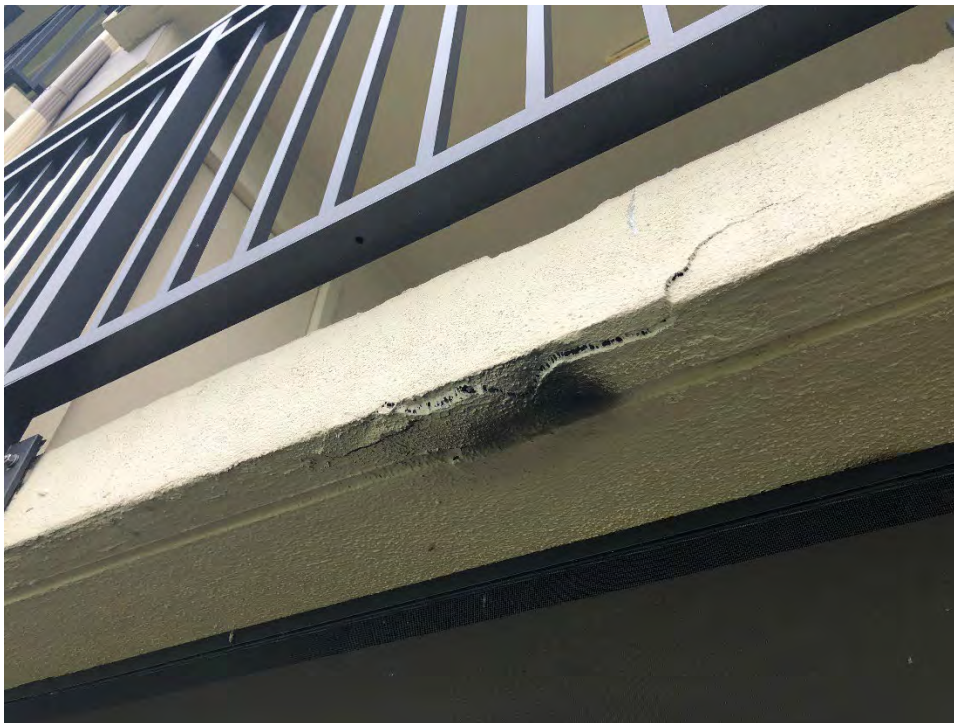
Figure E- 69 – Typical Wood Trim Rot

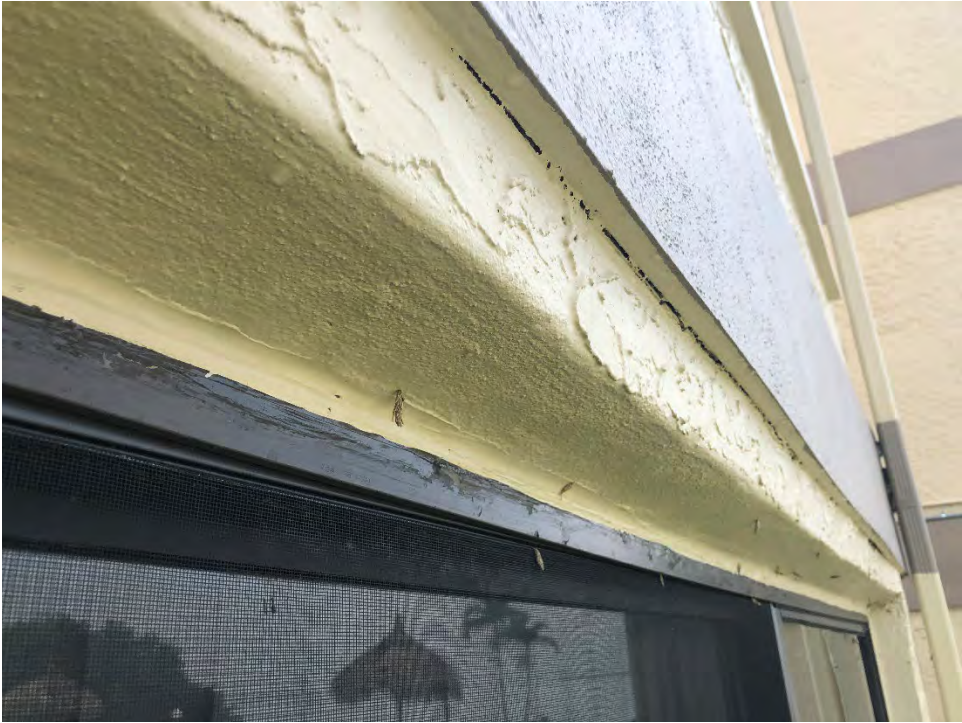
Figure E- 71 – Typical Separation at Stucco Banding

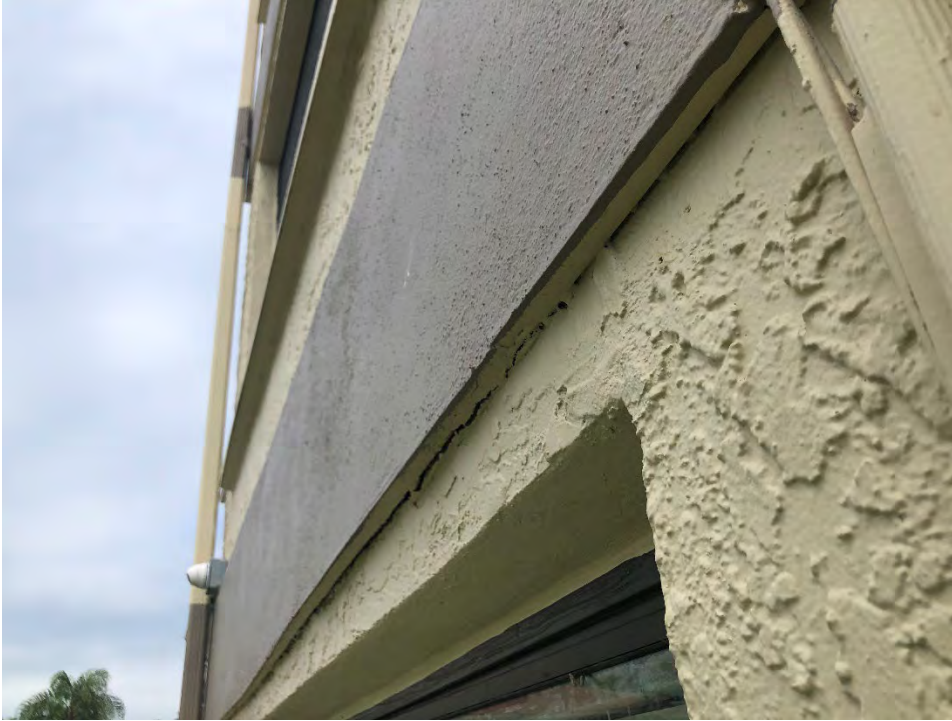
Figure E- 72 – Typical Separation at Stucco Banding
