FULL RESERVE STUDY

Palma Del Mar Condominium Association No. 5 of St Petersburg, Inc.

St. Petersburg, Florida

May 3, 2022

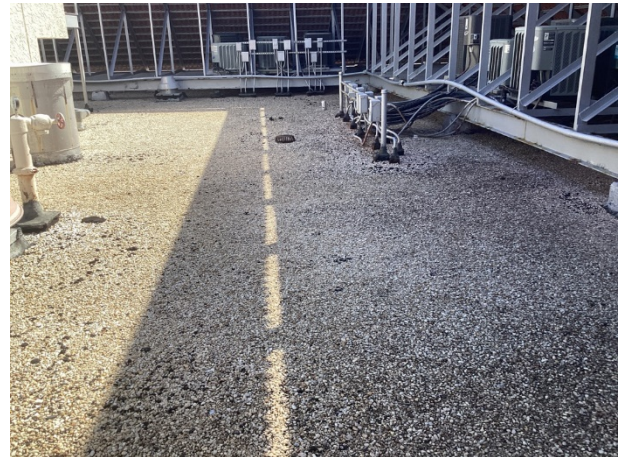
Built-up roof – granular loss evident

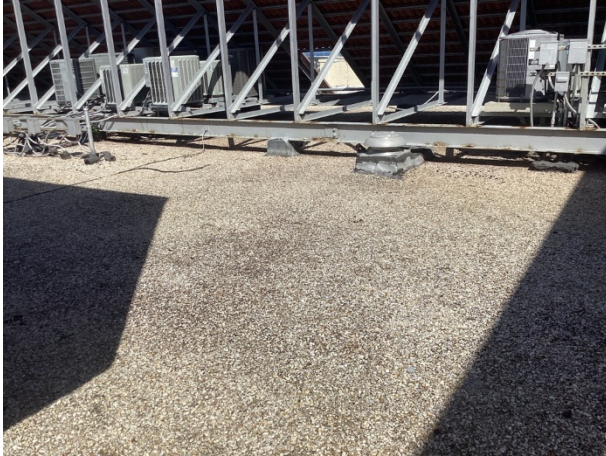
Built-up roof – granular loss evident

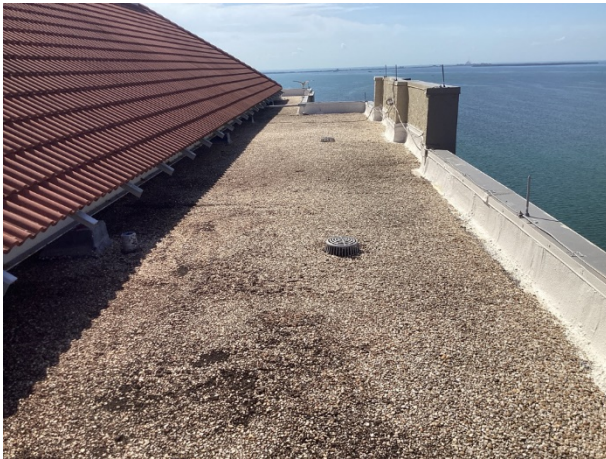
Built-up roof – granular loss evident

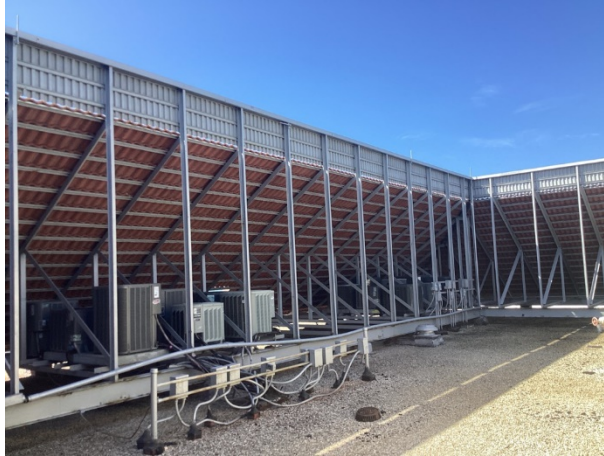
Steel structure - overview

Useful Life: Inspections and capital repairs every 10 years to be done in conjunction with roof replacement projects

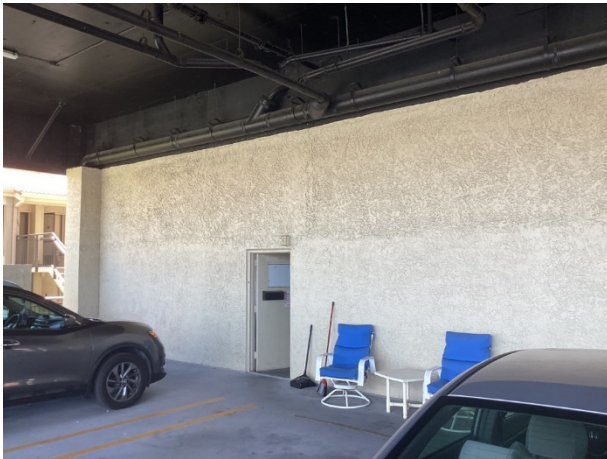
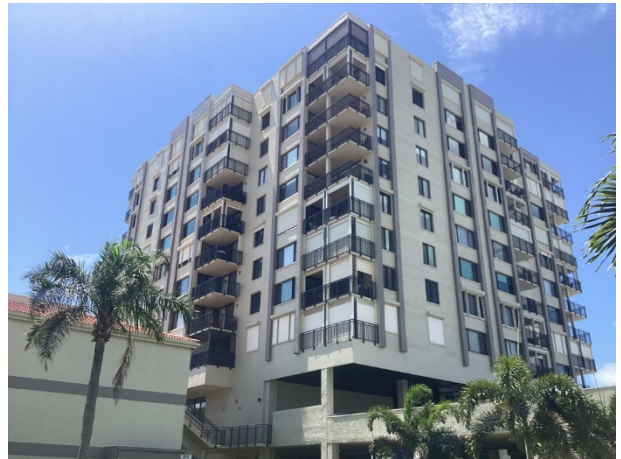
Paint finishes – tower - overview

Useful Life: We recommend inspections, repairs and paint finish applications every five-to seven-years.

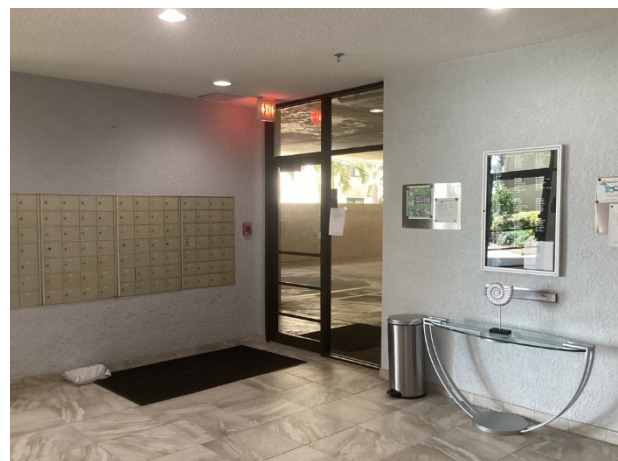
Condition: Good overall with no significant deterioration evident.

Storefront windows - overview

Storefront windows and doors – overview

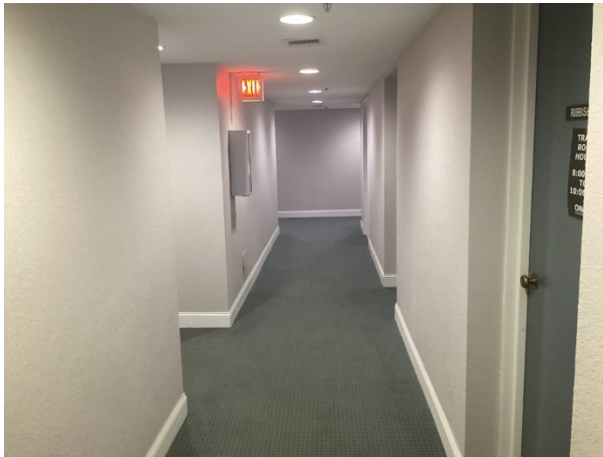
Condition: Good overall with no significant deterioration evident.

Hallway floor coverings - overview

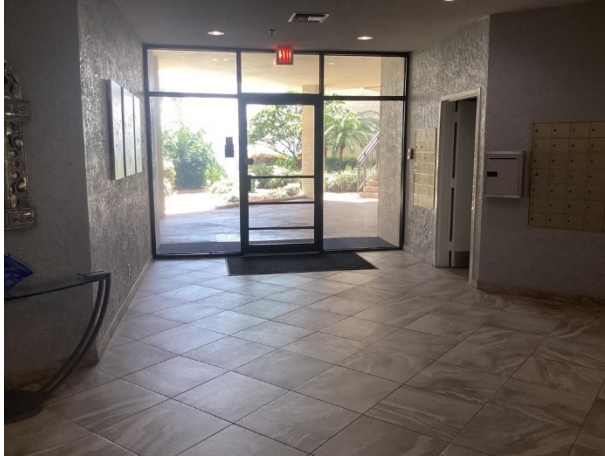
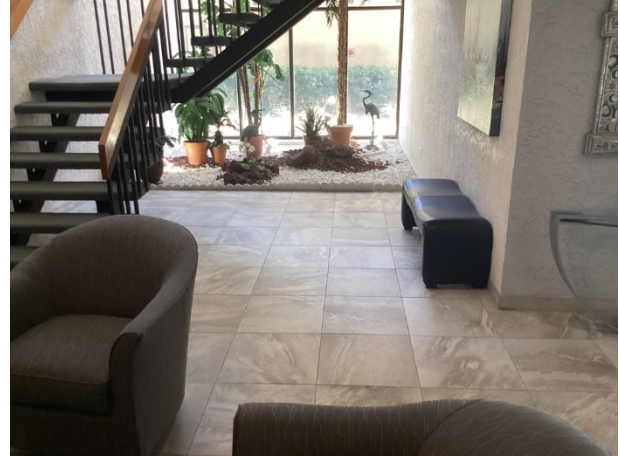
Condition: Good overall with no significant deterioration evident.

Tile floor coverings - overview

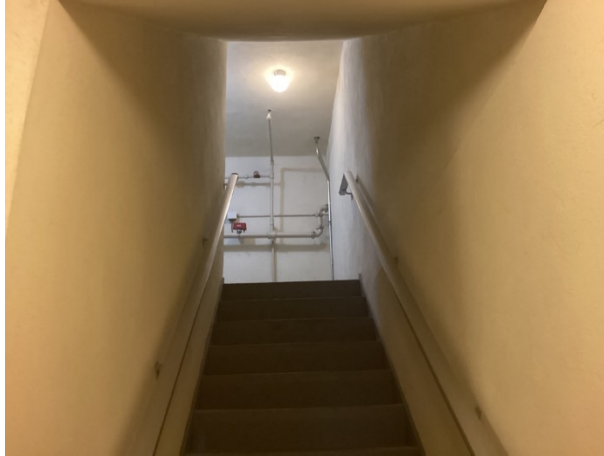
Conditions: Good to fair overall

Paint finishes – stairwells - overview

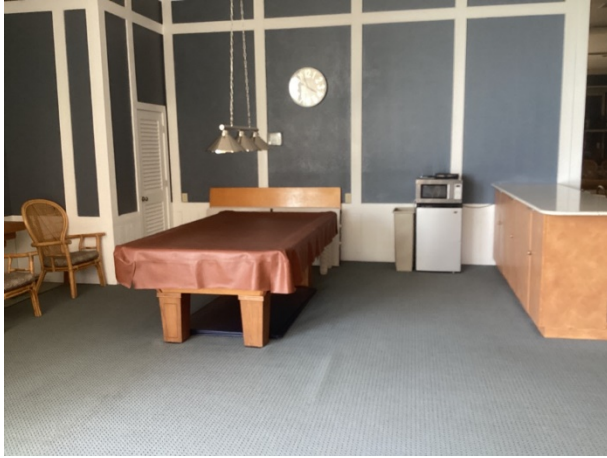
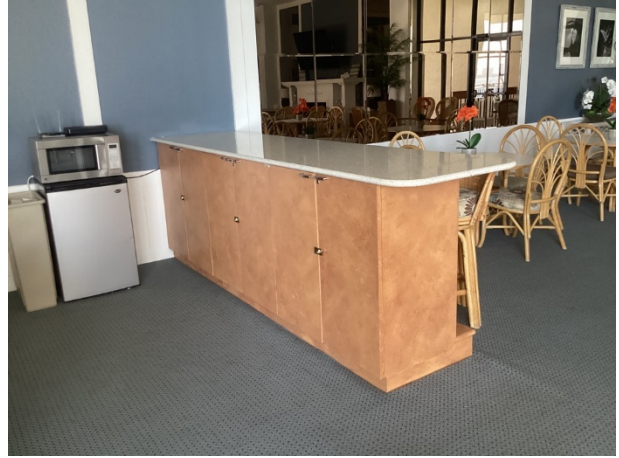
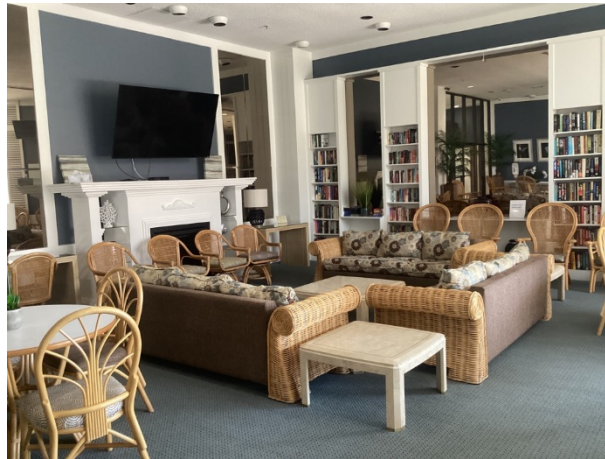
Condition: Good overall with no significant deterioration evident.

Social room renovation - overview

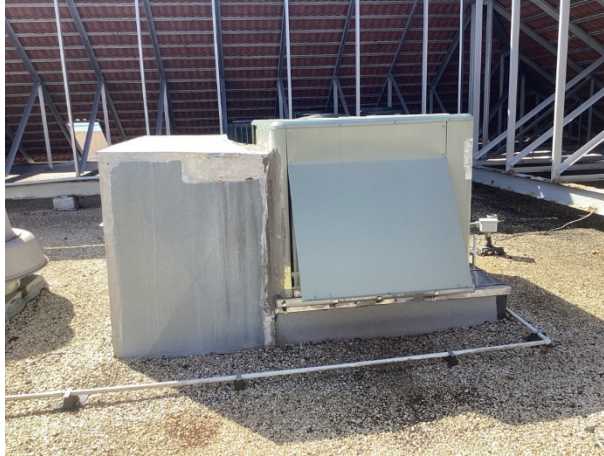
Condition: Reported satisfactory with operational deficiencies

Roof top unit

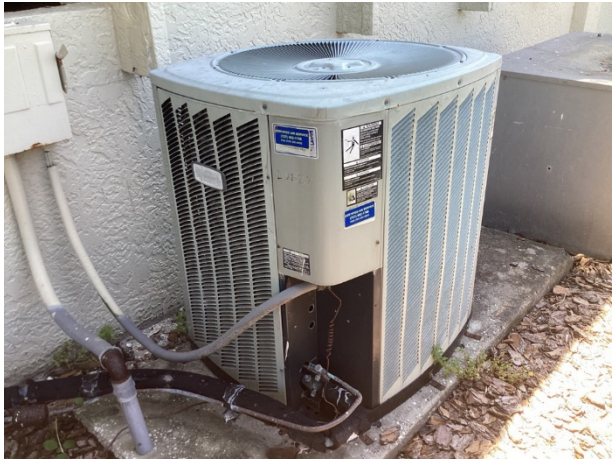
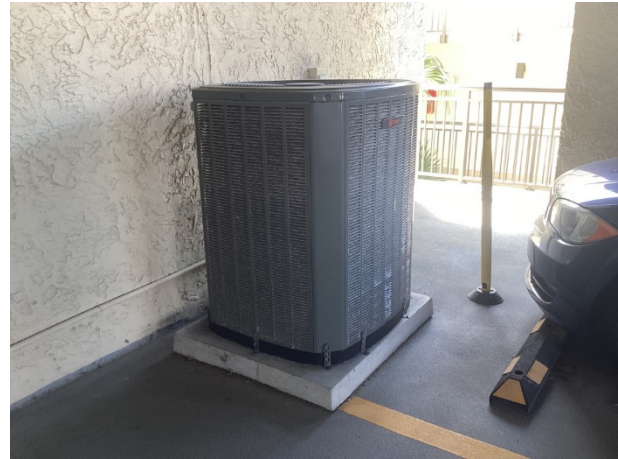
Condition: Reported satisfactory with operational deficiencies

Split systems – overview

Split systems - overview

Expenditure Detail Notes: Expenditure timing and costs are depicted in the **Reserve Expenditures** table in Section 3. The condensing unit may require replacement prior to replacement of the related interior forced air unit. For purposes of this Reserve Study, we assume coordination of replacement of the interior forced air unit, evaporator coil, refrigerant lines and exterior condensing unit. Due to the varied ages of the split systems we depict replacement in phased manner with replacement of up to fifty percent (50%) of the total quantity per event.

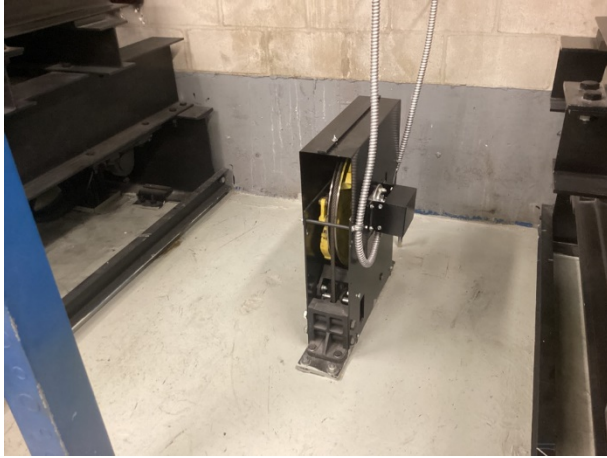
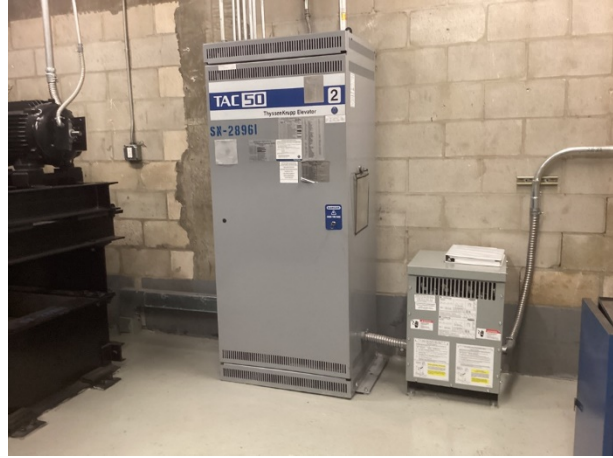
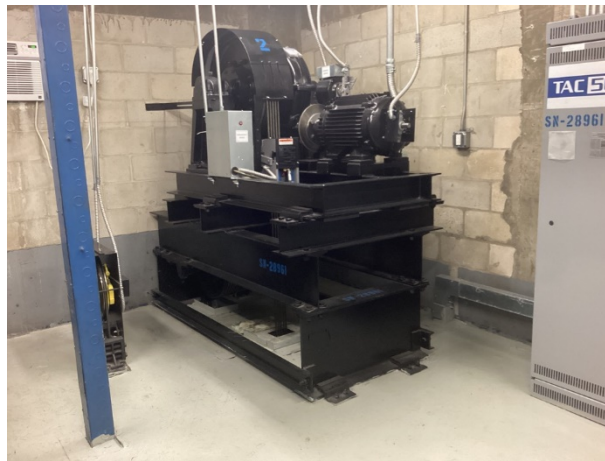
Condition: The controls and call buttons are reported in satisfactory condition and the hoists and motors are reported in satisfactory condition. Service interruptions are reportedly infrequent.

Elevator equipment - hoists

Elevator equipment – control panel

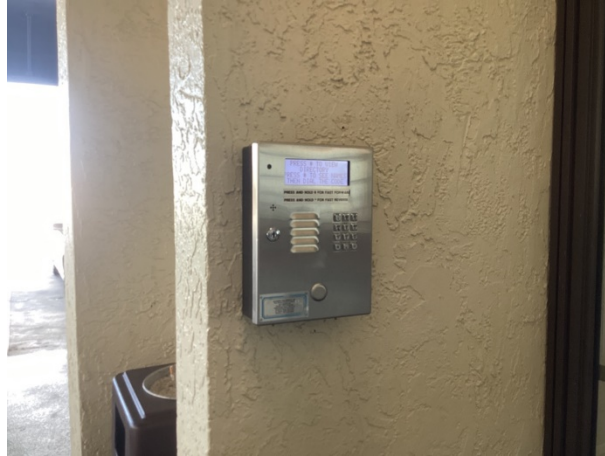
Condition: Reported satisfactory

Intercom panel - typical

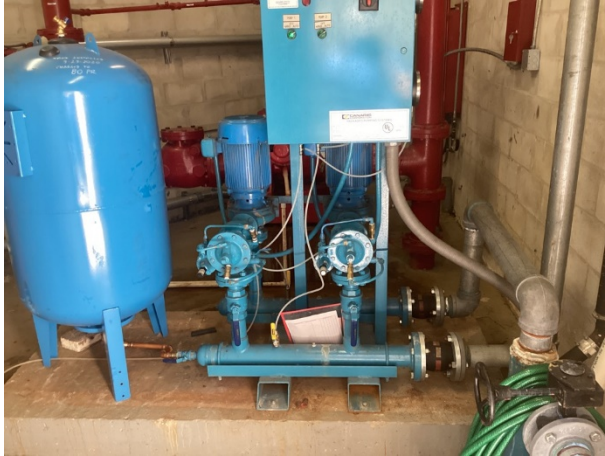
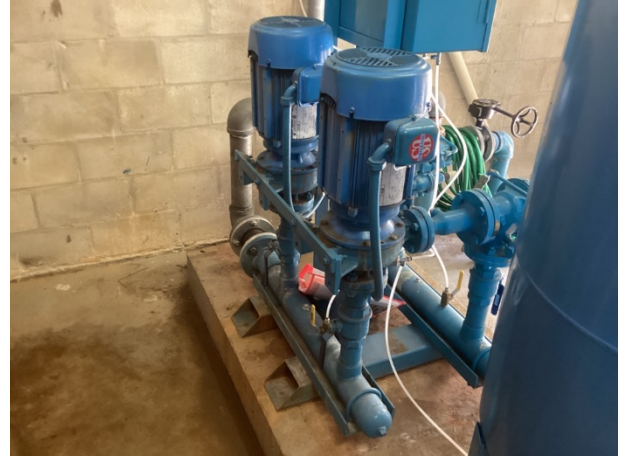
Condition: Reported satisfactory without operational deficiencies

Domestic water pumps

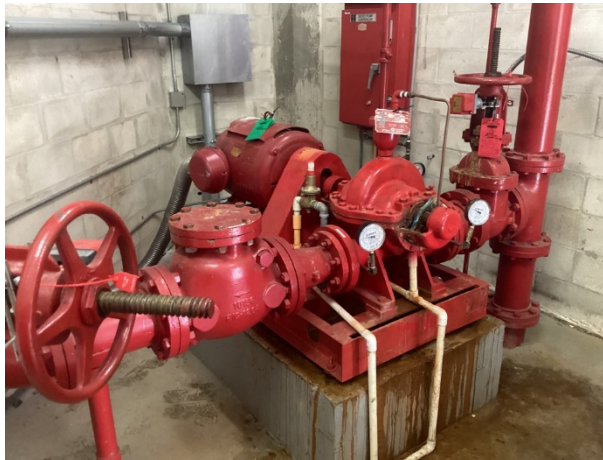
Condition: Reported satisfactory

Fire pump - overview

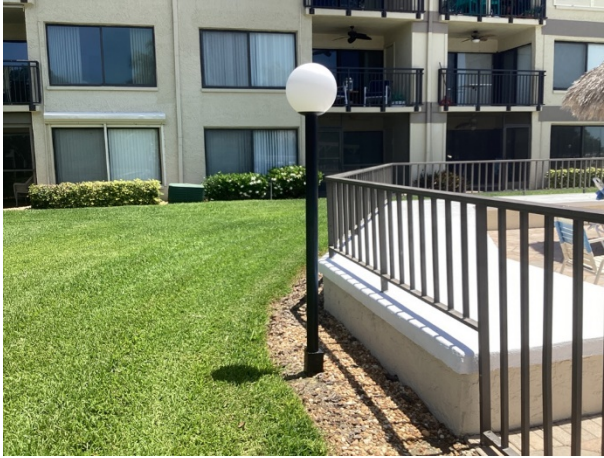
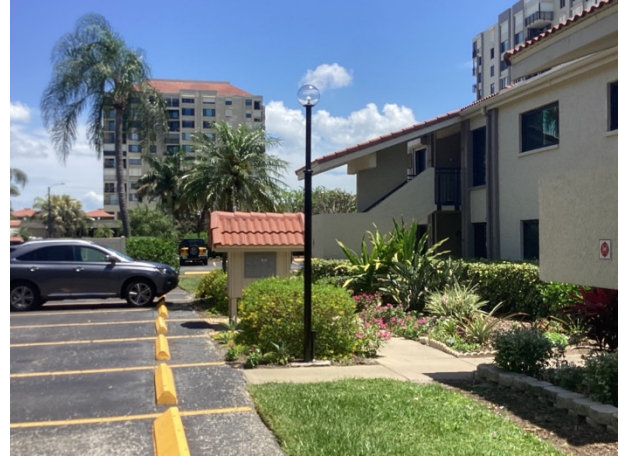
Condition: Fair overall

Light pole and fixture

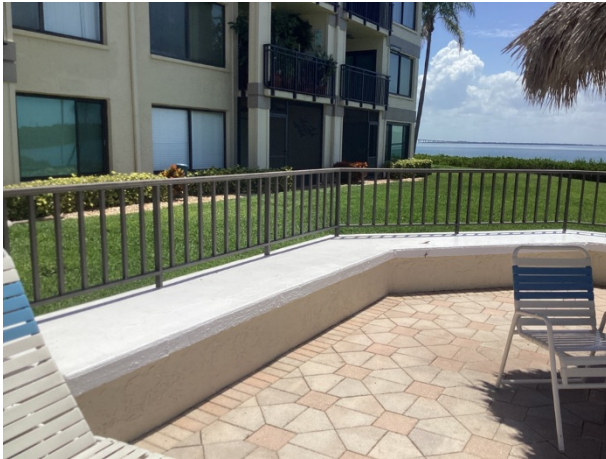
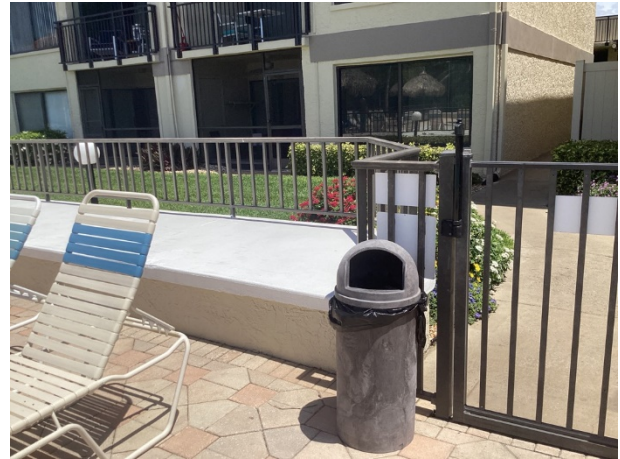
Condition: Good overall

Pool fences - overview

- Annually:
 - Inspect and repair loose fasteners or sections, and damage
 - Repair leaning sections and clear vegetation from fence areas which could cause damage

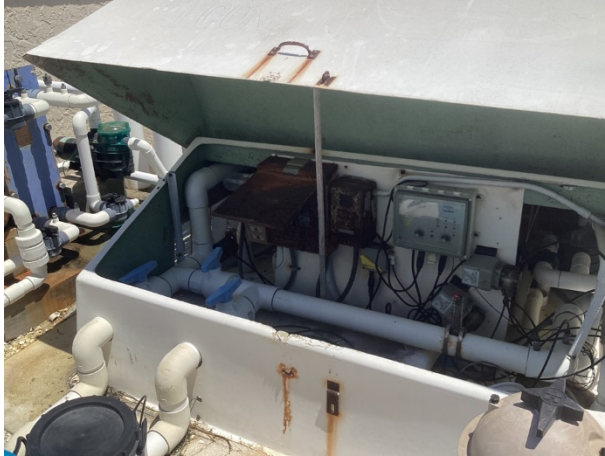
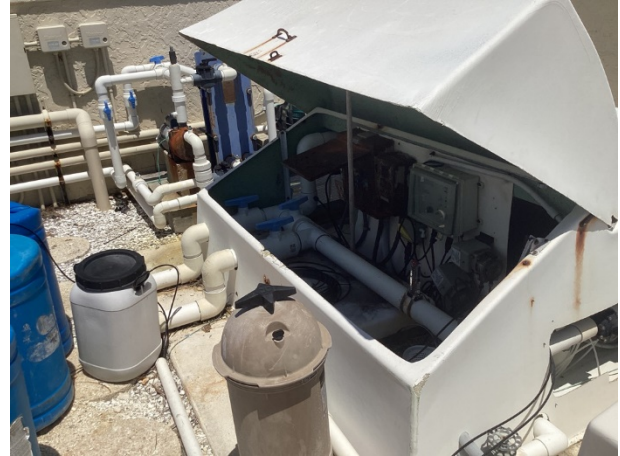
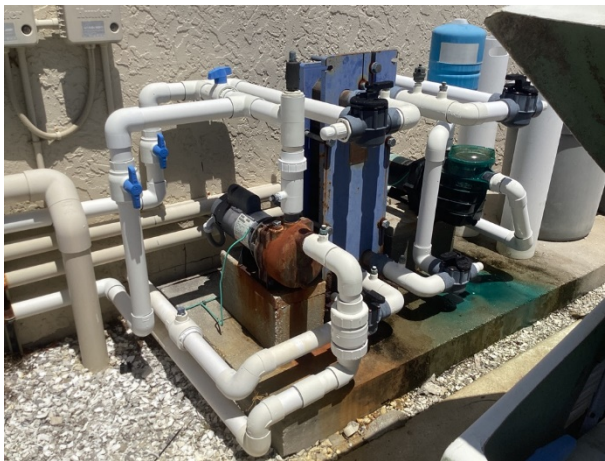
Condition: Reported satisfactory overall

Pool mechanical equipment – overviews

Preventative Maintenance Notes: We recommend the Association maintain a maintenance contract with a qualified professional and follow the manufacturer's specific recommended maintenance and local, state and/or federal inspection guidelines.

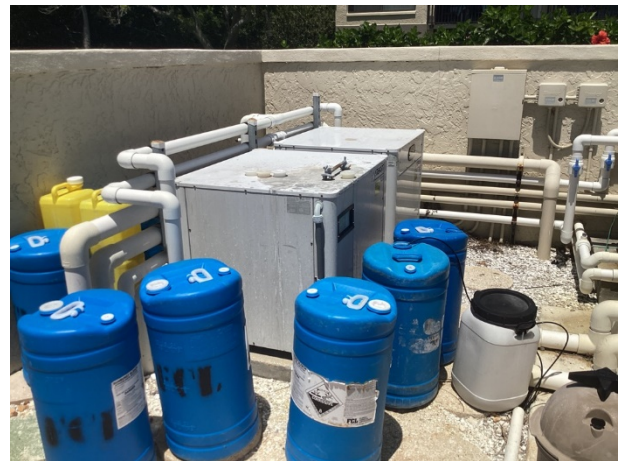
History: The geothermal heaters were installed in 2019

Pool mechanical equipment – geothermal heaters

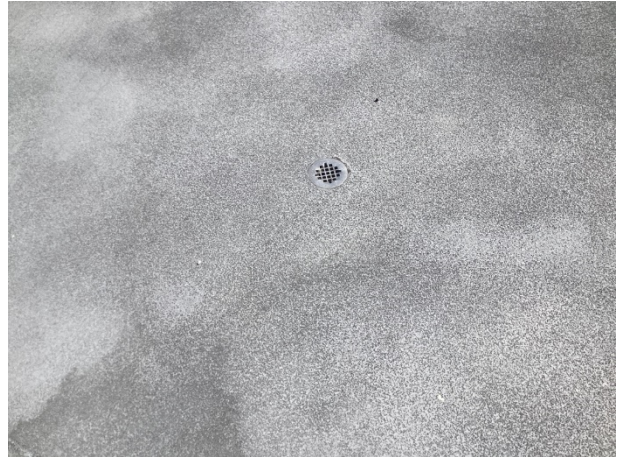
Elevated concrete – drainage detail evident

- Semi-annually:
 - Clean floors and remove vehicular oil stains
- Annually:
 - Inspect for large cracks, concrete spalls and vehicular damage at walls and columns
 - Verify drains are working properly and check for areas of extensive water ponding
 - Check for any signs of exposed rebar

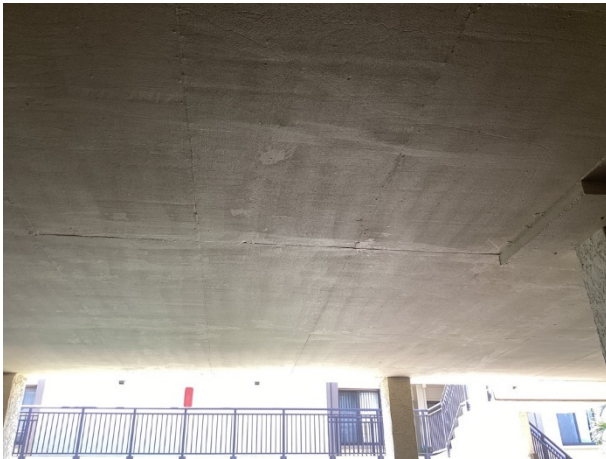
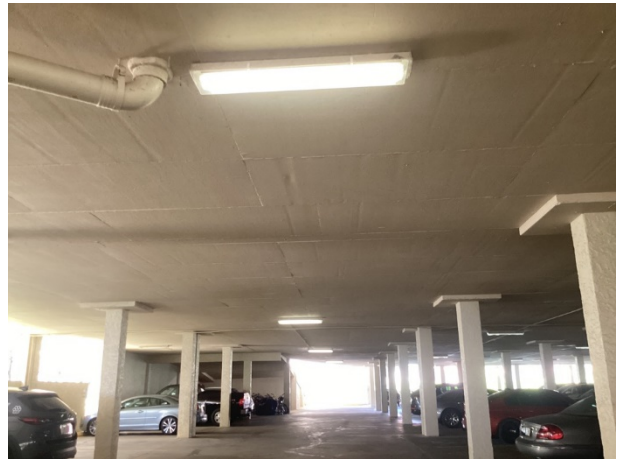
Condition: Good overall isolated cracks and patch repairs evident

Elevated concrete - overview

- Complete inspection of the garage concrete
- Partial depth concrete replacement of a limited amount of the surface area of the concrete floors
- Partial depth concrete replacement of a limited amount of the surface area of the elevated structural concrete ceilings
- Remediation of structural concrete columns and beams as needed
- Crack repairs on all surfaces as needed

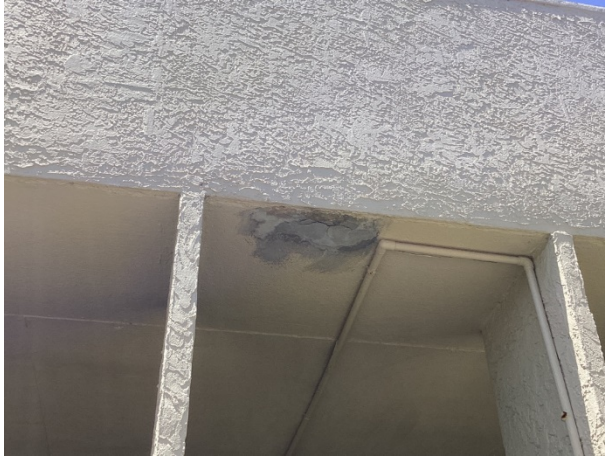
Elevated concrete – concrete patches evident

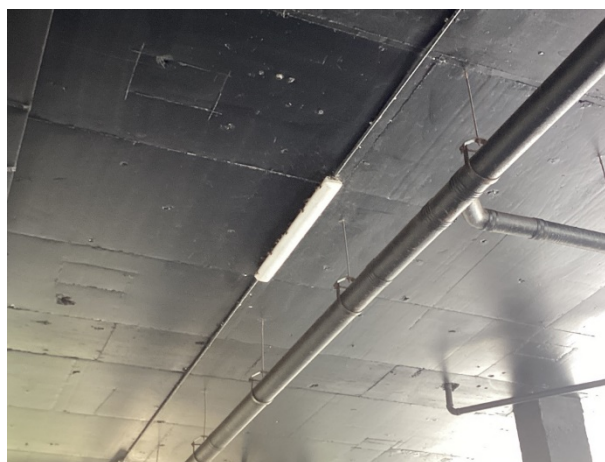
History: We are informed that a portion of the fluorescent light fixtures was replaced in 2018

Condition: Reported satisfactory

Garage light fixtures

- As-needed:
 - Inspect and replace/repair broken or dislodged fixtures
 - Replace burned out bulbs
