Revised **FULL RESERVE STUDY**

**Palma Del Mar Condominium Association
No. 5 of St Petersburg, Inc.**

**St. Petersburg, Florida
Inspected - May 3, 2022
Revised - December 1, 2022**

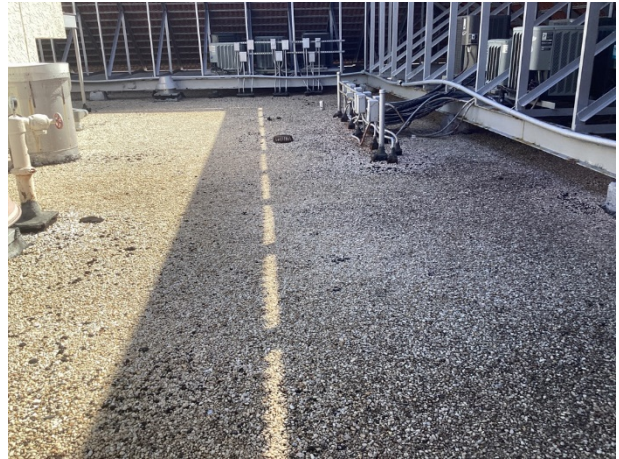
Built-up roof – granular loss evident

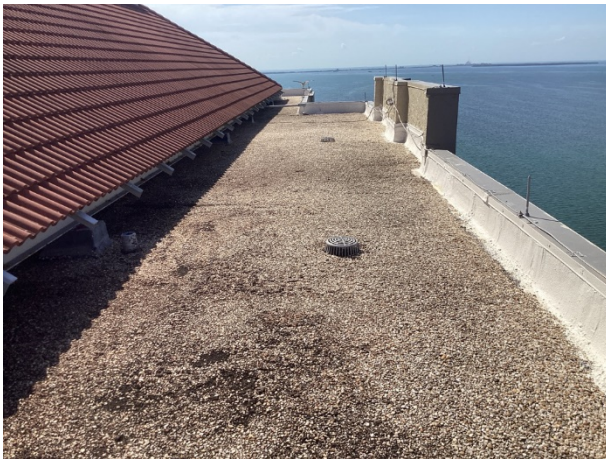
Built-up roof – granular loss evident

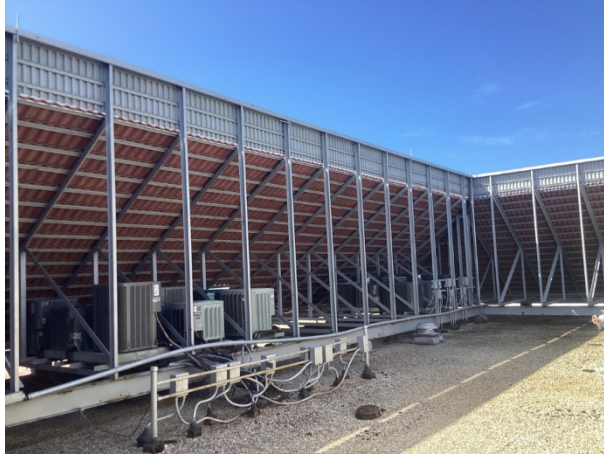
Steel structure - overview

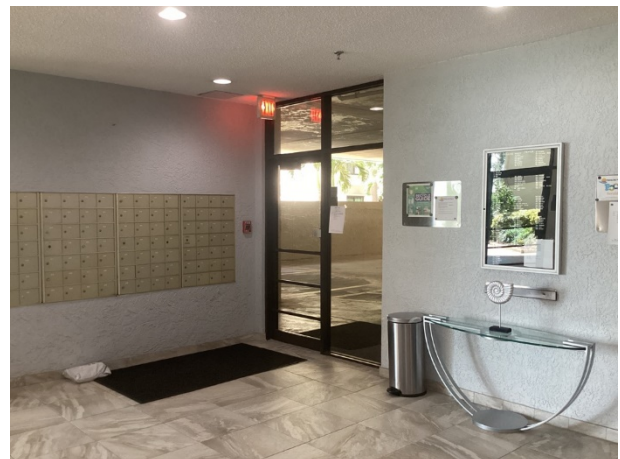
Storefront windows and doors – overview

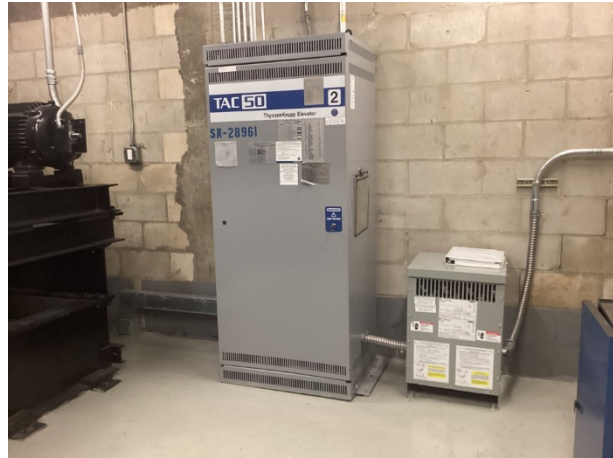
Condition: The controls and call buttons are reported in satisfactory condition and the hoists and motors are reported in satisfactory condition. Service interruptions are reportedly infrequent.

Elevator equipment – control panel

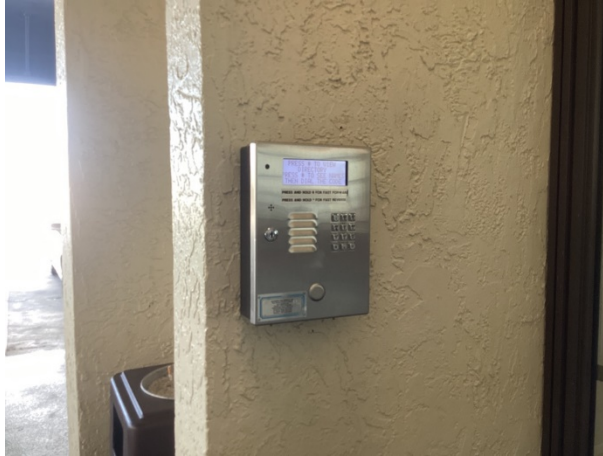
Condition: Reported satisfactory

Intercom panel - typical

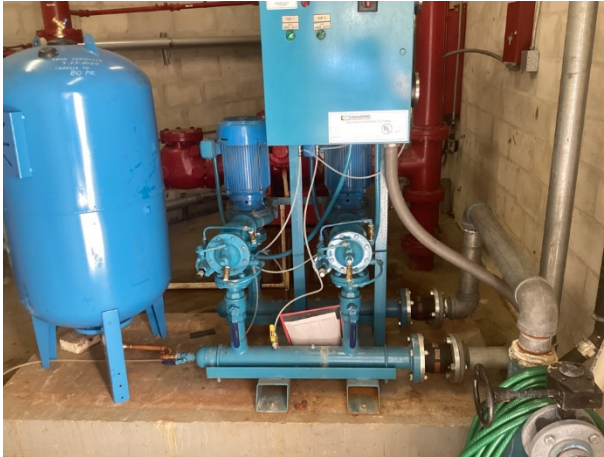
Domestic water pumps

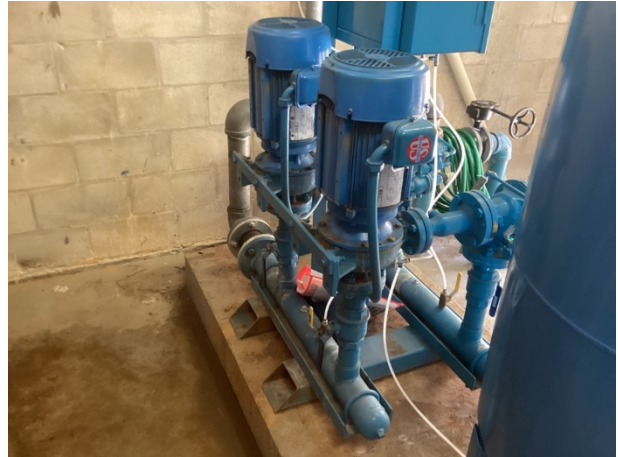
Domestic water pumps

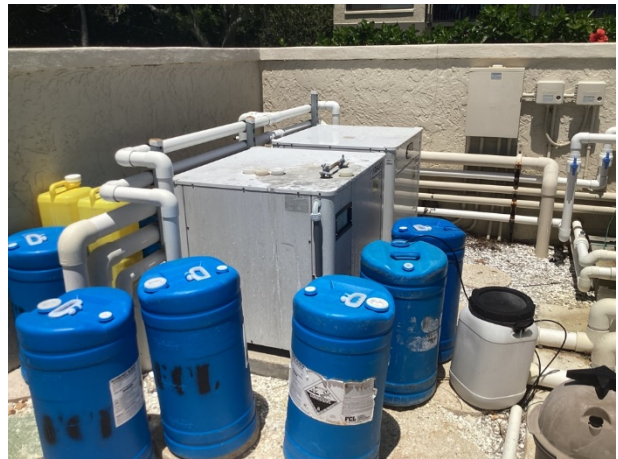
Pool mechanical equipment – geothermal heaters

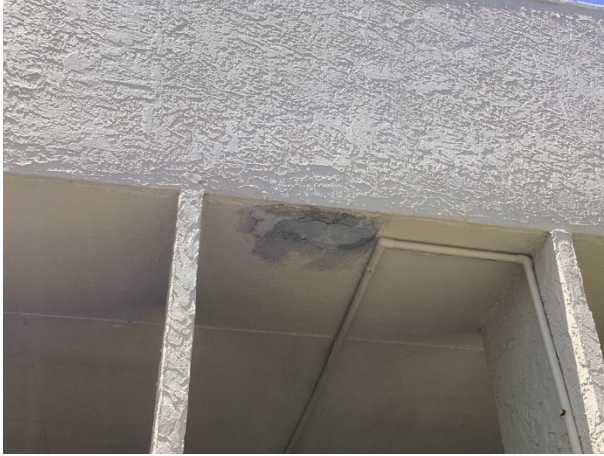
Elevated concrete – concrete patches evident
