# Palma Del Mar Condominium No. 5 of St Petersburg, Inc.

November 30, 2023 • St. Petersburg, FL

**STRUCTURAL INTEGRITY  
RESERVE STUDY**

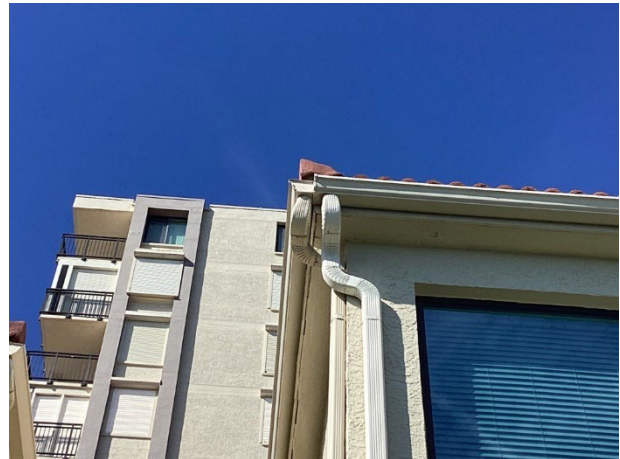
Gutters and downspouts - overview

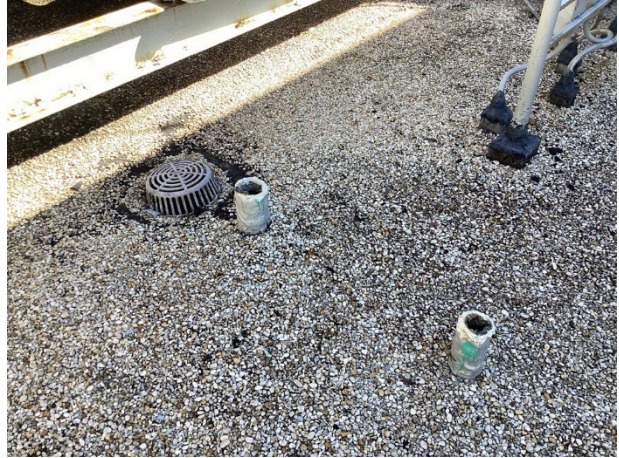
**Built-up roof - granular loss evident**

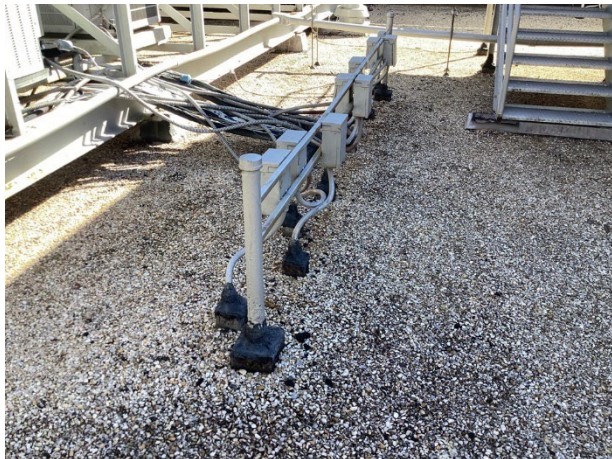
**Built-up roof - granular loss evident**

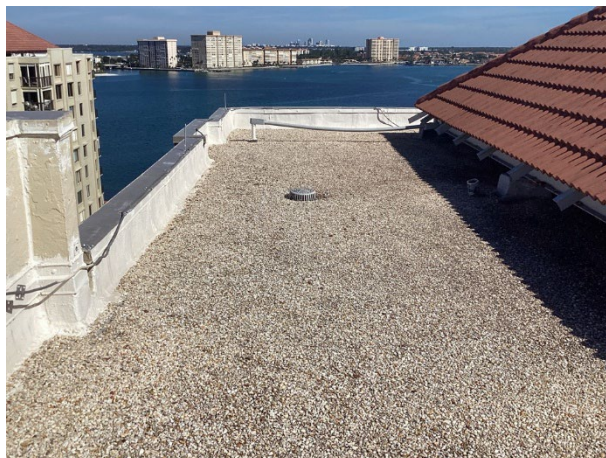
**Built-up roof - overview**

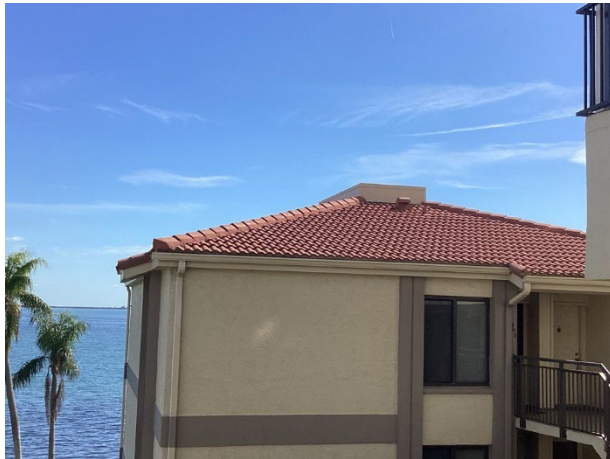
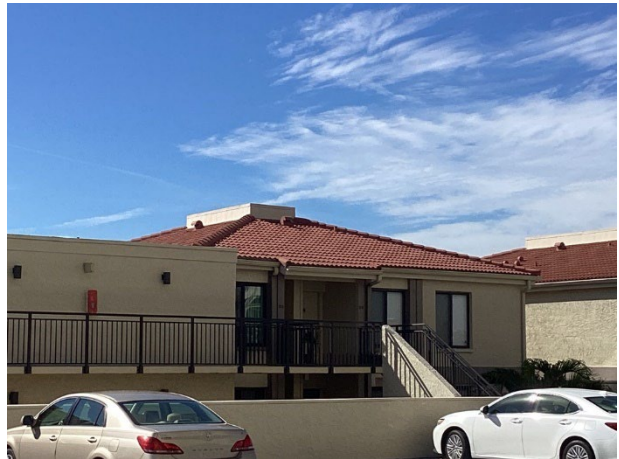
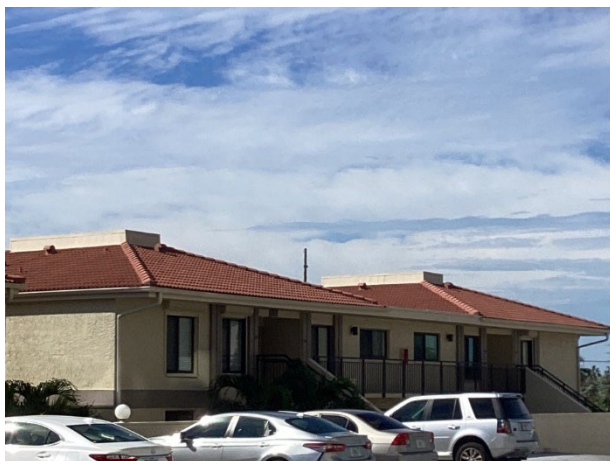
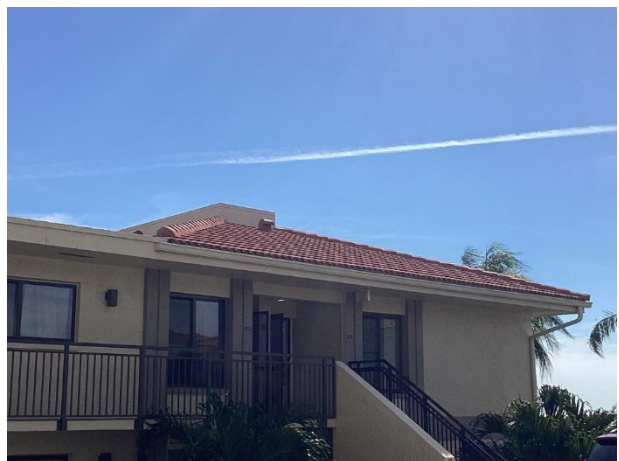
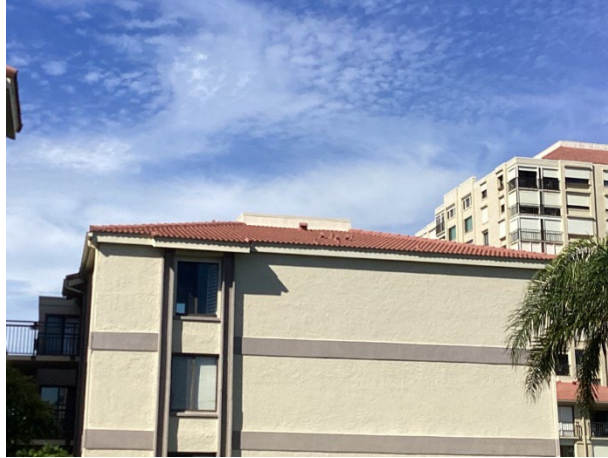
**Condition:** Good overall with no significant deterioration evident from our visual inspection

Concrete tile roofs - overview

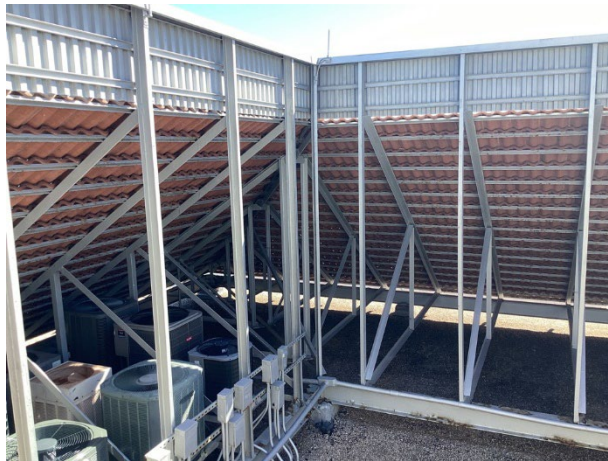
**Steel structure – overview**

**Useful Life:** Inspections and capital repairs every 10 years to be done in conjunction with roof replacement projects

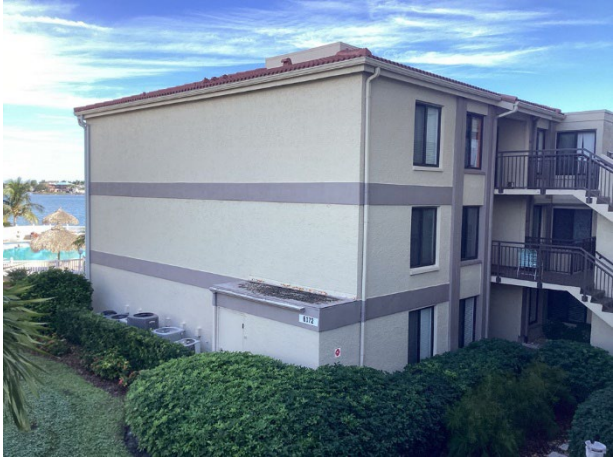
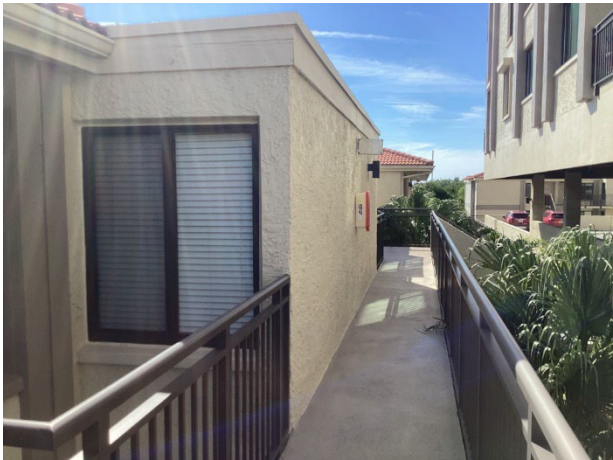
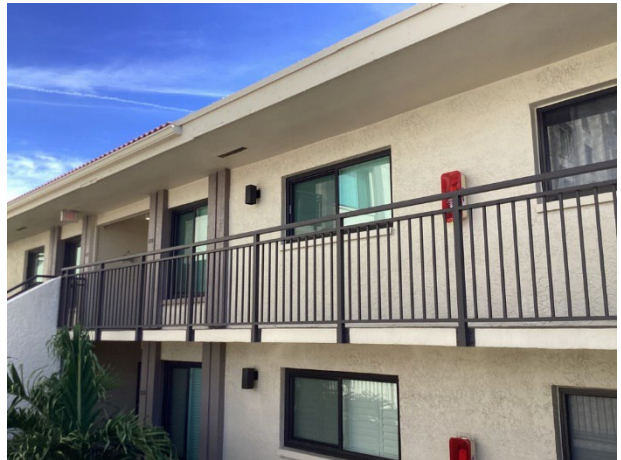
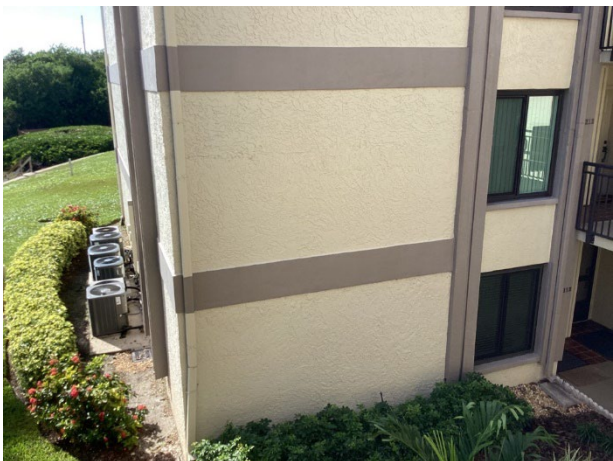
**Condition:** The paint finishes throughout the community are in good to fair condition overall with deterioration of the paint finishes and cracks evident

**Paint finish applications – Villas - overview**

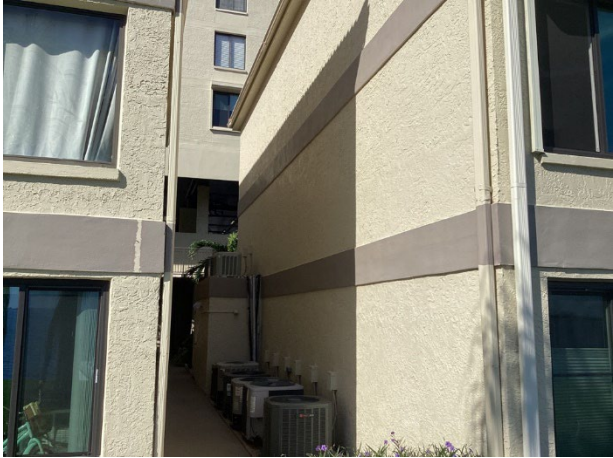
**Paint finish applications – Villas - overview**

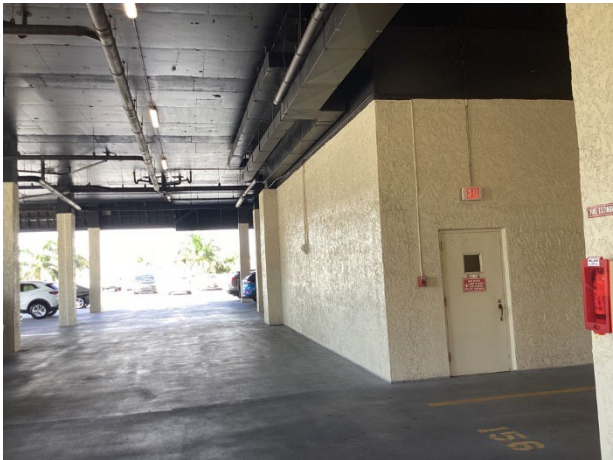
**Paint finish applications – Tower – paint finish deterioration evident**

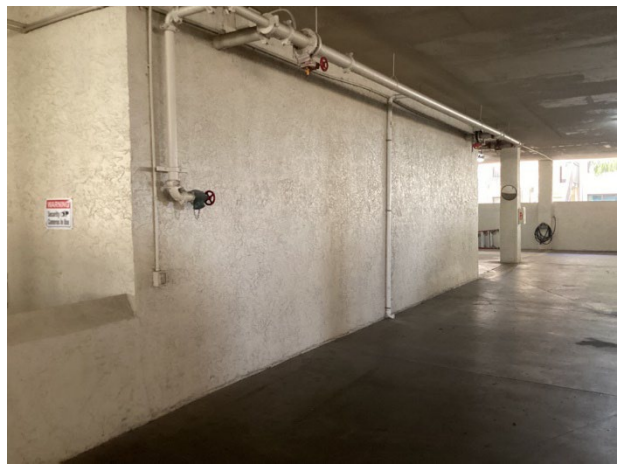
**Paint finish applications – Garage – cracks evident**

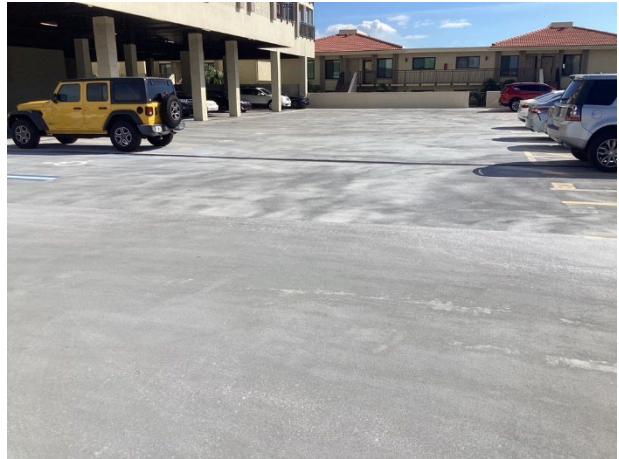
**Elevated concrete – spalling evident**

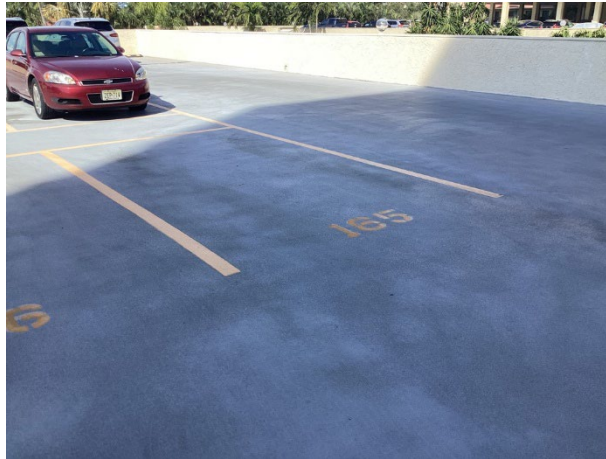
**Elevated concrete – cracks evident**

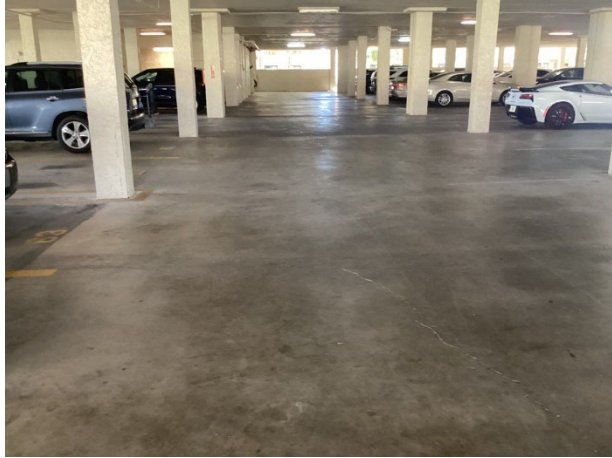
**On-grade concrete – cracks evident**

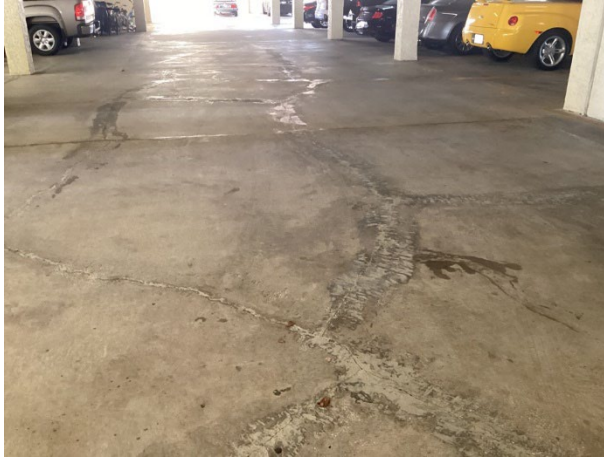
**On-grade concrete – cracks evident**

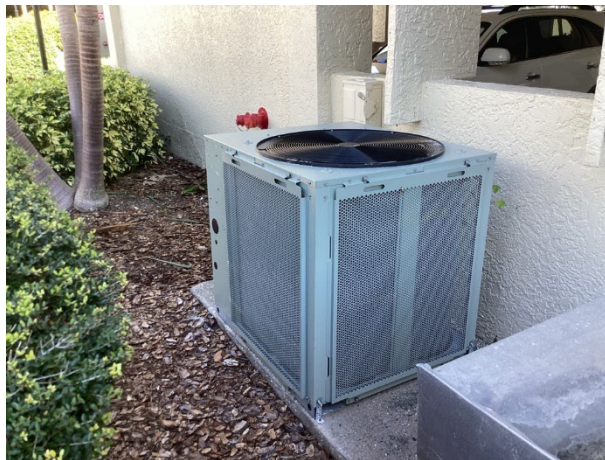
**Condition:** Reported satisfactory with operational deficiencies

**HVAC – split system**

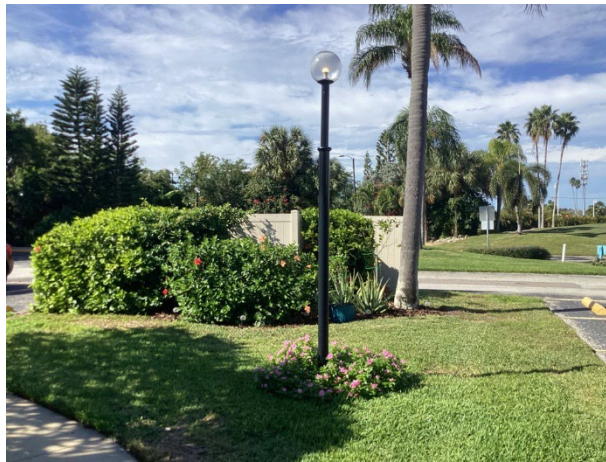
**Condition:** Fair overall

**Light poles and fixtures - typical**

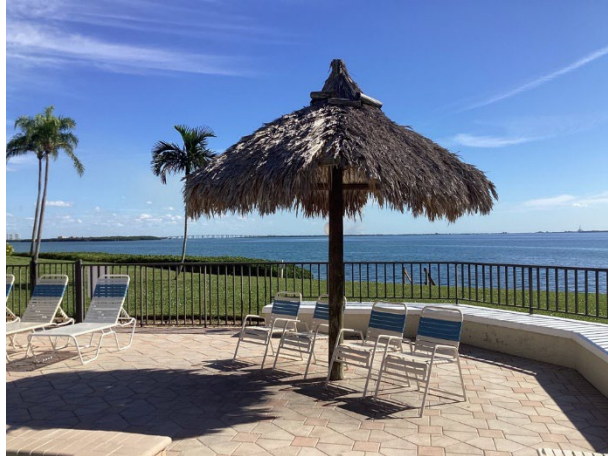
**Condition:** Fair overall. Based on information provided by the Association, we have accelerated the replacement of the tiki huts.

**Tiki huts – overview**
