## CONDITION SURVEY REPORT

**PALMA DEL MAR 5**

**CONDOMINIUM**

**6372 PALMA DEL MAR BLVD. S.**

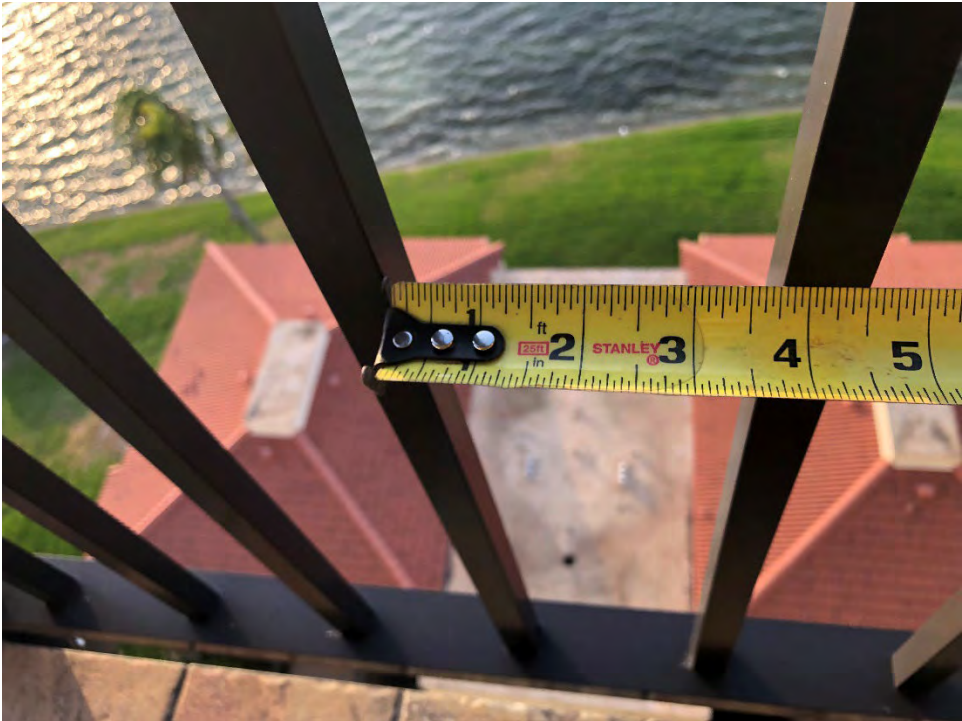
- The pickets appear to be  $\frac{3}{4}$ " x  $\frac{3}{4}$ " and appear to be designed to resist a 4-inch sphere, which is the current building code requirement (Refer to Figure A-2).

Figure A- 2 – Typical Tower Guardrail Clear Spacing

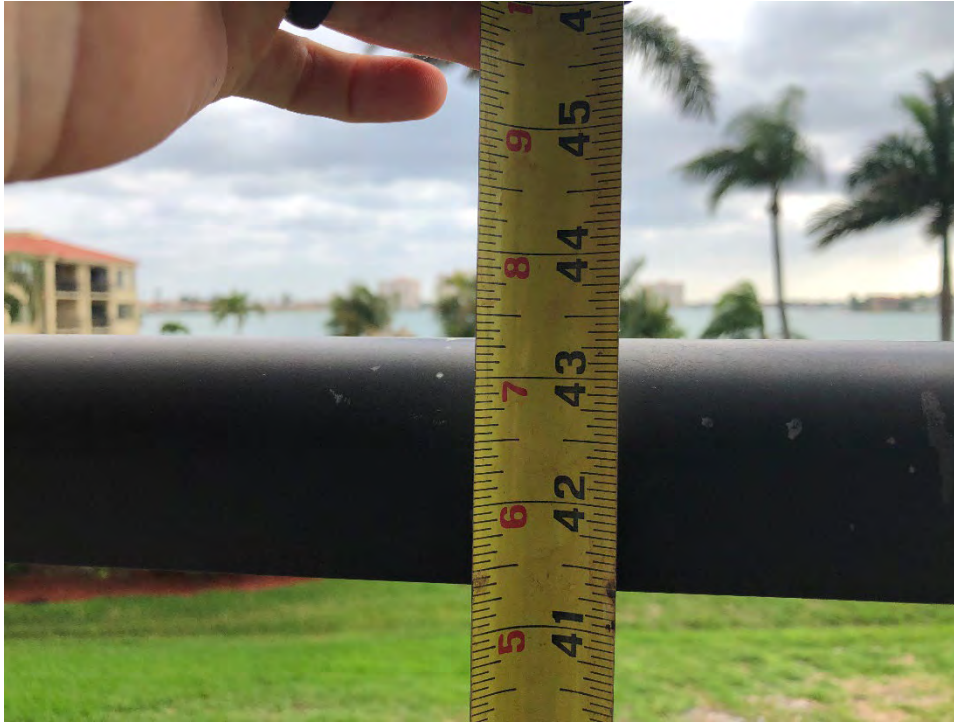
- The guardrails appear to be designed to be approximately 43 inches high, which is above the current building code minimum height requirement of 42 inches (Refer to Figure A-13).
- Areas of delaminated floor tile finishes were observed on Units 309, 220, and 208.
- Concrete lintel spall was observed at the south window opening of Unit 204 (Refer to Figure A-14).
- Areas of delaminated exterior stucco ceiling and wall finishes were observed at Unit 318, 220, and 218 (Refer to Figure A-15).

*Figure A- 13 – Typical Villa Guardrail Height*

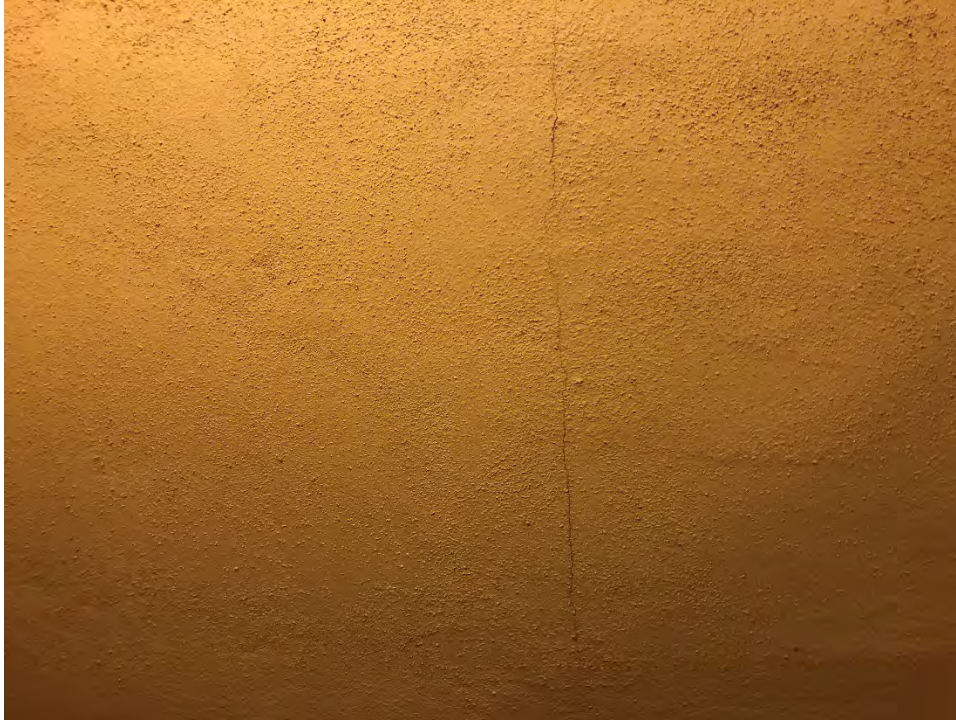
*Figure C- 7 – Ceiling Crack*

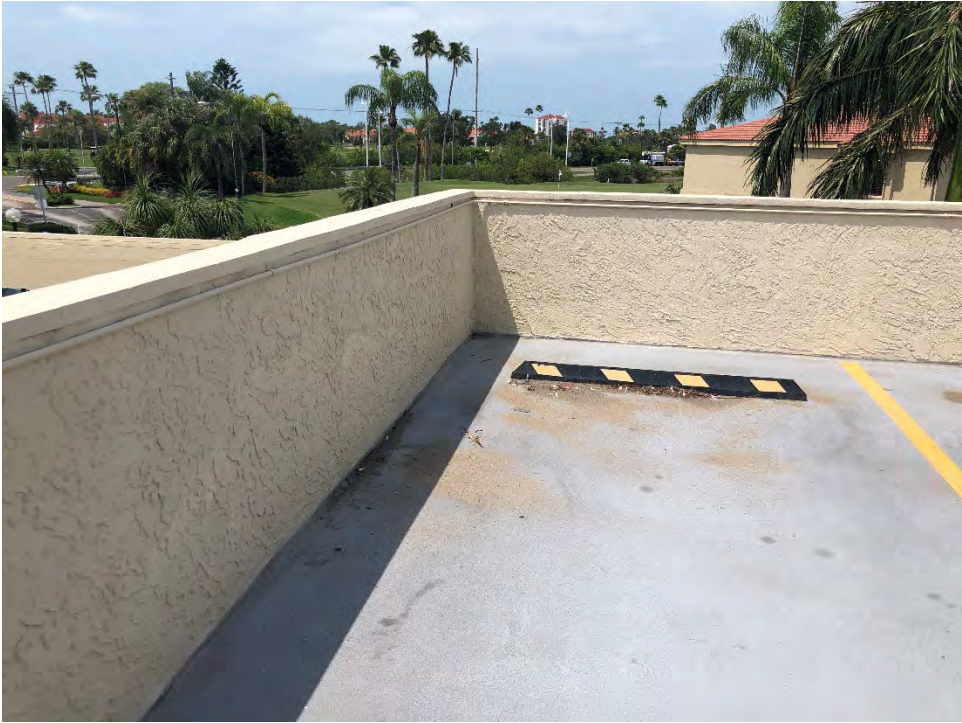
Figure D- 9 – Typical Concrete Guardrail

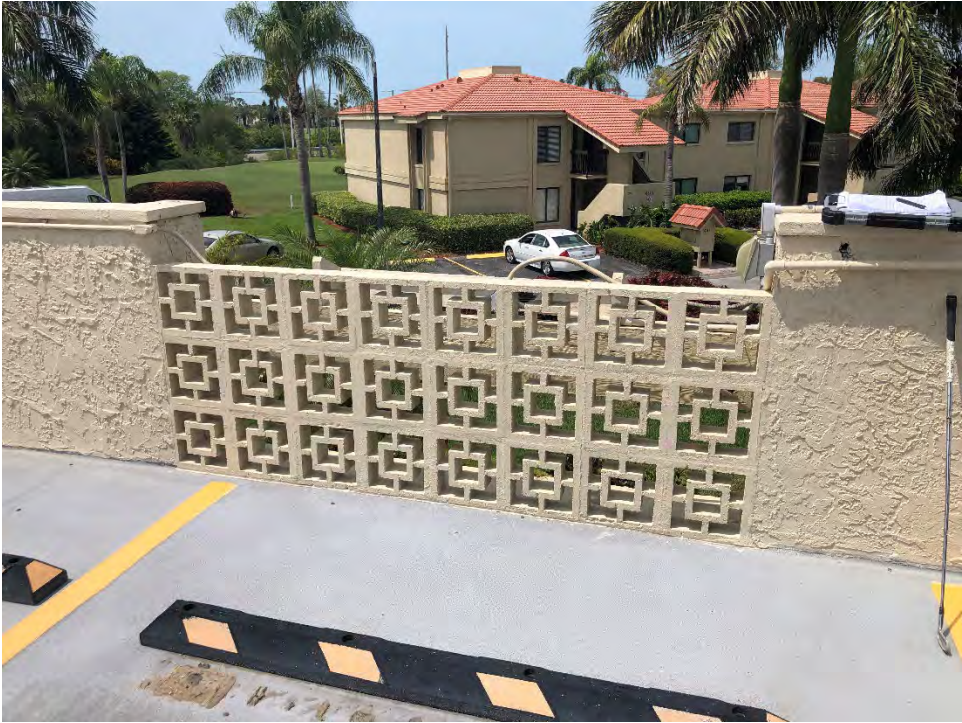
Figure D- 10 – Typical Concrete Guardrail

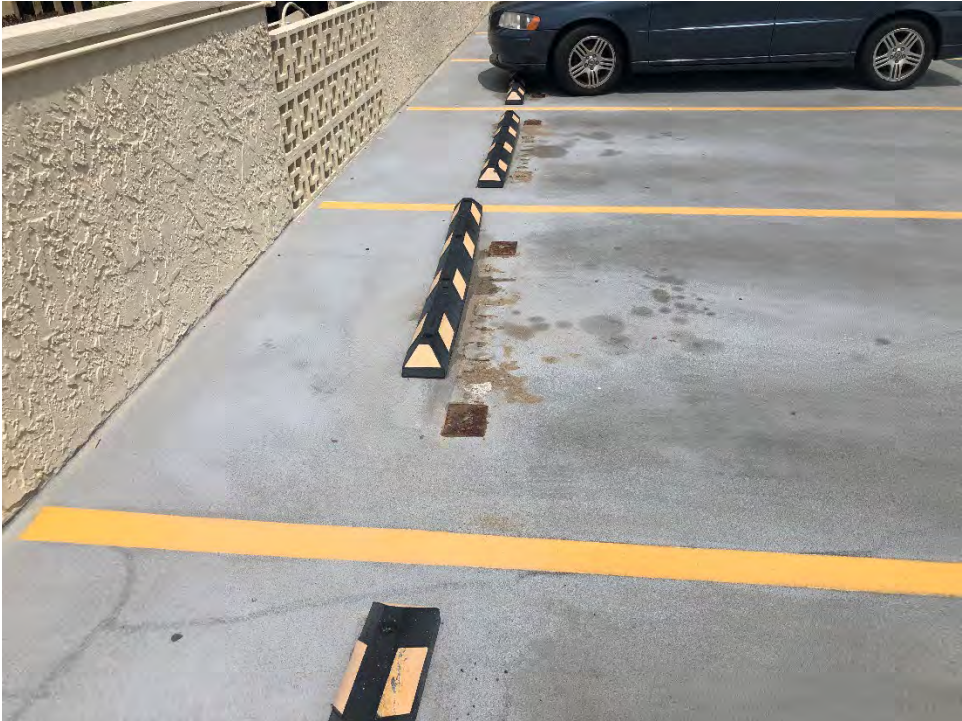
Figure D- 11 – Unadhered Parking Stops

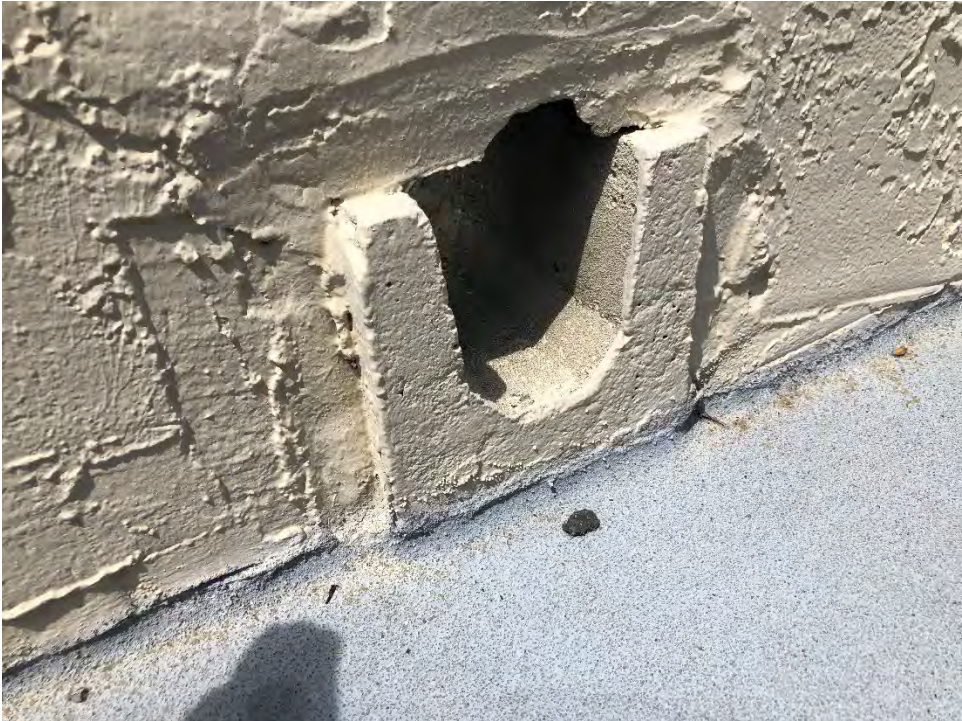
Figure D- 12 – Typical Drainage Scupper

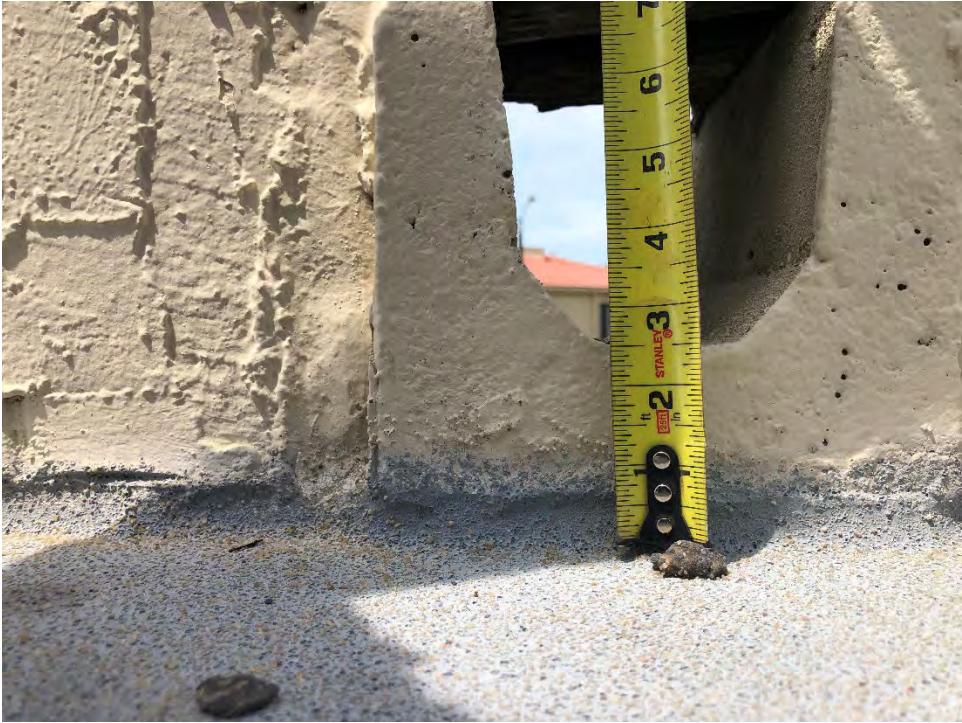
Figure D- 13 – Typical Drainage Scupper

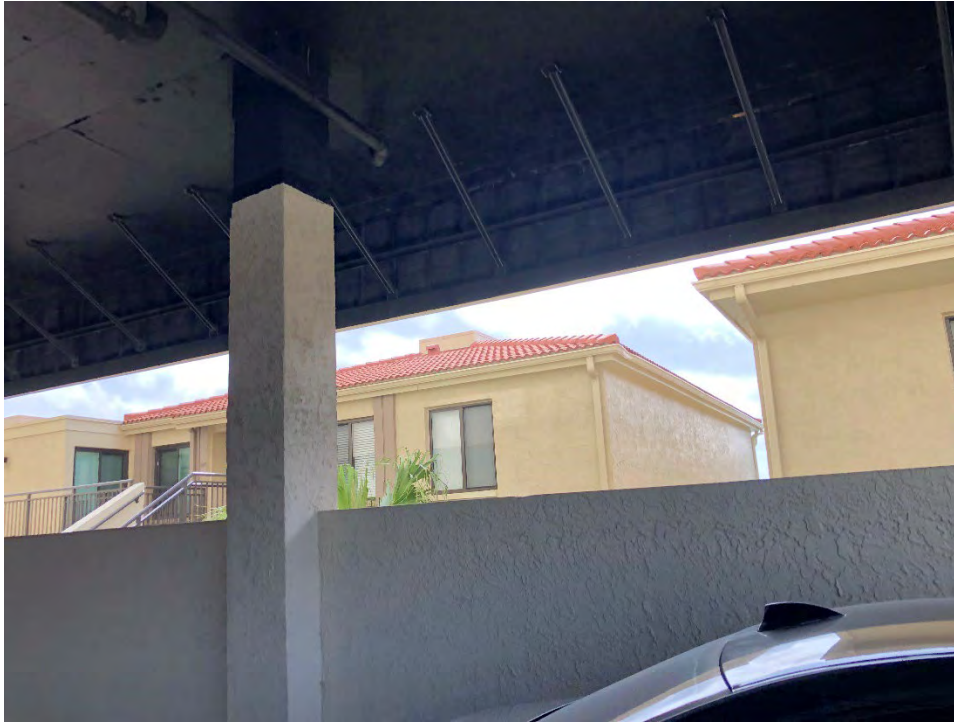
Figure E- 5 – Drop Down Walls/Beams

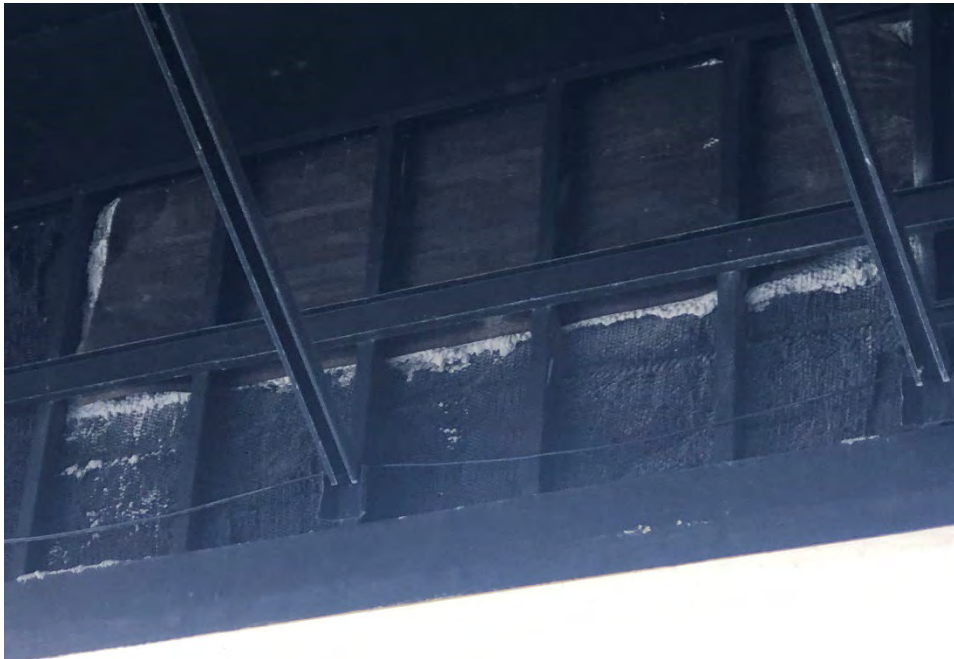
Figure E- 6 – Drop Down Walls/Beams

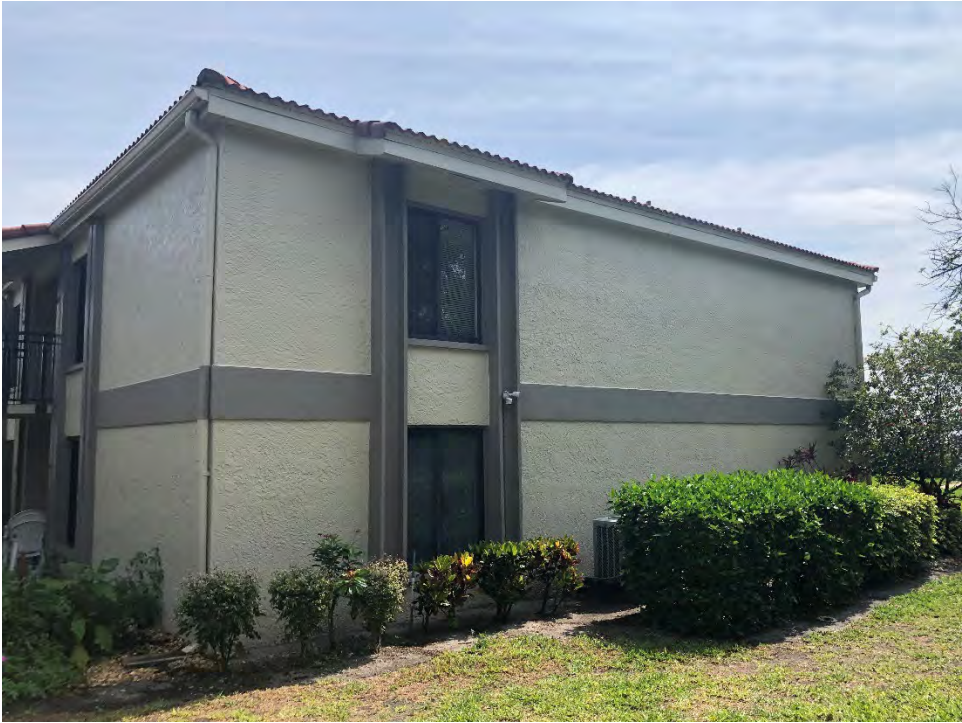
Figure E- 29 – North Elevation (Units 21 - 24)

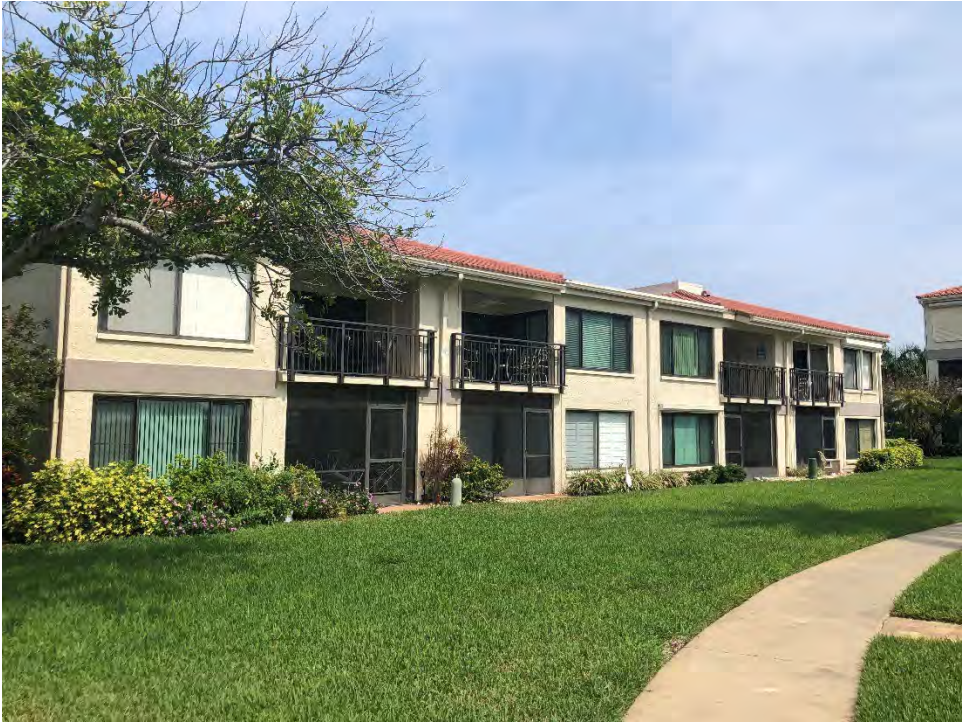
Figure E- 30 – West Elevation (Units 21 - 24)

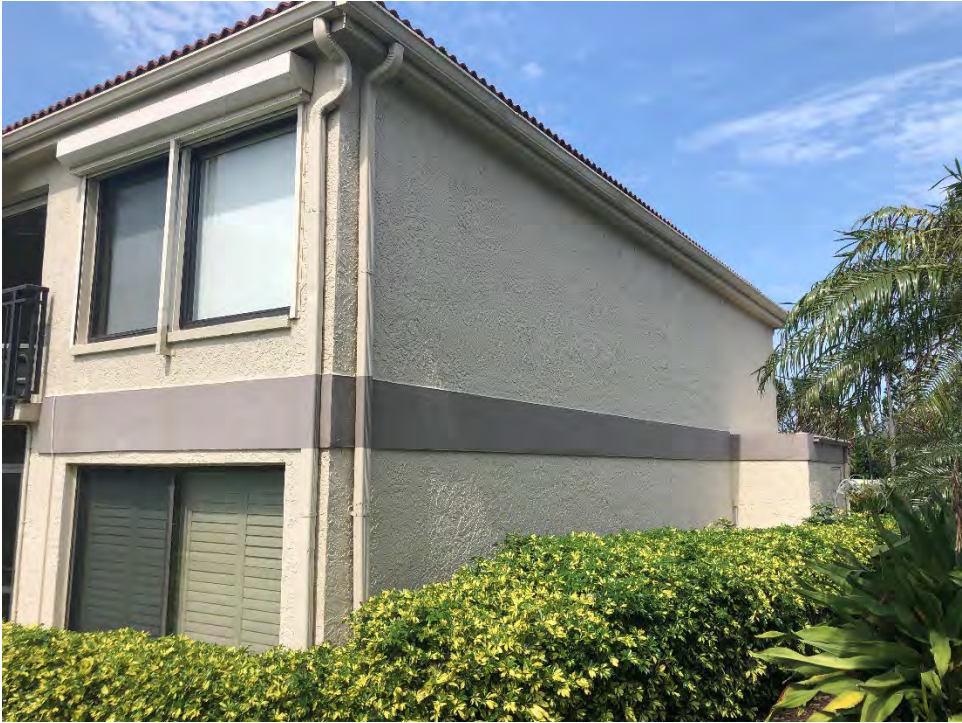
Figure E- 31 – South Elevation (Units 21 - 24)

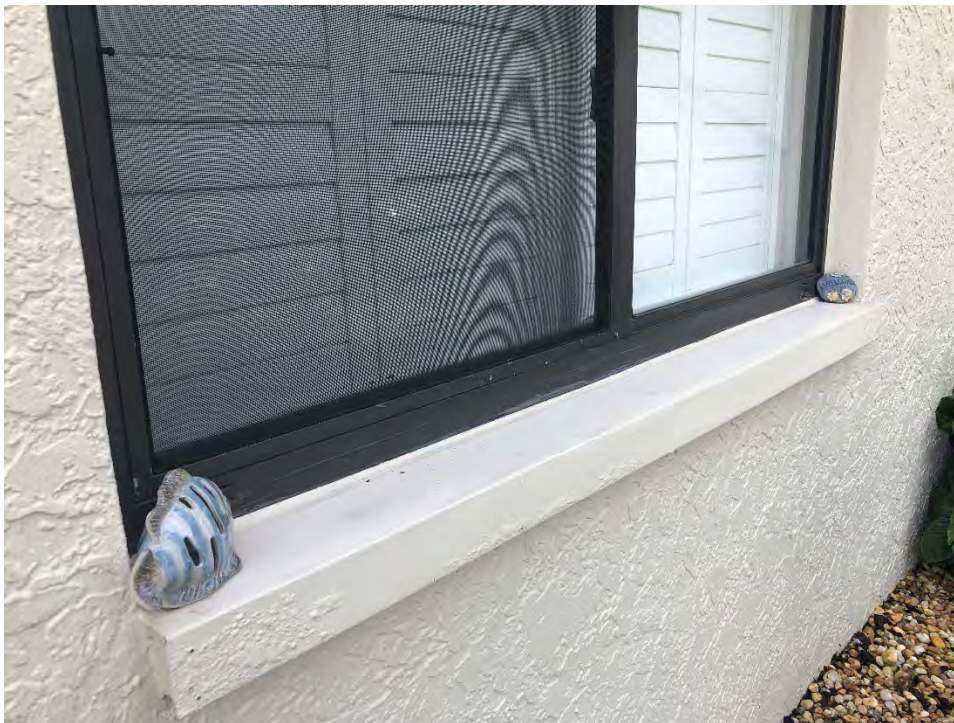
*Figure E- 53 – Windowsill Spall (Unit 223)*

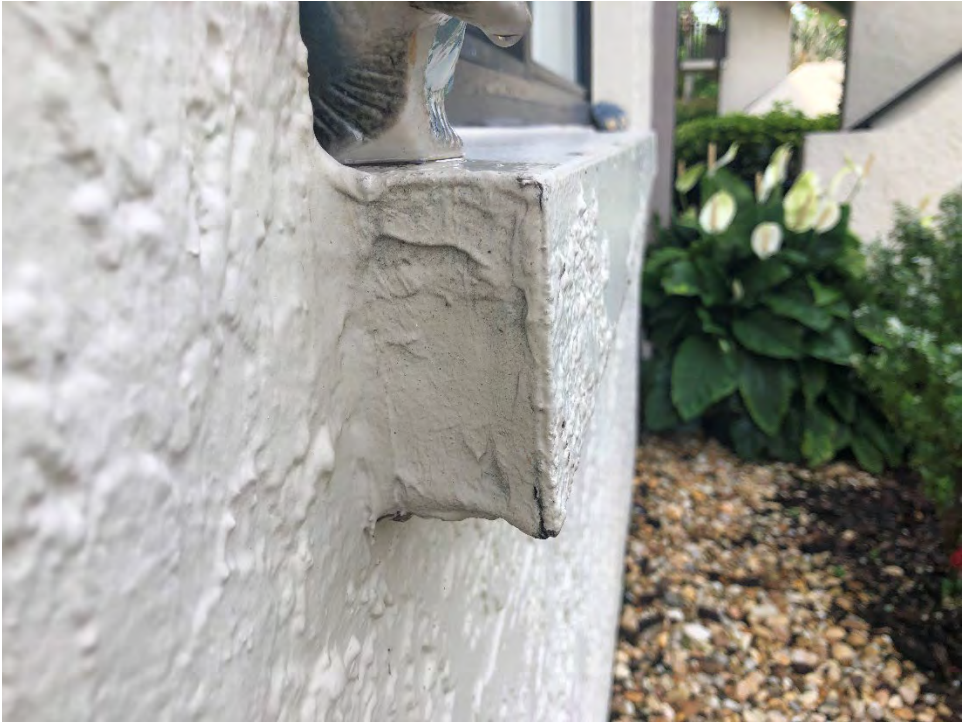
*Figure E- 54 – Typical Metal Flashing at Windowsill*

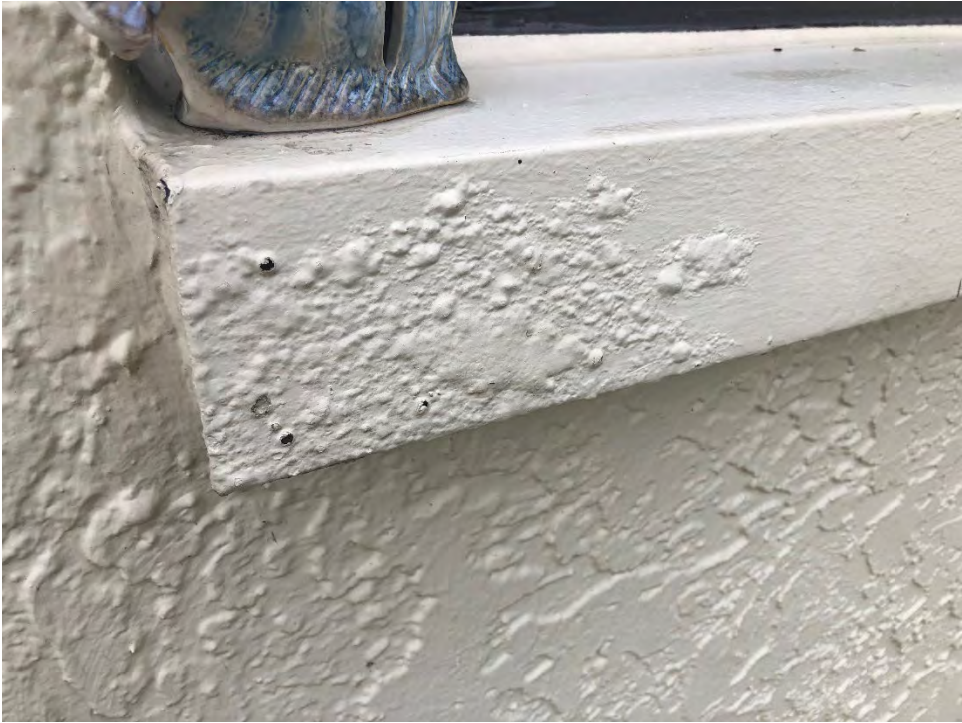
Figure E- 55 – Typical Metal Flashing at Windowsill

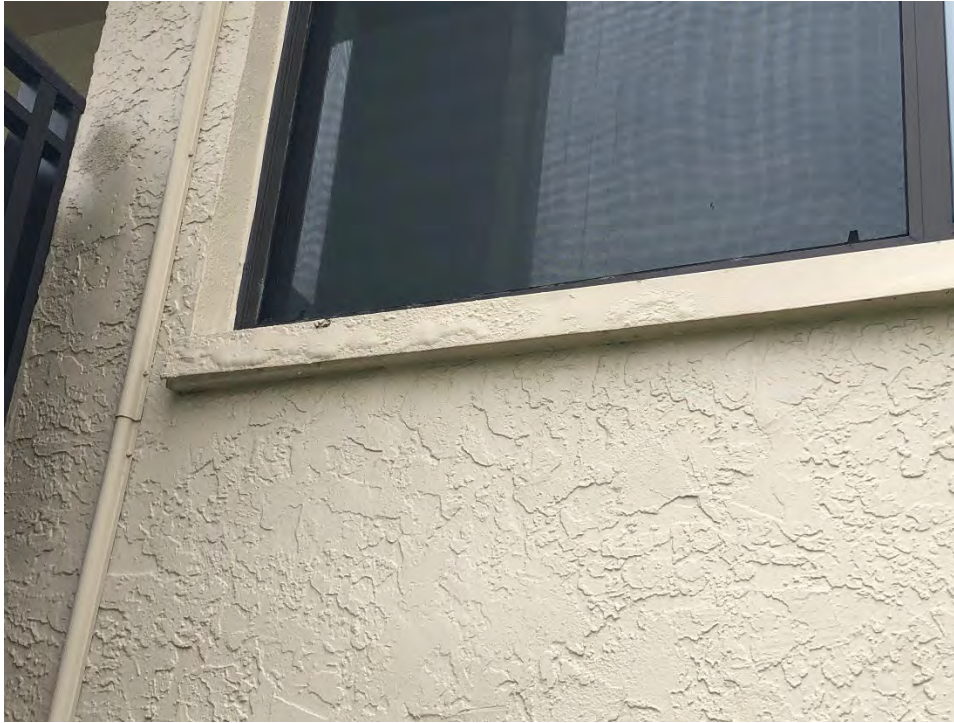
Figure E- 58 – Typical Metal Flashing at Windowsill
