FULL RESERVE STUDY

Palma Del Mar Condominium Association No. 5 of St Petersburg, Inc.

St. Petersburg, Florida

May 3, 2022

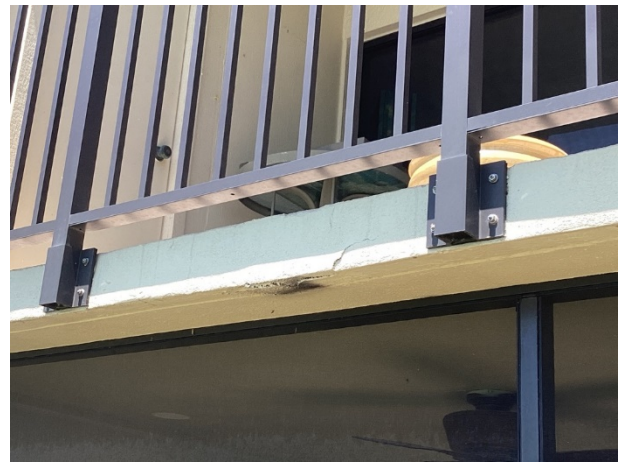
Balconies – railing connection detail

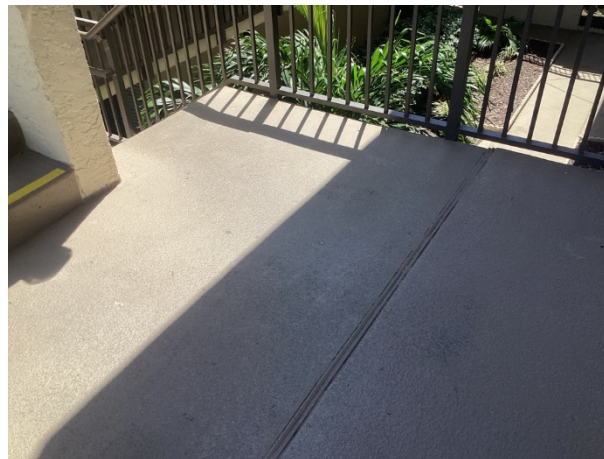
Condition: Fair overall with deterioration of the waterproof coating at the breezeways evident during our noninvasive inspection

Breezeways – overview

Useful Life: Capital repairs including a close-up visual inspection, patching of delaminated concrete, routing and filling of cracked concrete, and waterproof coating applications every 8- to 12-years.

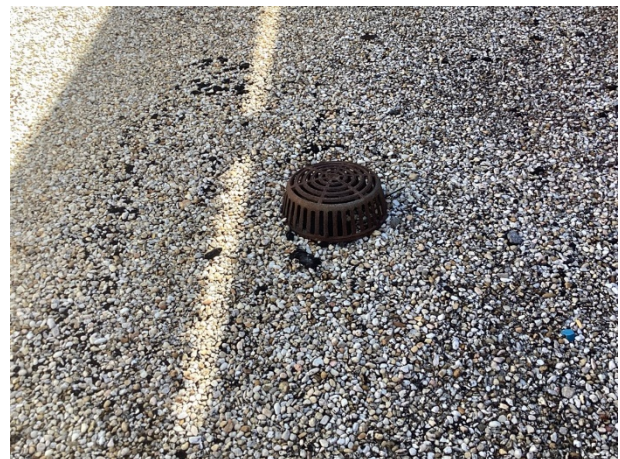
Built-up roof – penetration detail

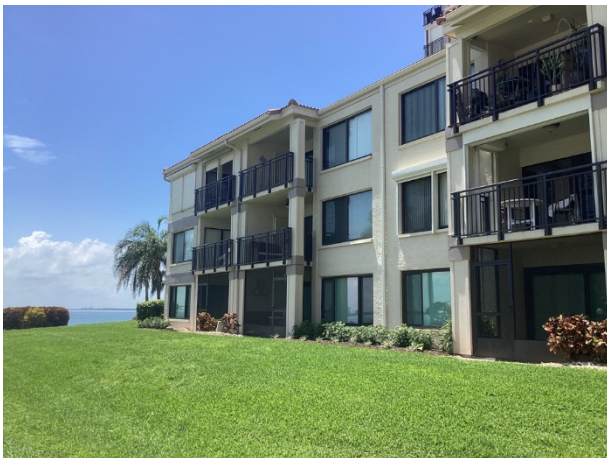
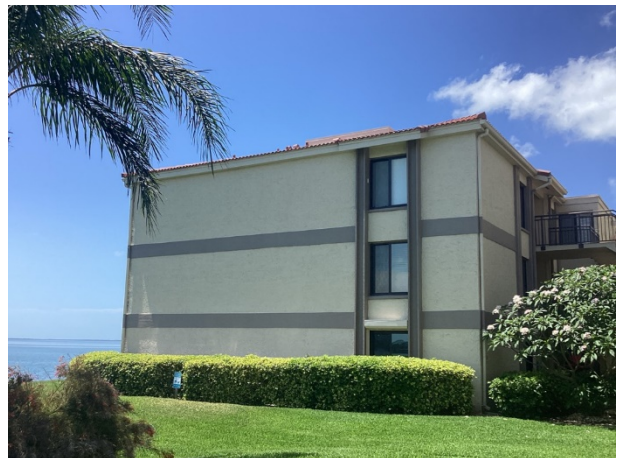
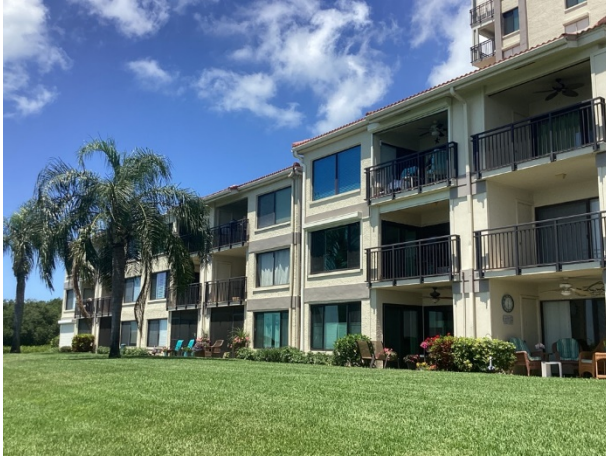
Paint finishes – villas - overview

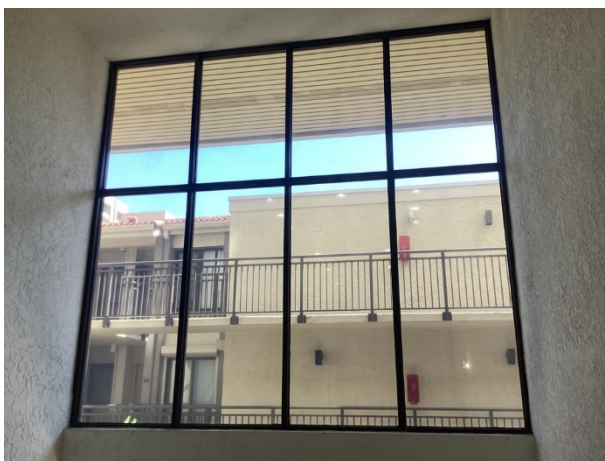
Condition: Good overall with no significant deterioration evident.

Storefront windows - overview

Storefront windows and doors – overview

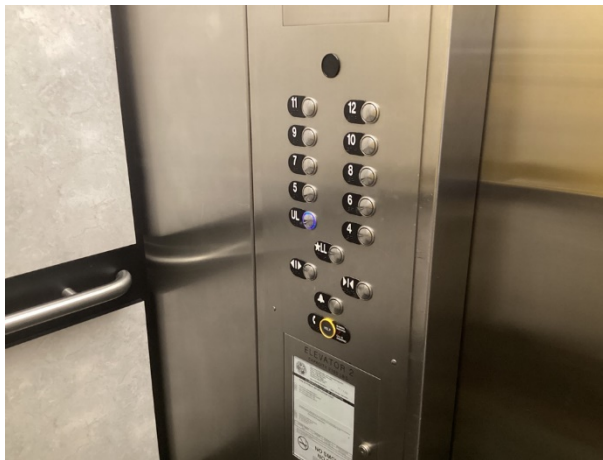
Condition: Good overall with no significant deterioration evident.

Elevator cab finishes

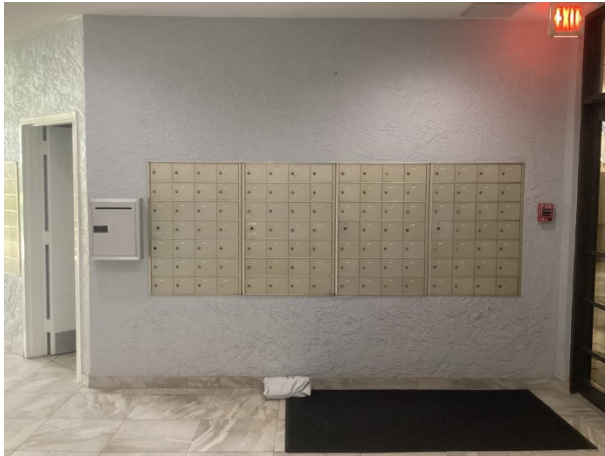
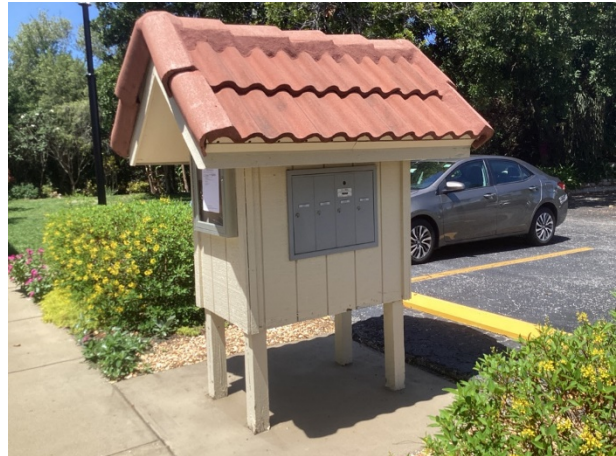
Condition: Reported good overall

Mailboxes - overview

Mailboxes – overview

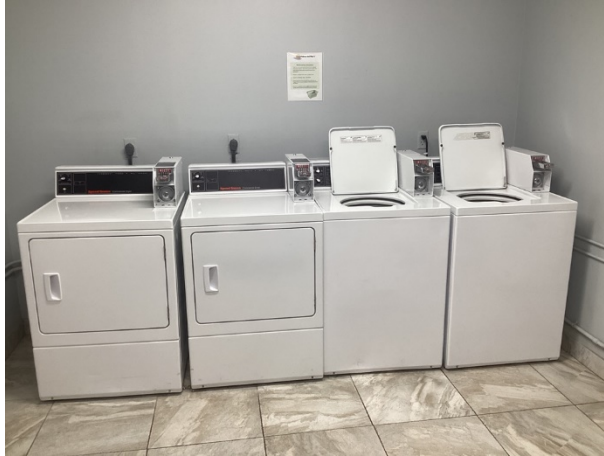
Condition: Reported satisfactory with operational deficiencies

Laundry equipment

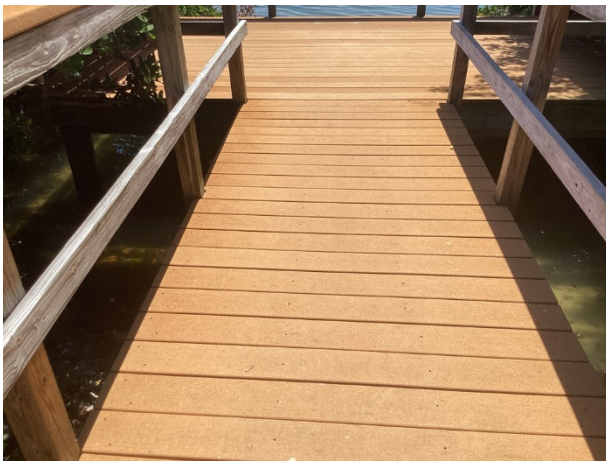
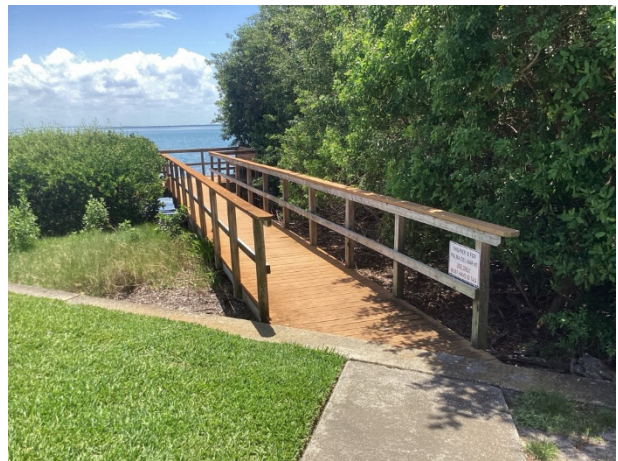
Condition: Good overall

Fishing pier – composite deck boards

Fishing pier – overview

Useful Life: We recommend the Association conduct complete replacement of the composite deck boards and partial replacements of the structures every 25 years

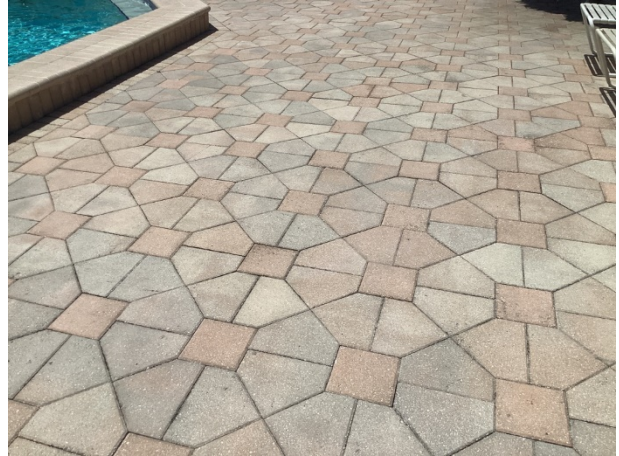
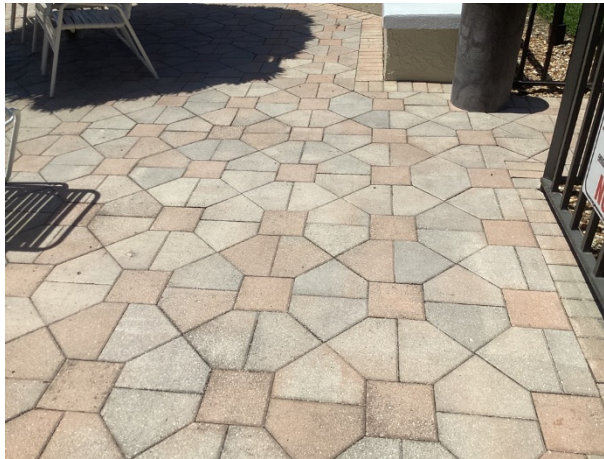
Deck pavers - overview

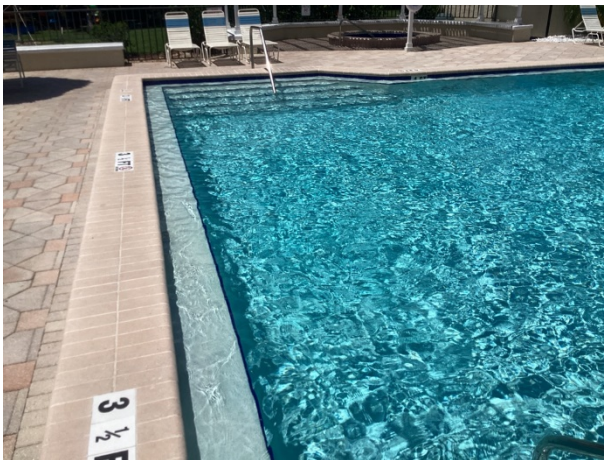
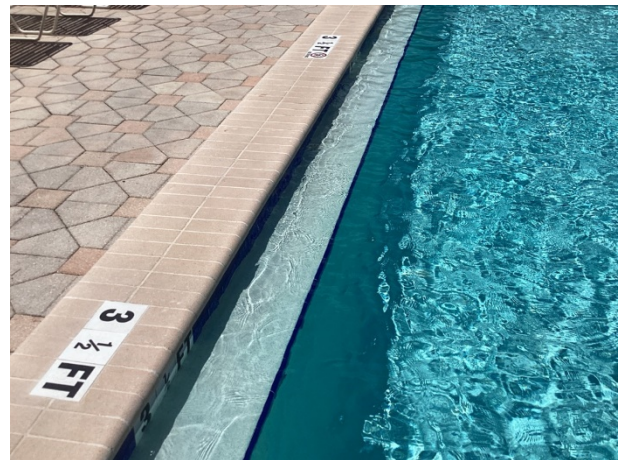
Condition: Good to fair overall with minor cracks evident. We are informed that there are some leaks at the spa and have allocated monies to replace the finishes at the pool in the near term.

Pool finishes – overview

Expenditure Detail Notes: Expenditure timing and costs are depicted in the **Reserve Expenditures** table in Section 3. We recommend the Association budget for full tile and coping replacement every other plaster replacement event. Removal and replacement of the finish provides the opportunity to inspect the pool structures and to allow for partial repairs of the underlying concrete surfaces as needed. To maintain the integrity of the pool structures, we recommend the Association budget for the following:

- Removal and replacement of the plaster finishes
- Partial replacements of the scuppers and coping as needed
- Replacement of tiles as needed
- Replacement of joint sealants as needed
- Concrete structure repairs as needed

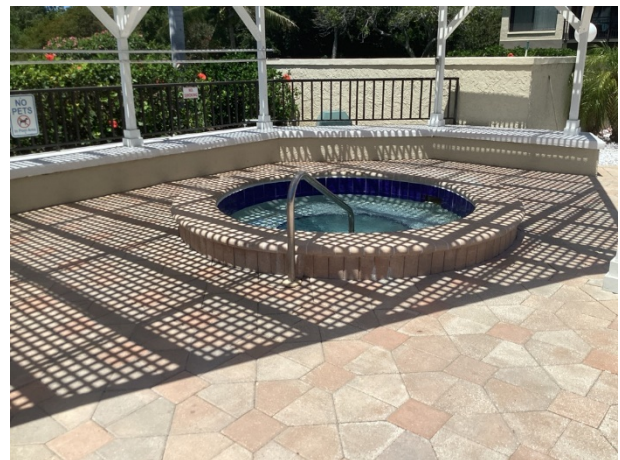
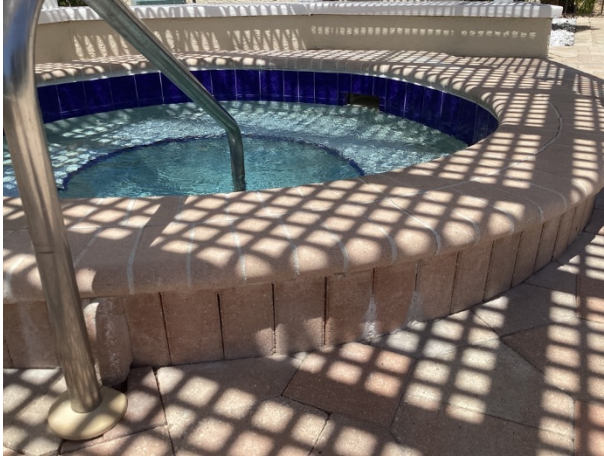
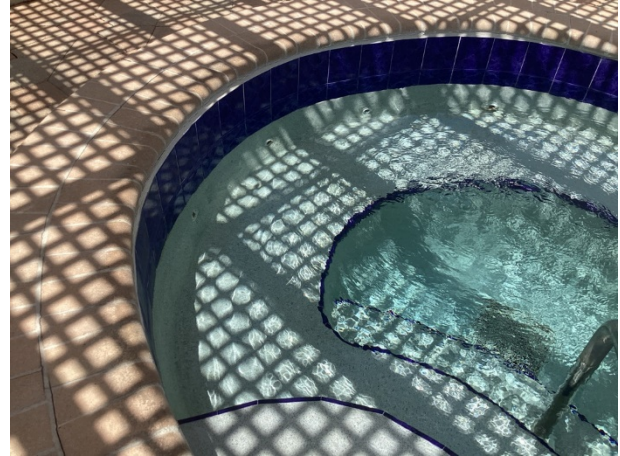
Spa finishes - overview

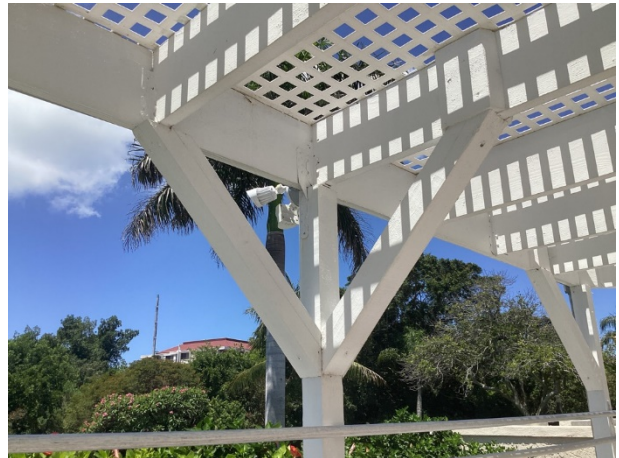
Condition: Good to fair overall

Shade structure – support detail

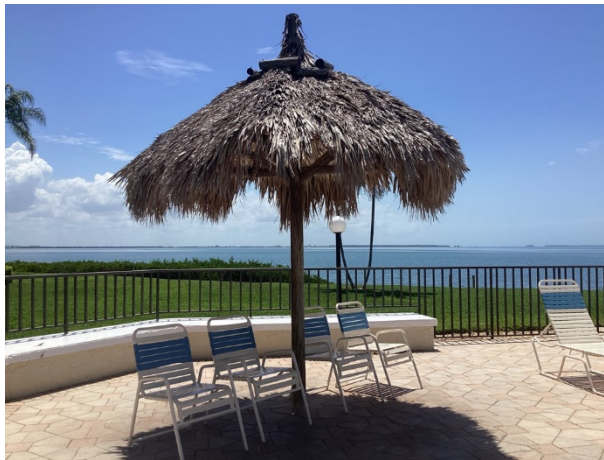
Condition: Fair overall

Tiki huts

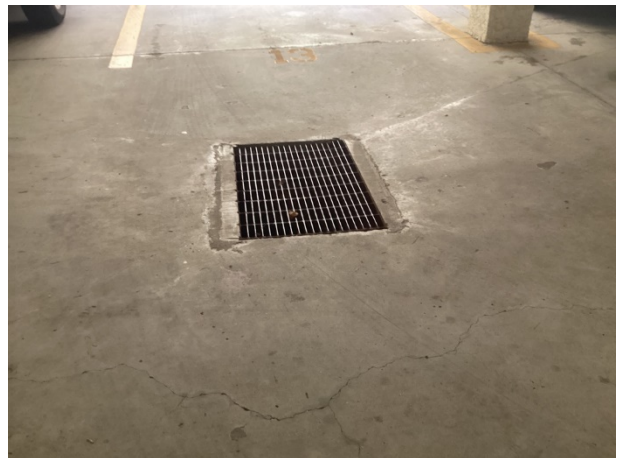
On grade concrete – drainage detail

- Semi-annually:
 - Clean floors and remove vehicular oil stains
- Annually:
 - Inspect for large cracks, concrete spalls and vehicular damage at walls and columns
 - Verify drains are working properly and check for areas of extensive water ponding
