Revised **FULL RESERVE STUDY**

**Palma Del Mar Condominium Association
No. 5 of St Petersburg, Inc.**

**St. Petersburg, Florida
Inspected - May 3, 2022
Revised - December 1, 2022**

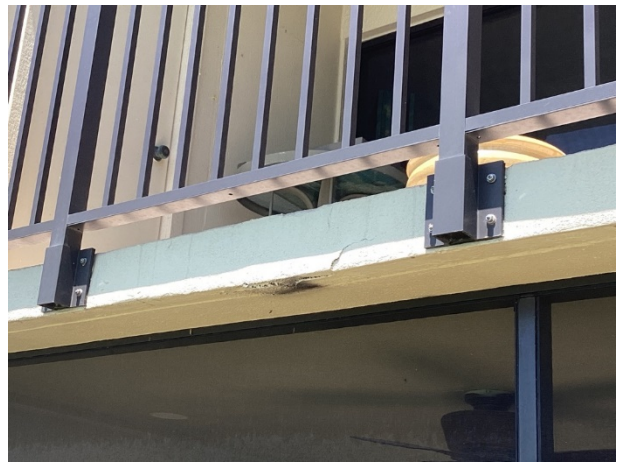
Balconies – railing connection detail

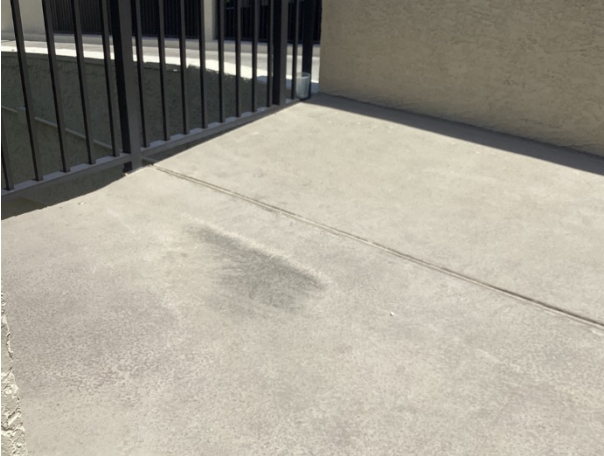
Breezeways – deterioration of the waterproof coating application evident

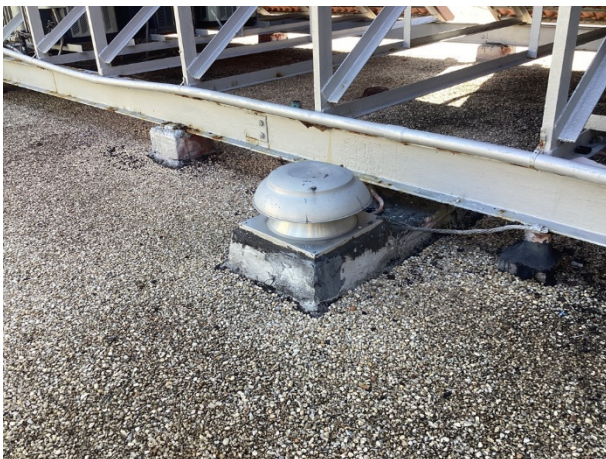
Built-up roof – penetration detail

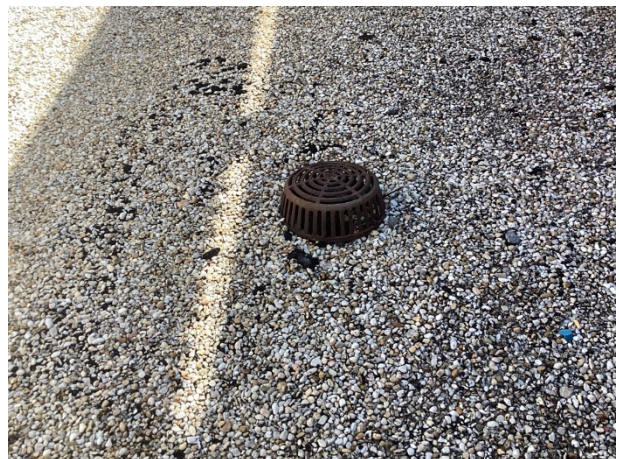
Built-up roof – penetration detail

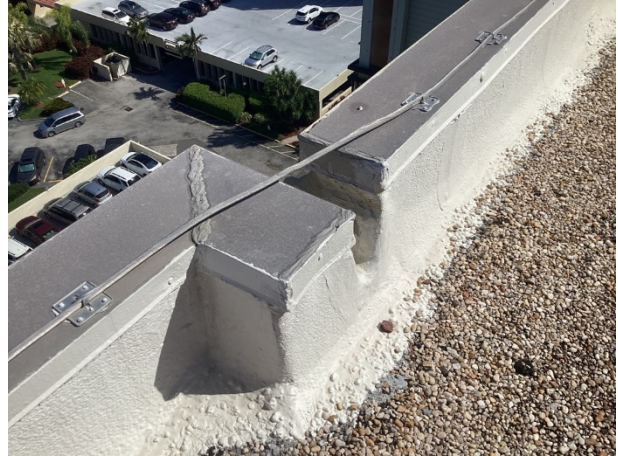
Built-up roof – coping detail

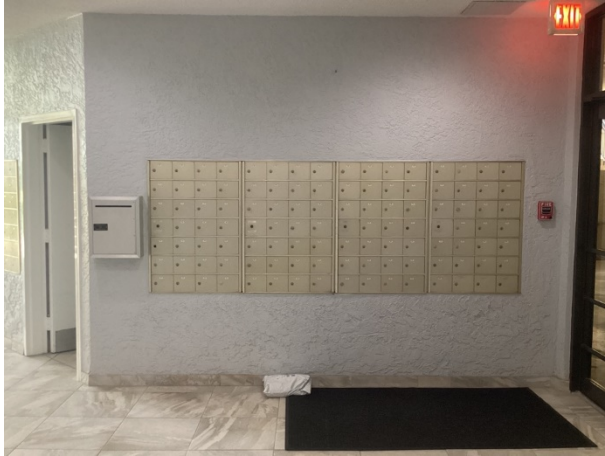
Mailboxes - overview

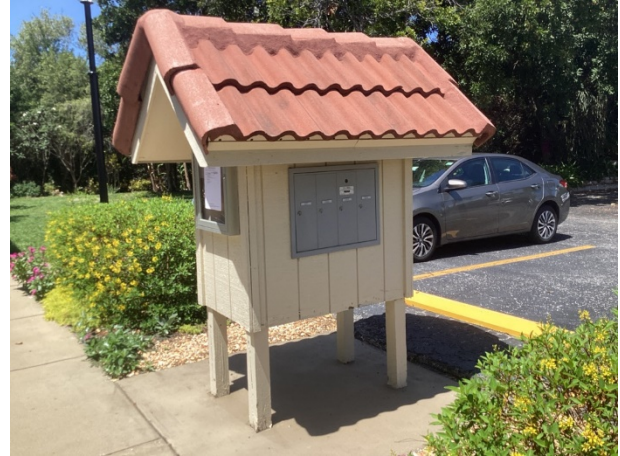
Mailboxes – overview

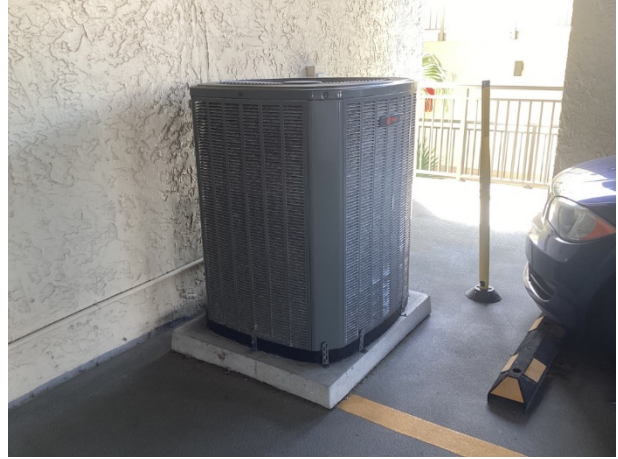
Condition: Reported satisfactory with operational deficiencies

Split systems - overview

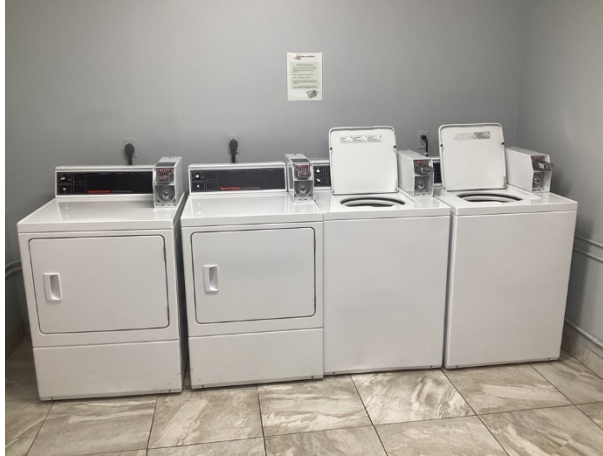
Condition: Reported satisfactory with operational deficiencies

Laundry equipment

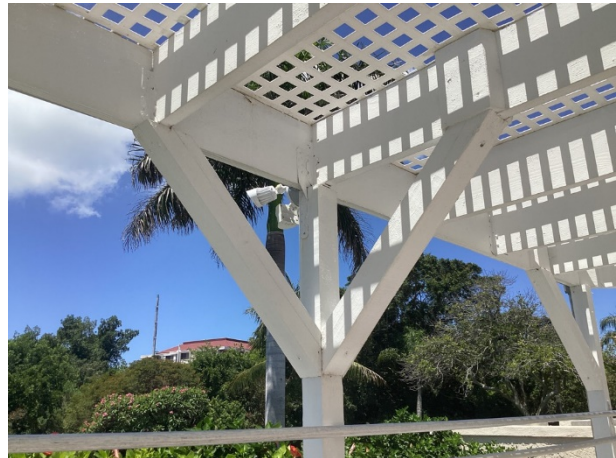
Shade structure – support detail
