# Palma Del Mar Condominium No. 5 of St Petersburg, Inc.

November 30, 2023 • St. Petersburg, FL

**STRUCTURAL INTEGRITY  
RESERVE STUDY**

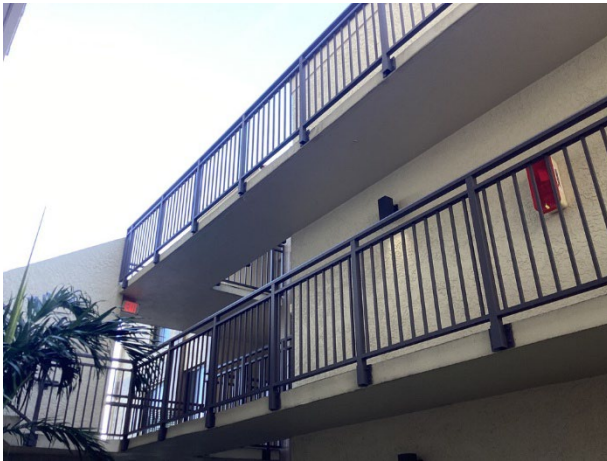
**Railings**

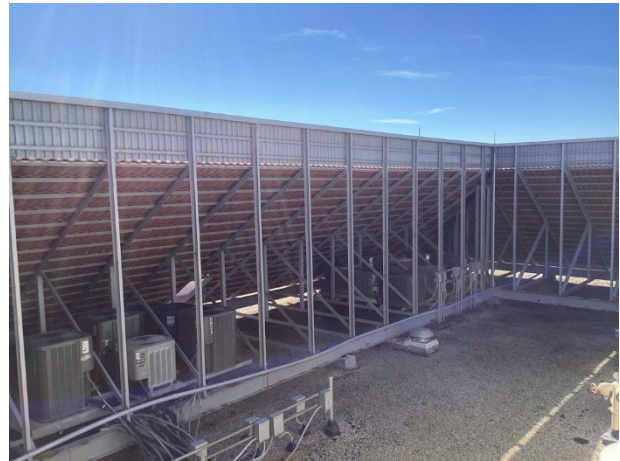
**Steel structure**

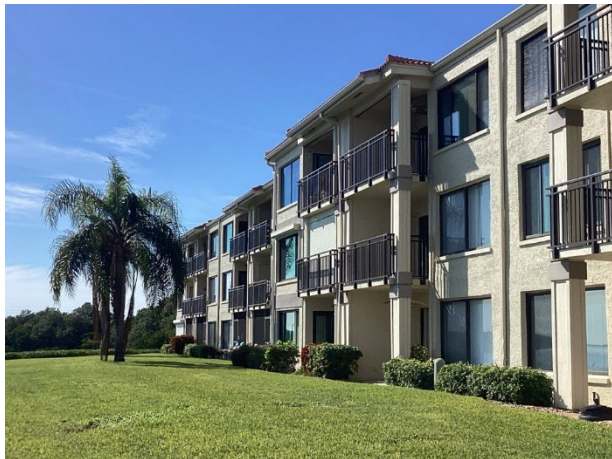
Three-story Villa - typical

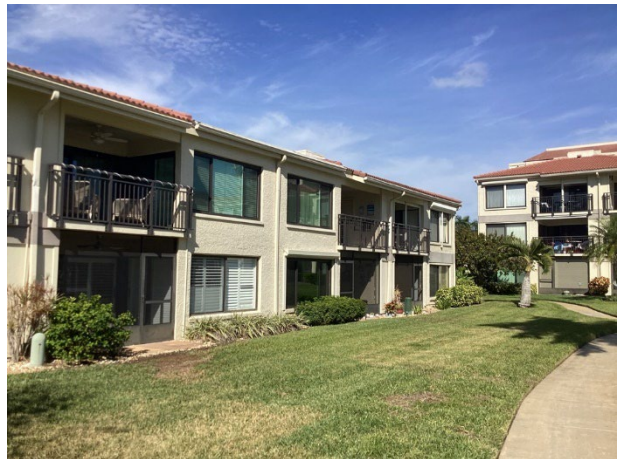
Two-story Villa - typical

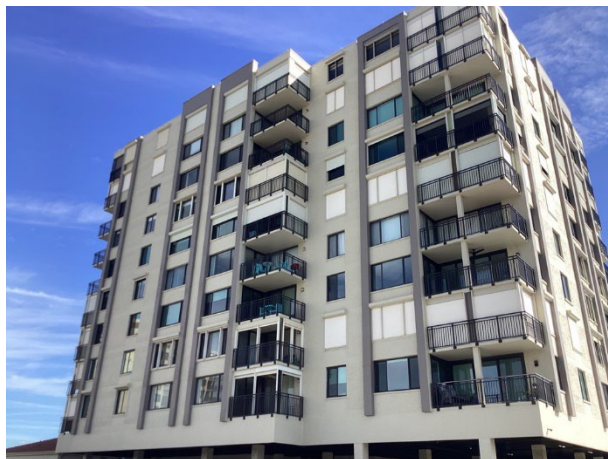
Tower – typical

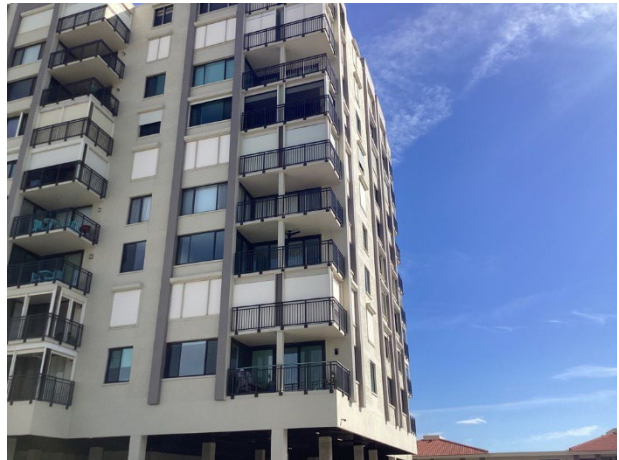
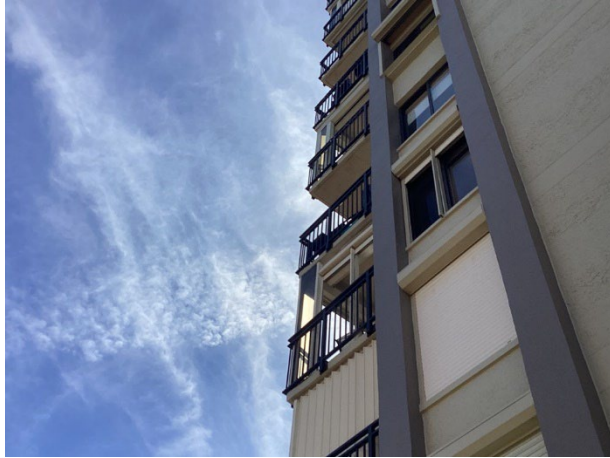
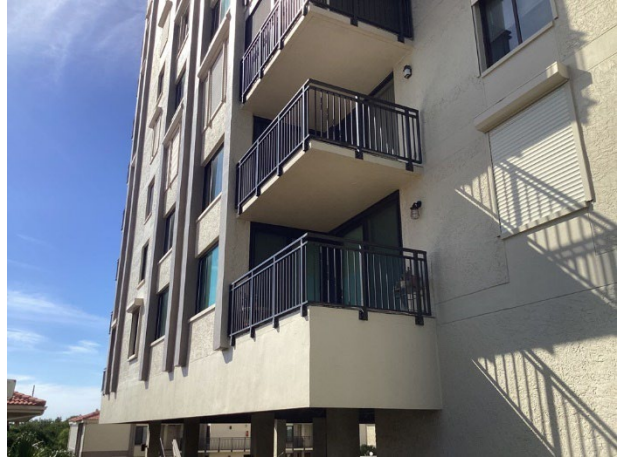
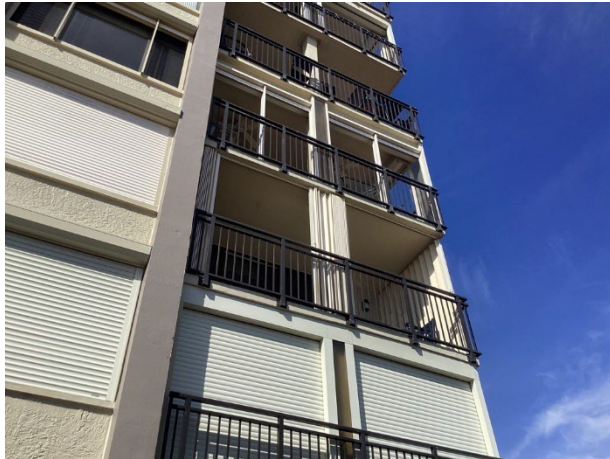
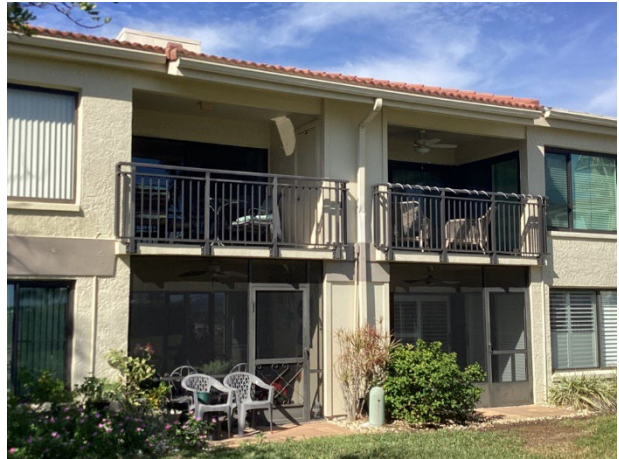
**Condition:** Fair overall with deterioration of the waterproof coating at the breezeways evident during our noninvasive inspection. We assume that the waterproof coating applications at the breezeways will be in good condition upon completion of the ongoing restoration project.

**Balconies - overview**

**Useful Life:** Capital repairs including a close-up visual inspection, patching of delaminated concrete, routing and filling of cracked concrete, and waterproof coating applications every 8- to 12-years.

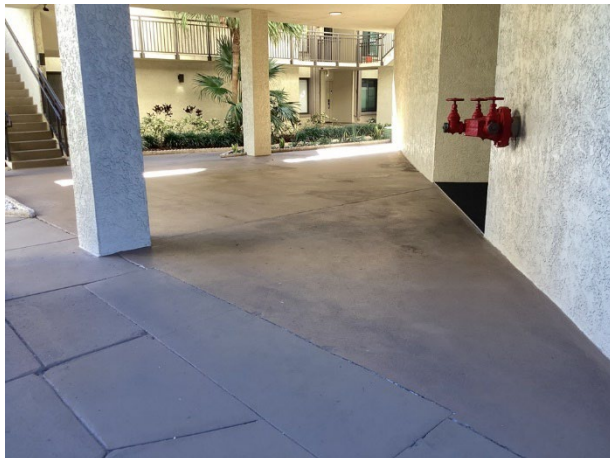
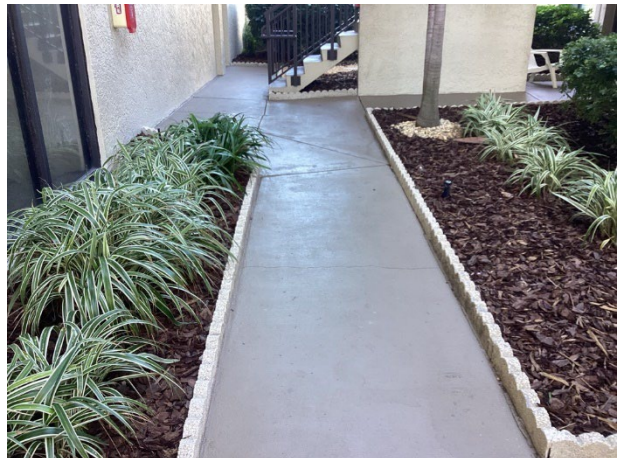
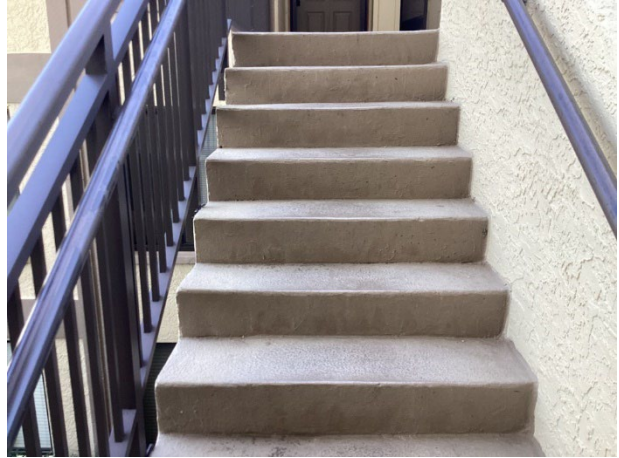
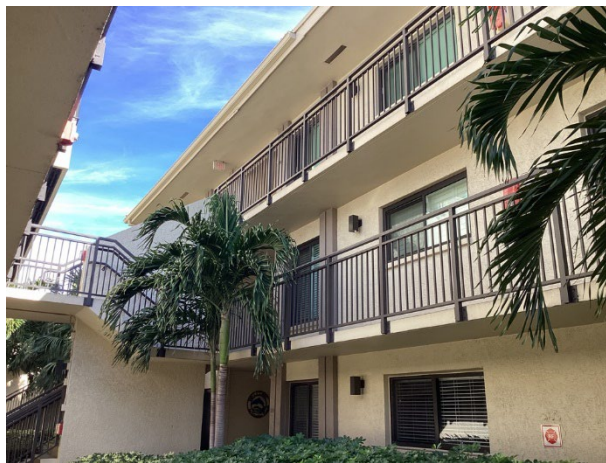
**Breezeways - overview**

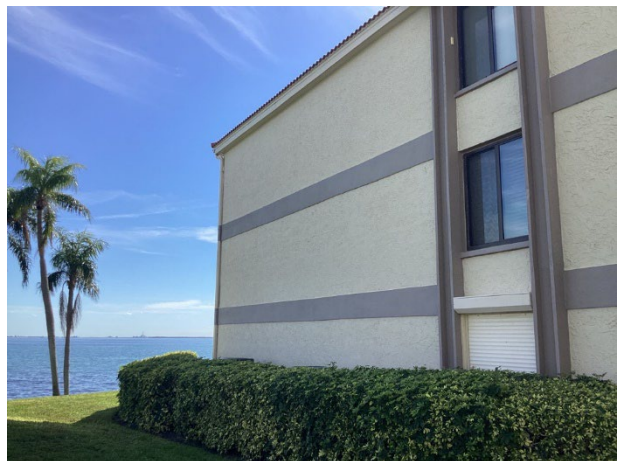
**Condition:** The paint finishes throughout the community are in good to fair condition overall with deterioration of the paint finishes and cracks evident

**Paint finish applications – Villas - overview**

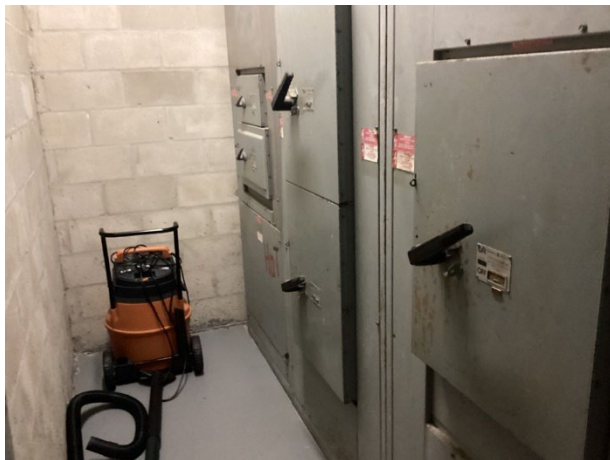
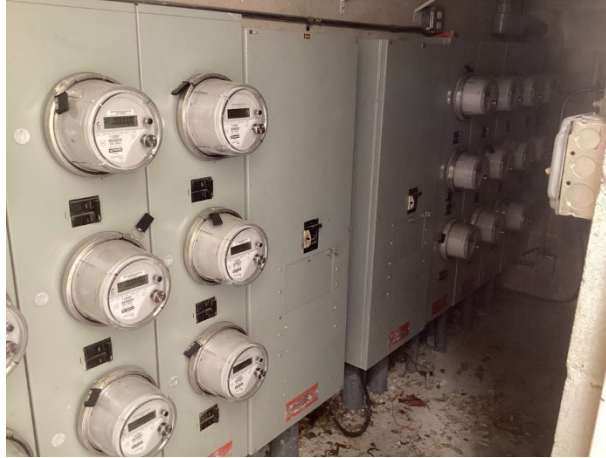
**Condition:** Reported satisfactory without operational deficiencies. We note the following:

**Electrical panels**

We recommend the Association conduct thermoscans of the distribution panels and circuit protection panels, and inspections of the transformers for any indications of arcing, burning or overheating on a regular basis, funded through the operating budget. Verification of the integrity of all connection points minimizes the potential for arcing and fires.

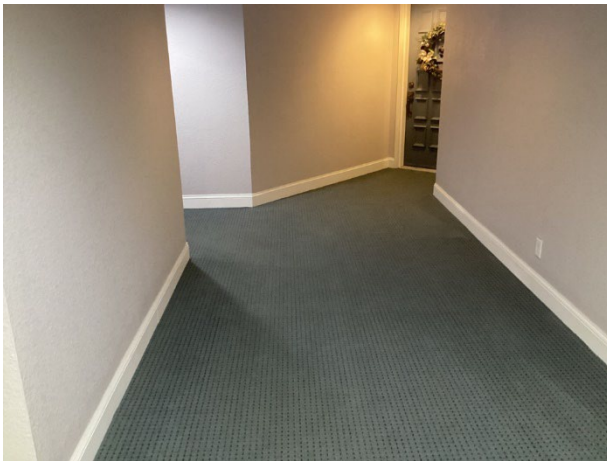
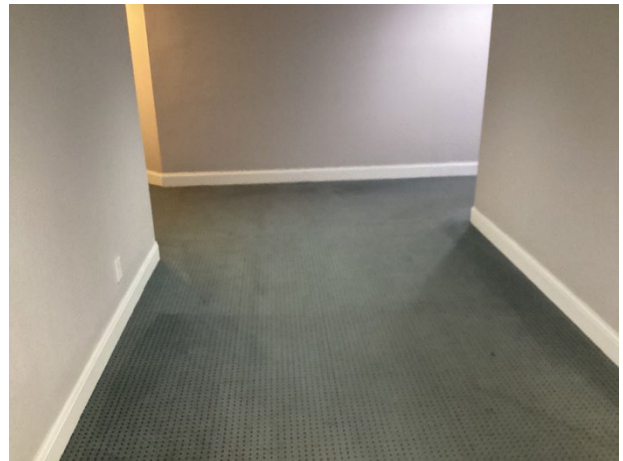
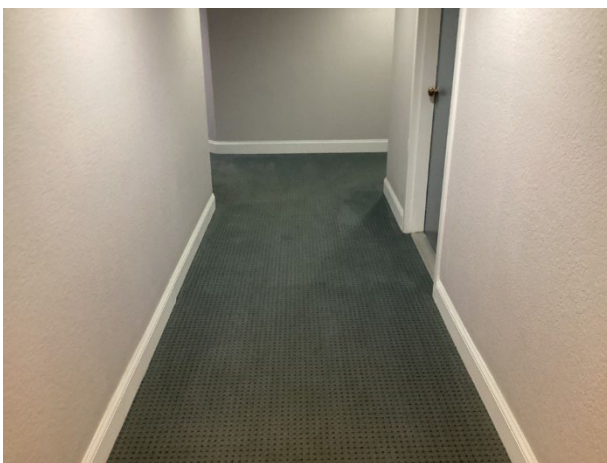
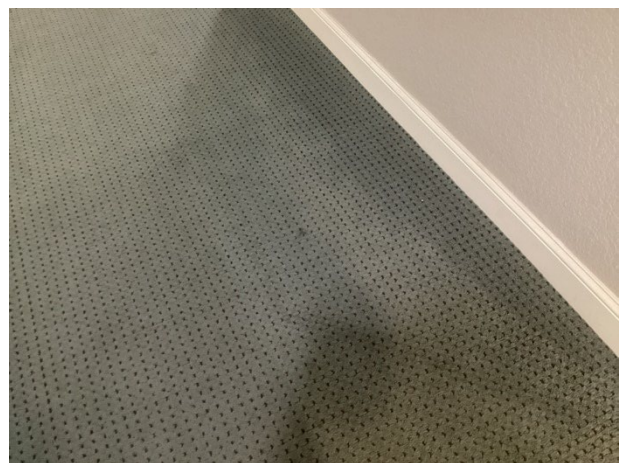
**Condition:** Good overall with minor deterioration evident

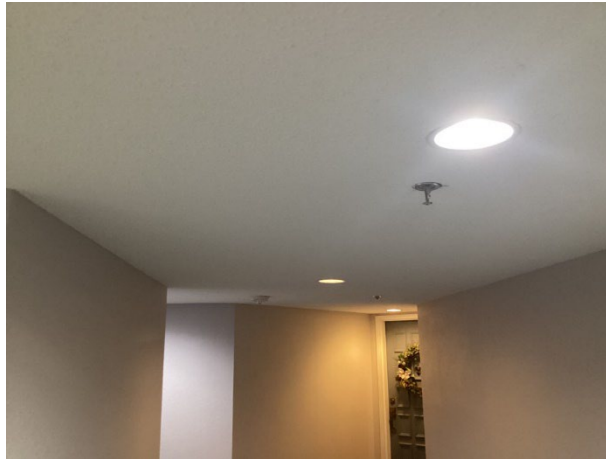
Paint finishes – overview

**Condition:** Good to fair overall

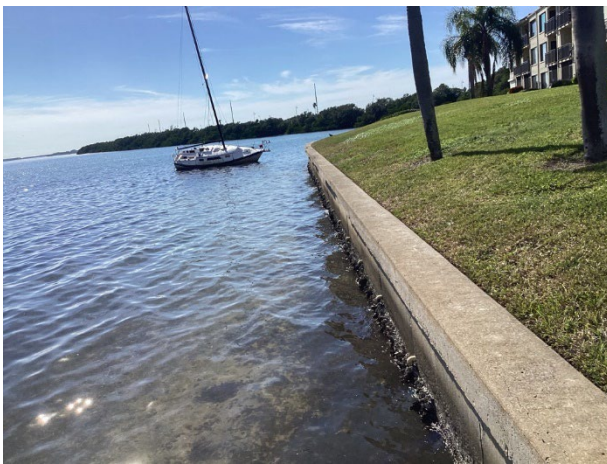
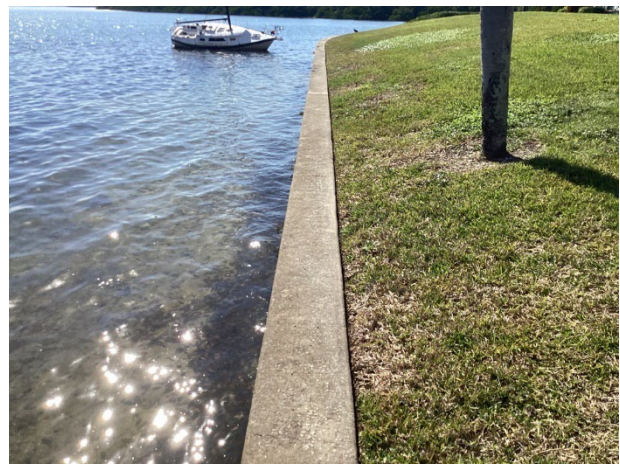
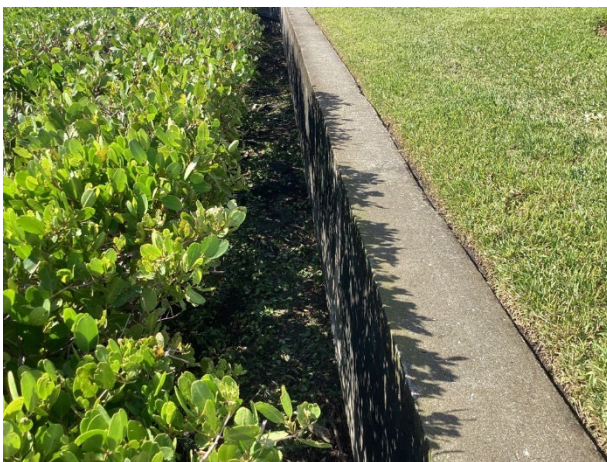
**Condition:** Fair overall with cracks in the concrete cap evident

Seawall - overview

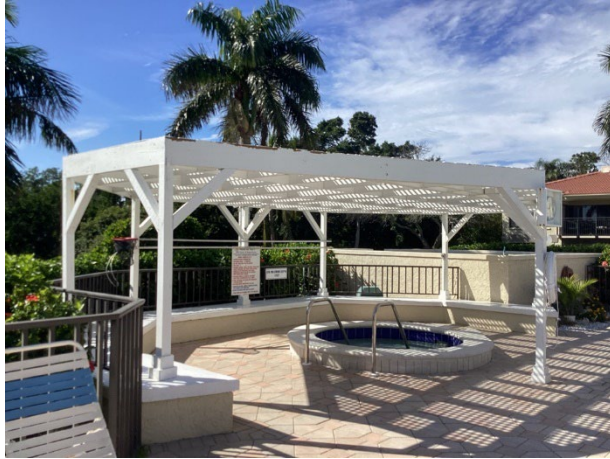
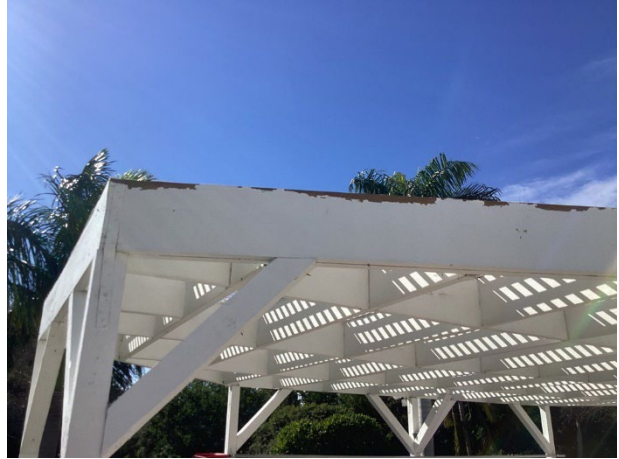
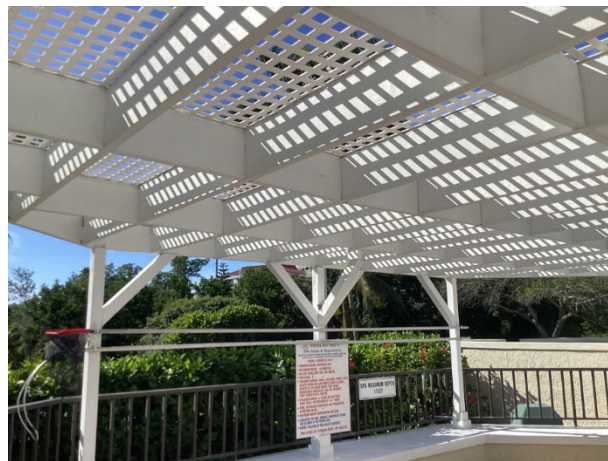
**Condition:** Good to fair overall

Pergola - overview
